June 1, 2020

Project: Tree review and assessment at 3633 90th Avenue SE, Mercer Island, WA.
Parcel number 5021900400.

Objectives: Addendum to MacCoy report dated 2/21/2020 correcting tree species, conditions, and sizes as necessary.

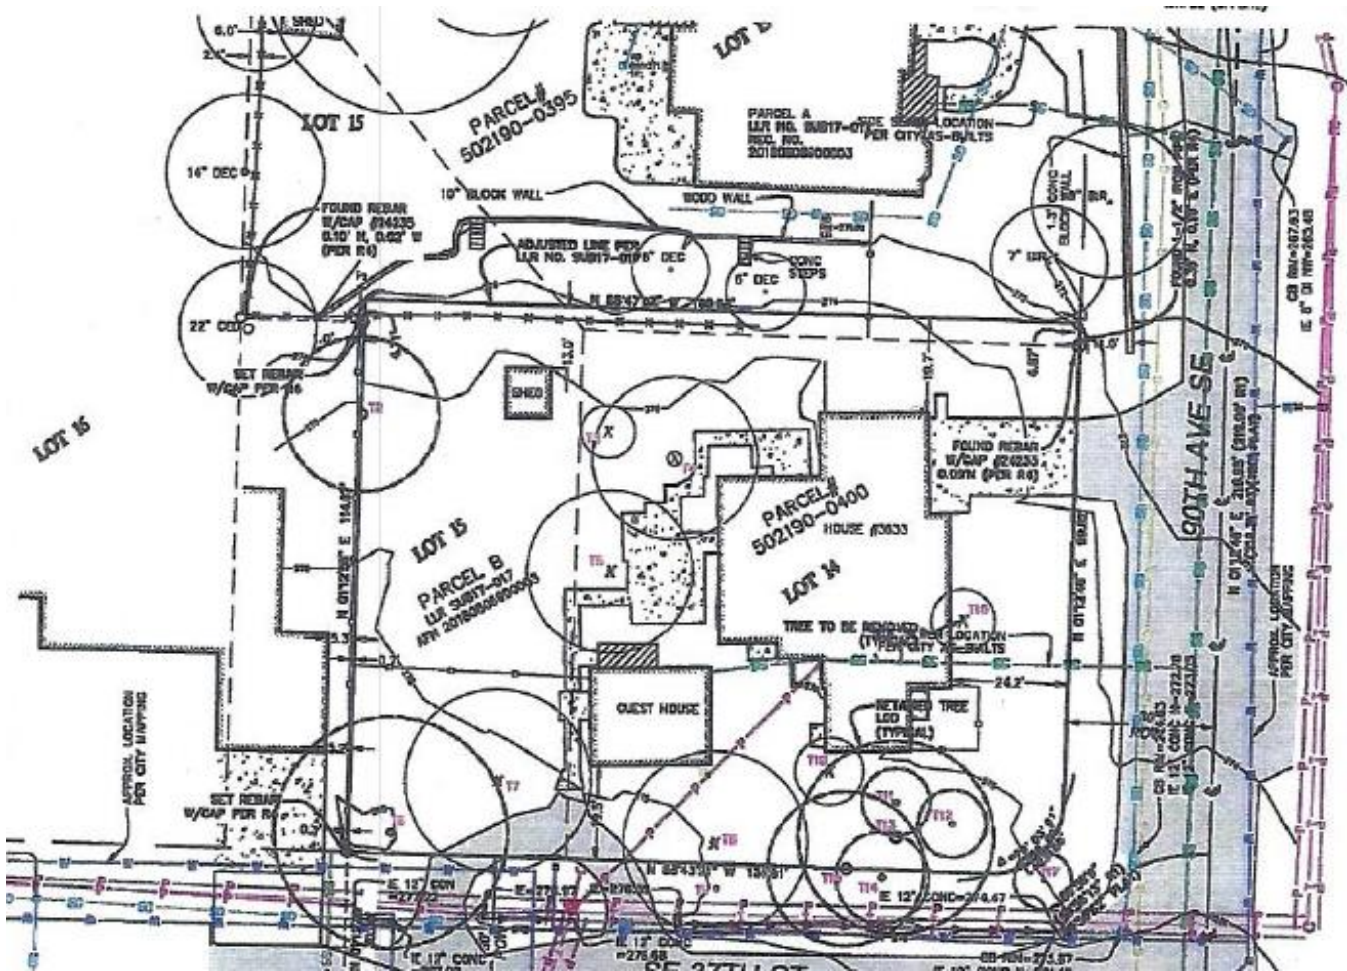
Figure 1. Excerpt from the MacCoy February 2020 report showing the tree placements and numbers.

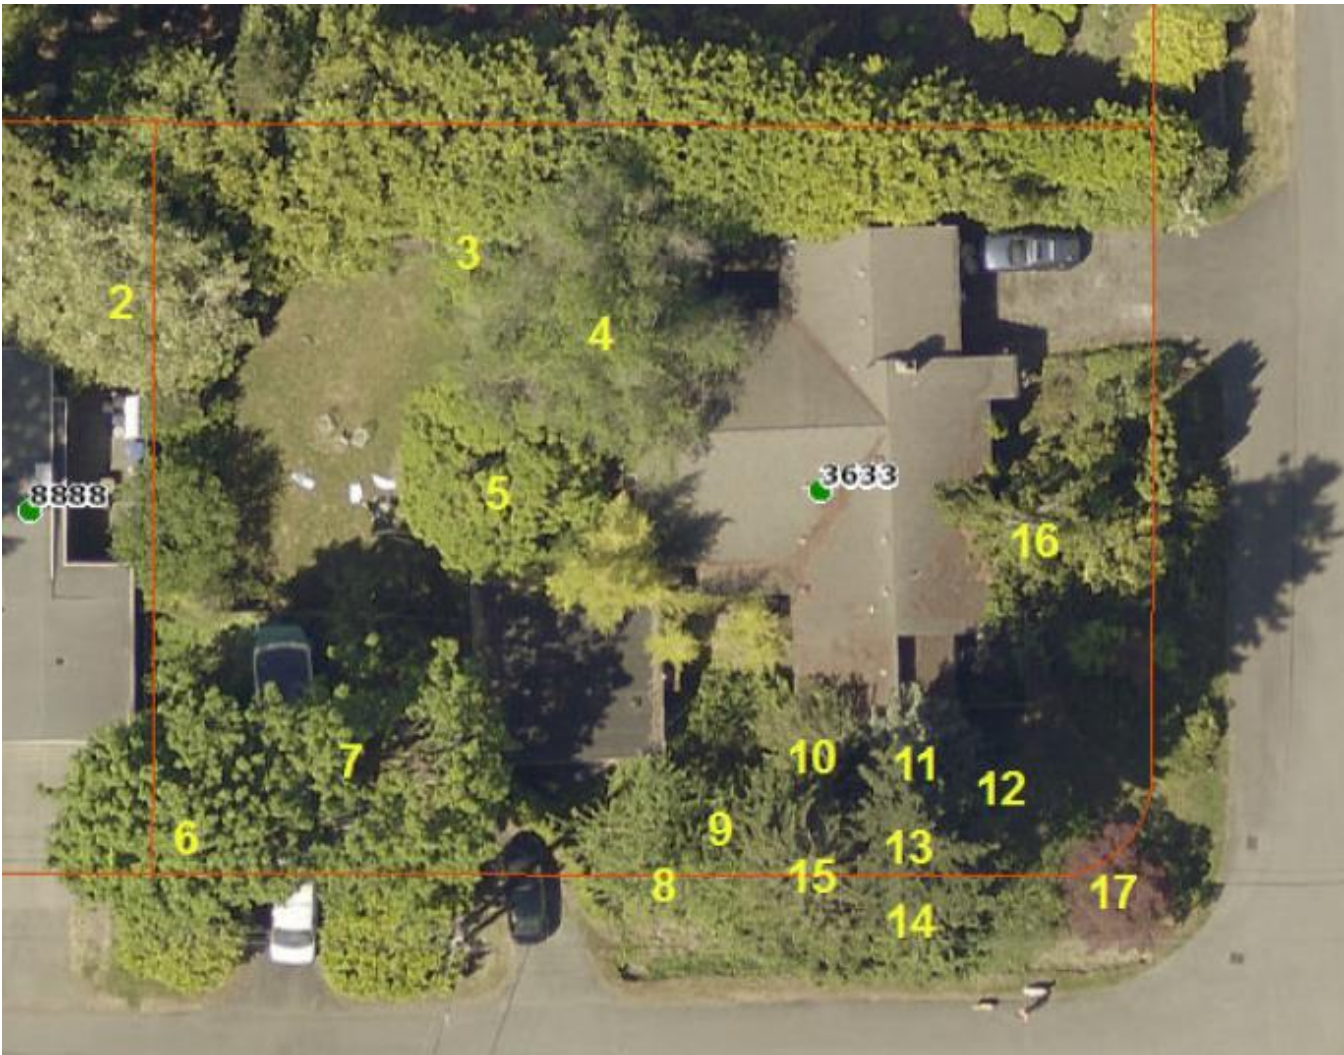
Figure 2. Aerial view of the subject property showing the rough locations of the trees listed in the description section.
