RE: HU - 02 Arborist, 2448 72<sup>nd</sup> AVE SE Mercer Island, WA.

I inspected the lot for significant trees and found two. A Japanese Maple with a 8.8" DBH and a Douglas Fir with a 32" DBH.

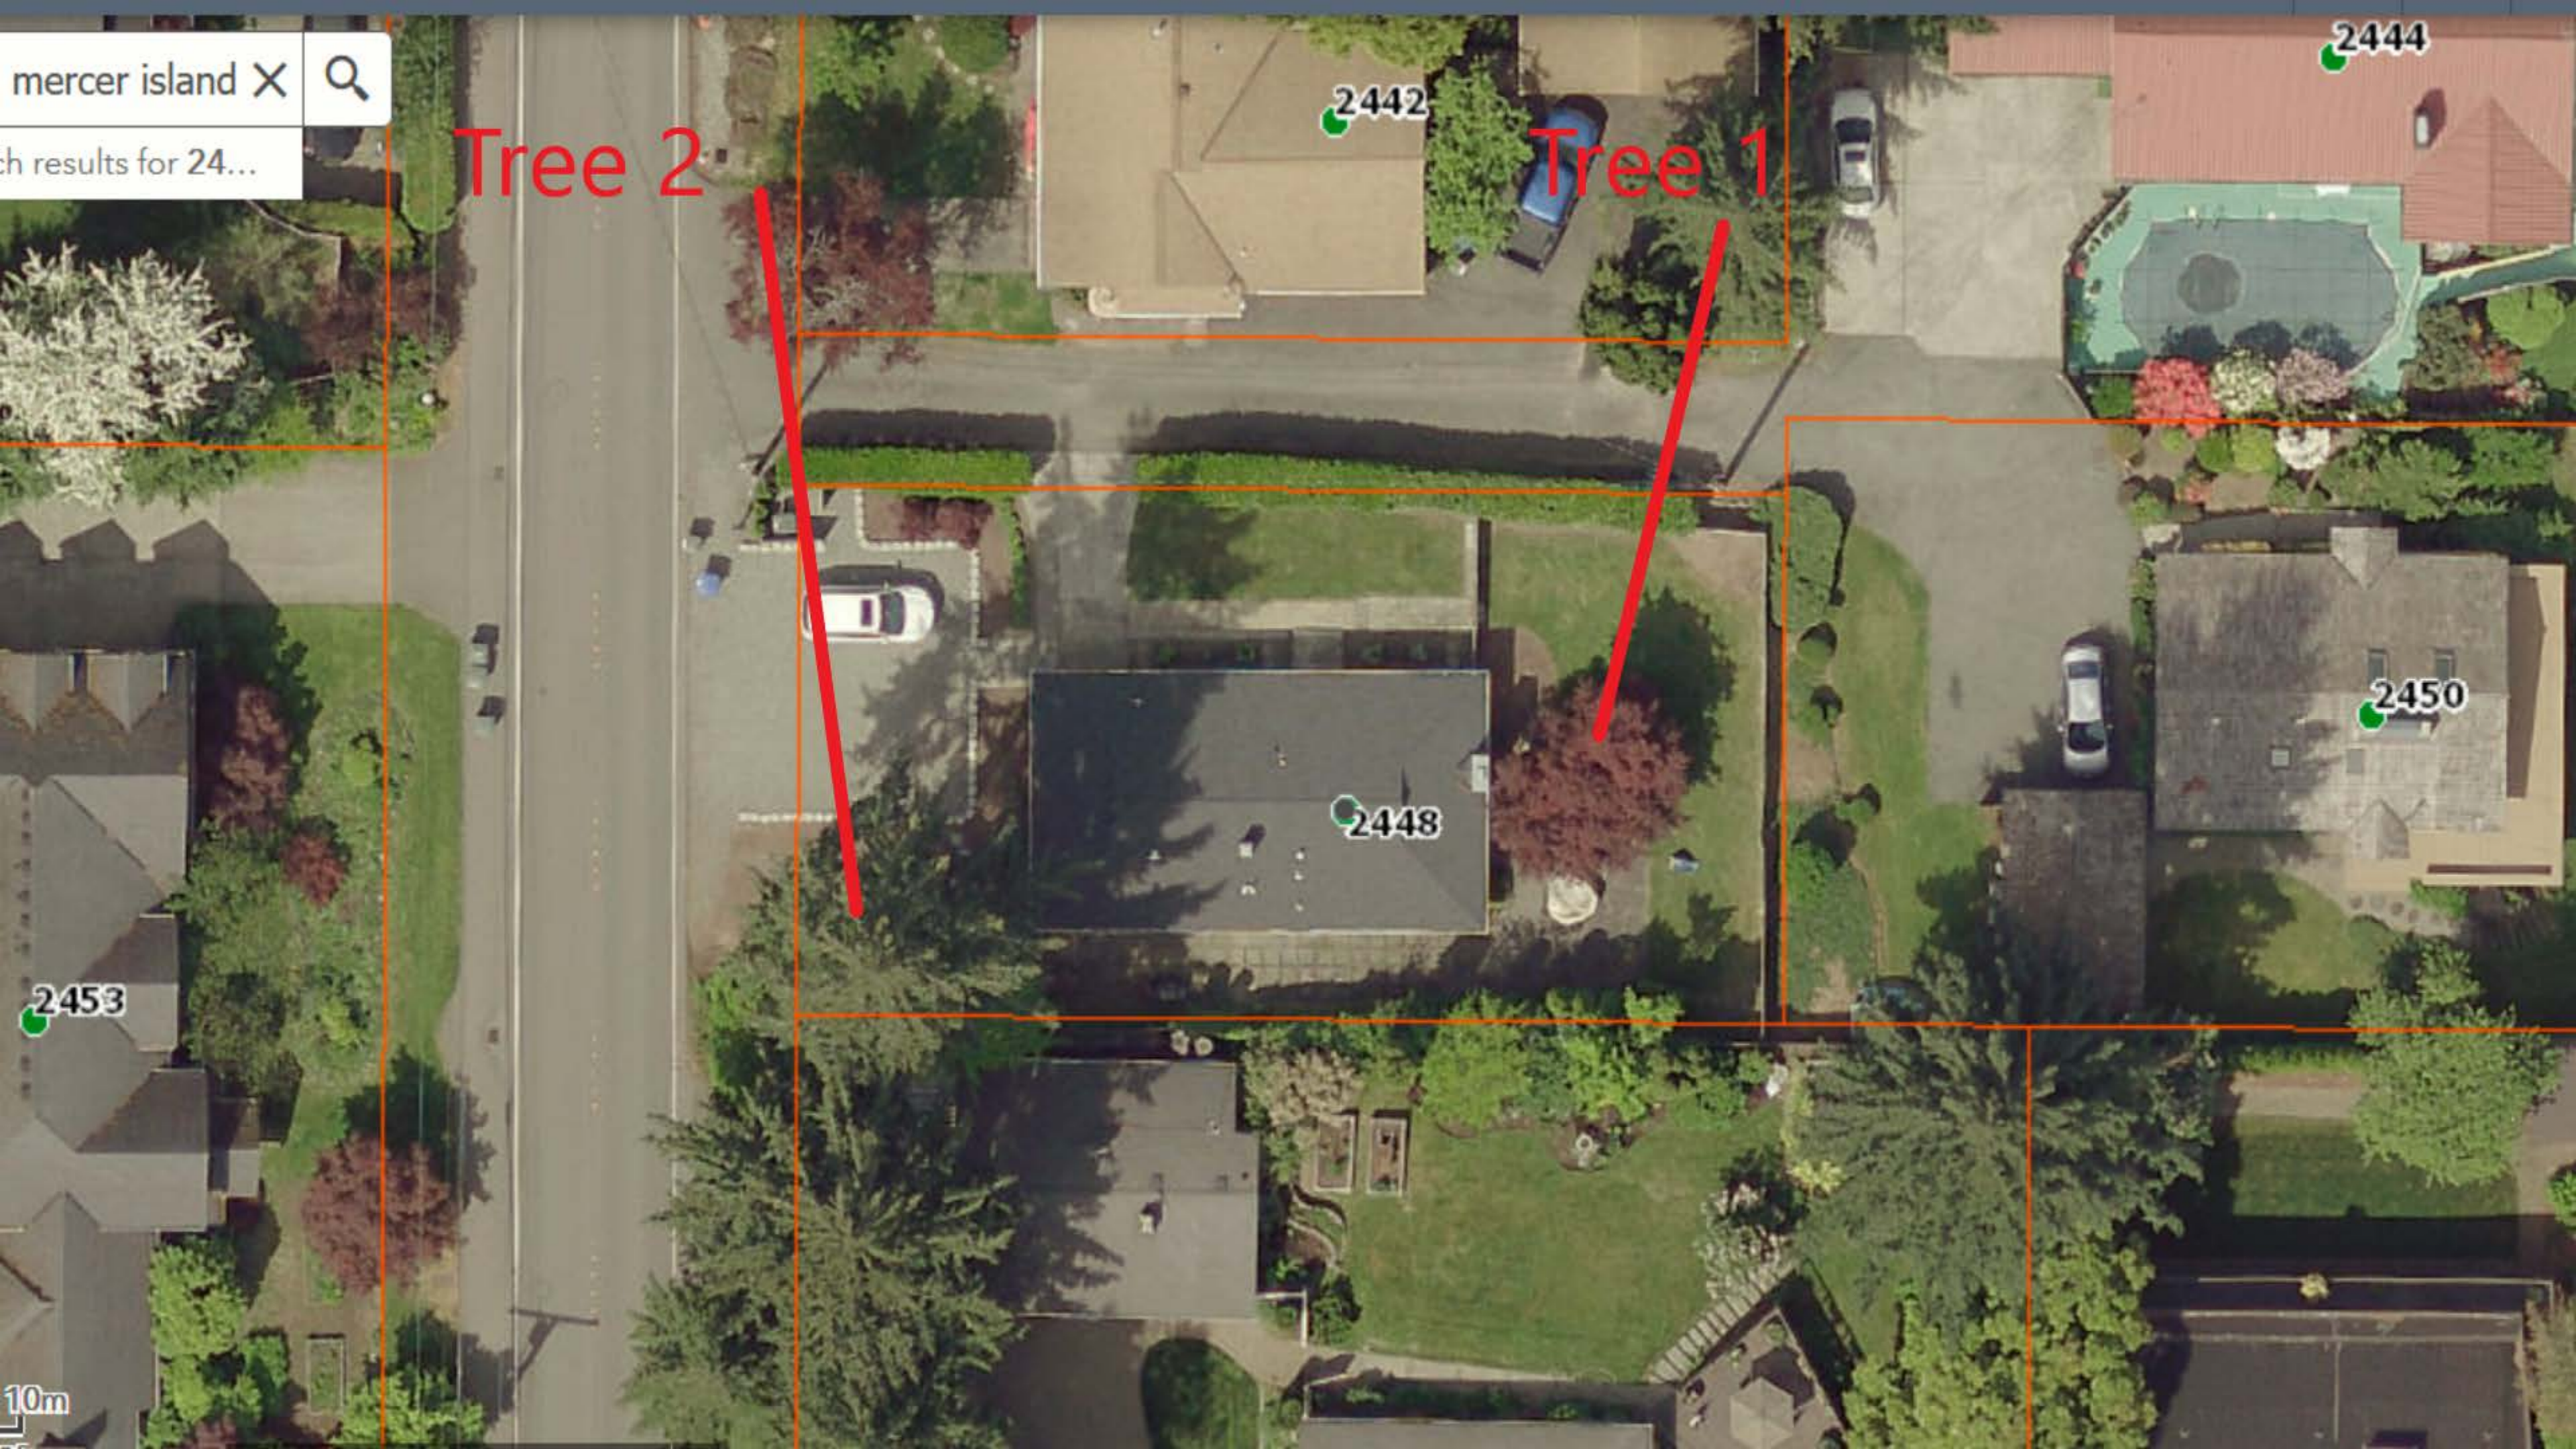
Tree 2

Tree 1

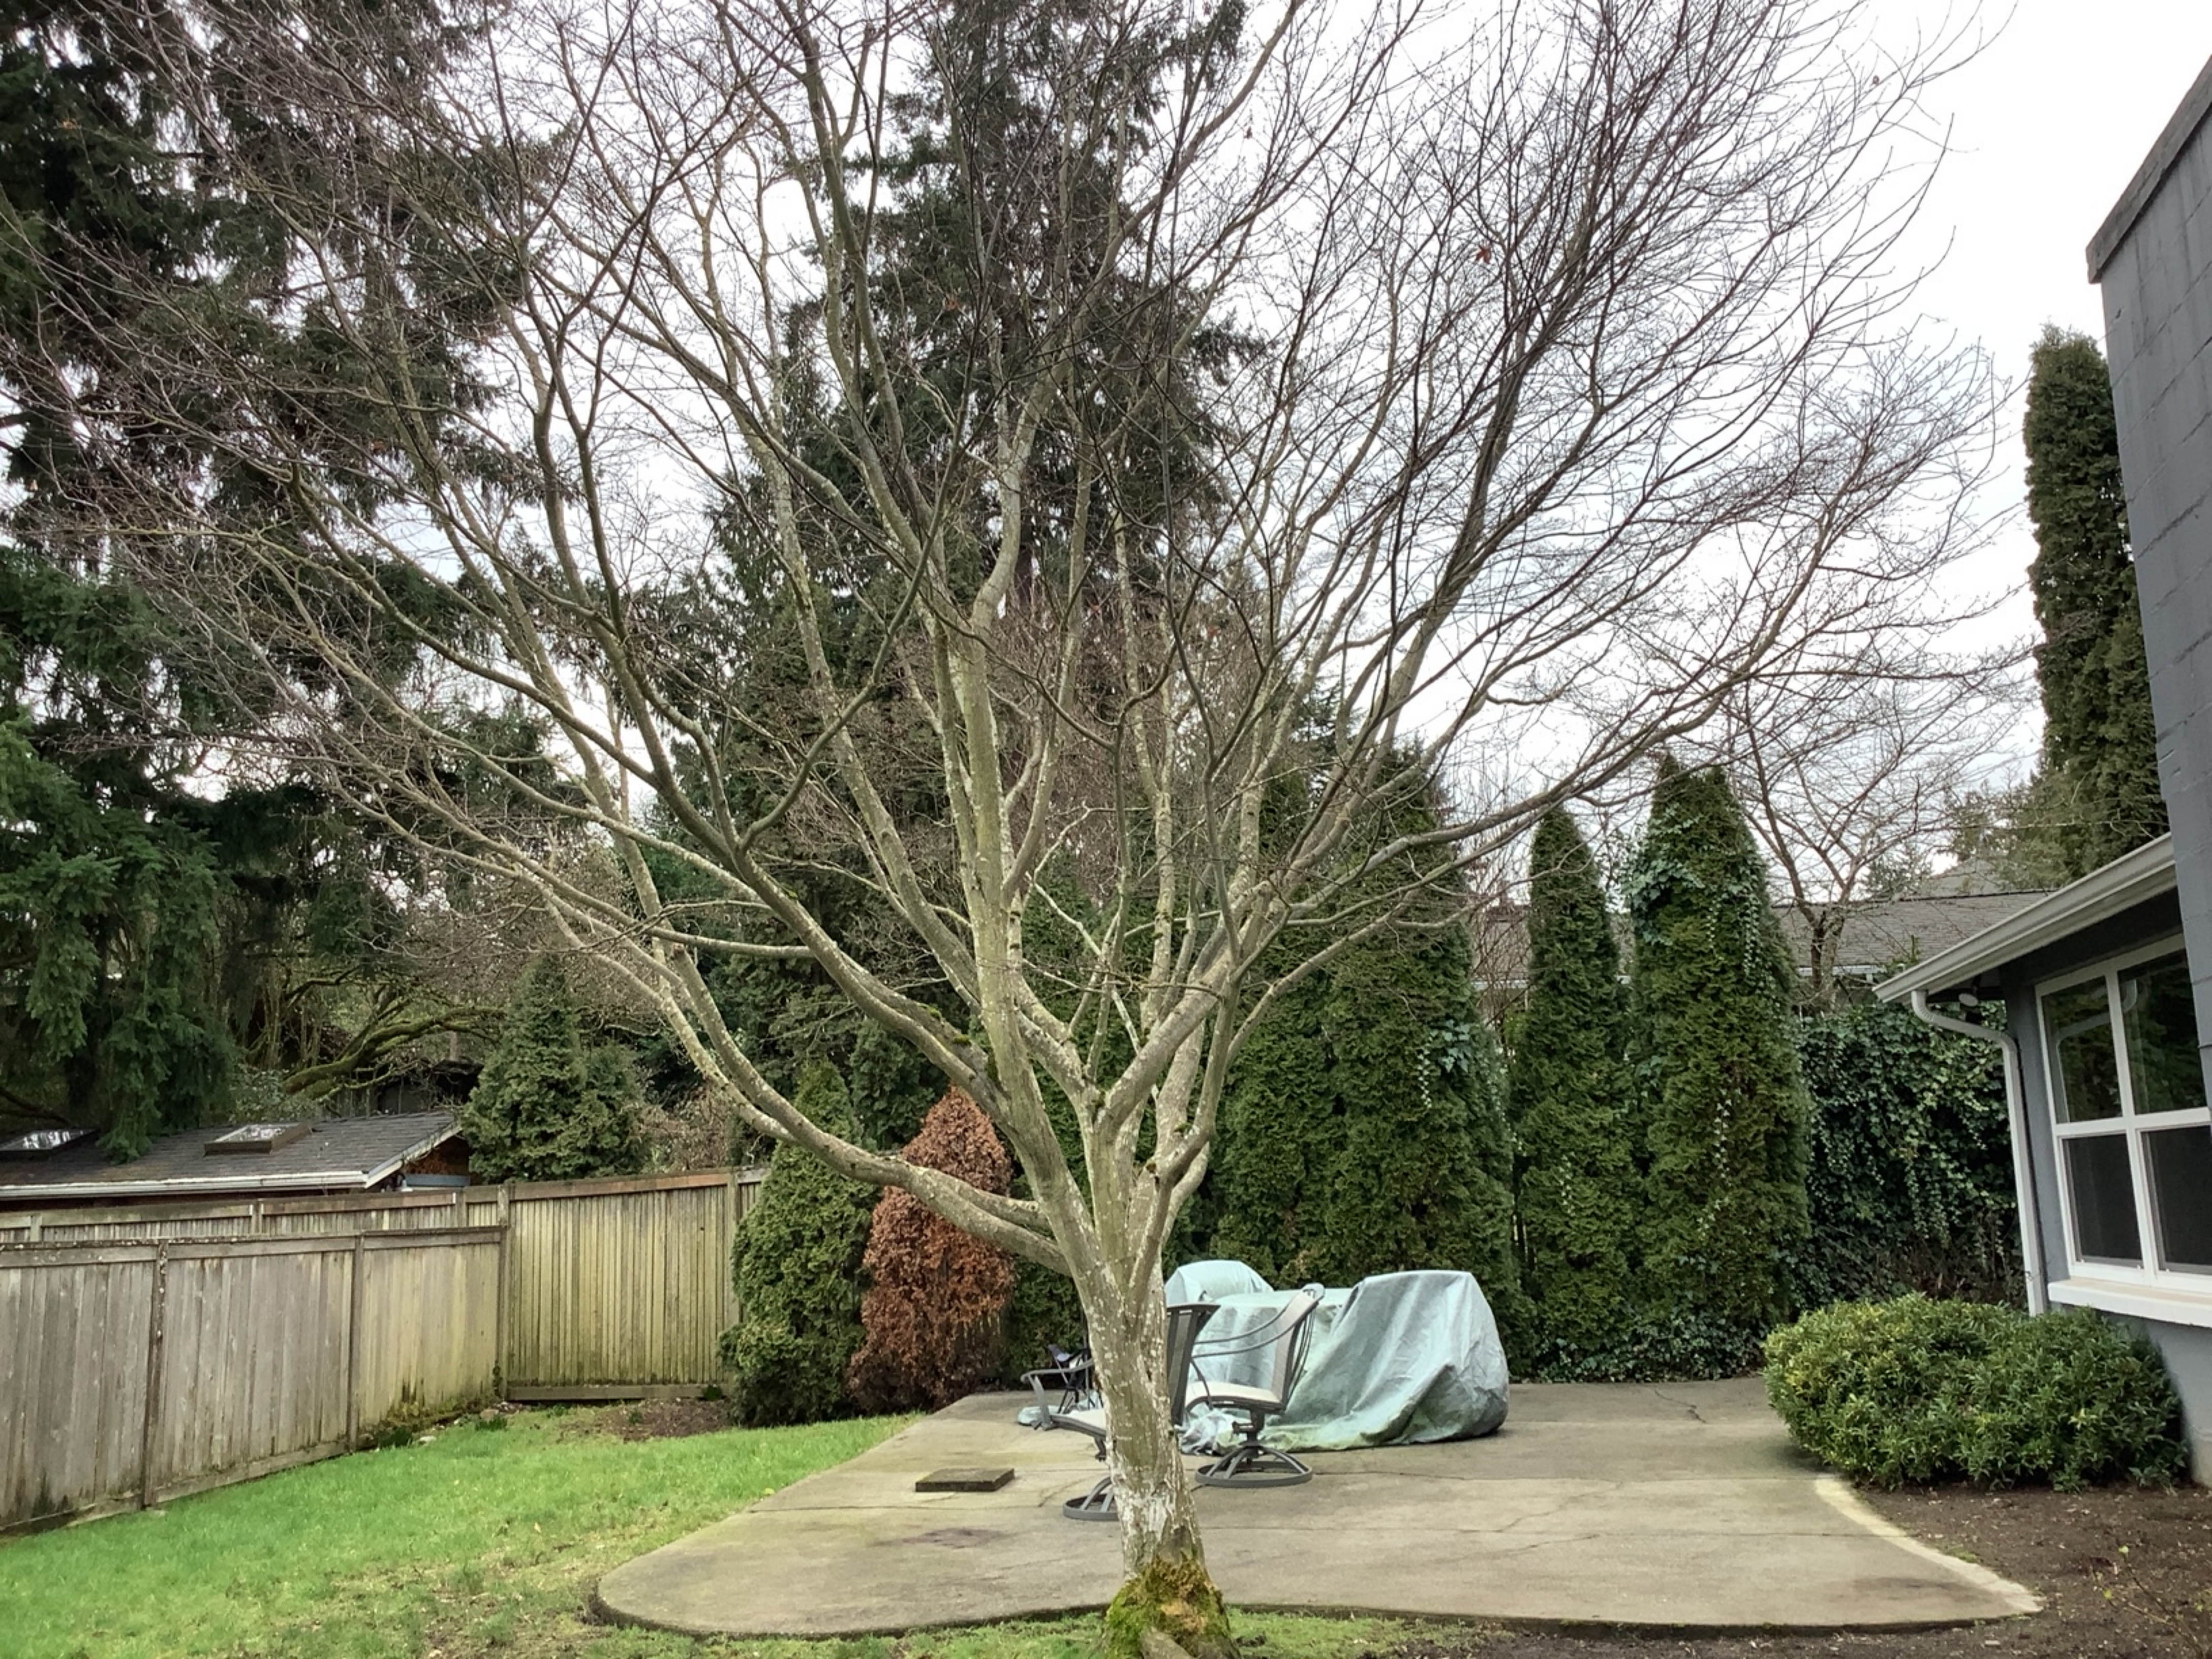
Tree #2 The Douglas Fir has poor taper. The DBH of this tree suggests what normally would be a much taller tree, this tree is 95' tall with a 20' dripline. The foliage on the tree has good color, but the crown is thinner than what would be normal. The top of the tree has been damaged and resprouted. English Ivy covers 25% of the tree. A higher level of inspection may expose inner weakness of the trunk.

top  
— damage
