Project: Pre-construction assessment for lot re-development at 3419 72nd Place SE, Mercer Island, WA. Parcel number 1300301381.

Objectives: Evaluate health of existing trees and establish criteria for the preservation of those to be retained.

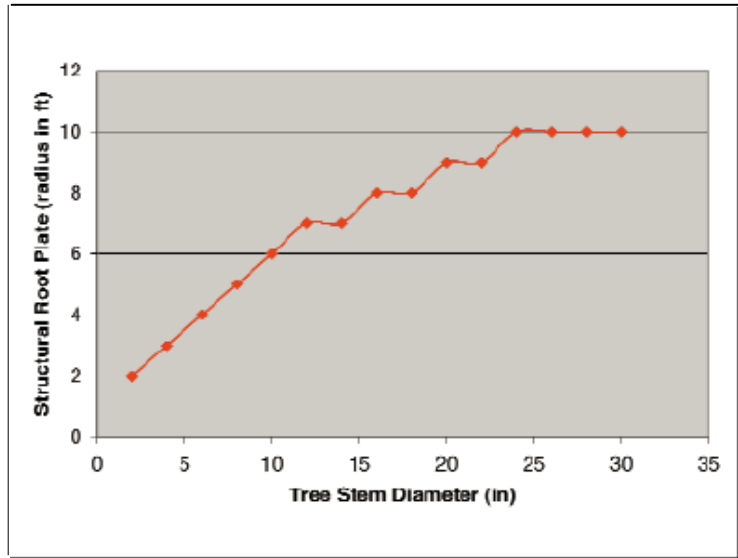
Figure 13. Size of the Structural Root Plate in relation to tree stem diameter. Note that the SRP levels off at 10' for any tree over 24" in diameter. (Coder, 1996)

Based on the plan set the #7 pine, with a full 10' radial SRP, is the only site tree that is close enough to potentially be affected by the demolition work. The SW patio sits right at the edge of its root plate. Extreme care will have to be taken when the demolition is taking place. This work should take place under arborist oversight.

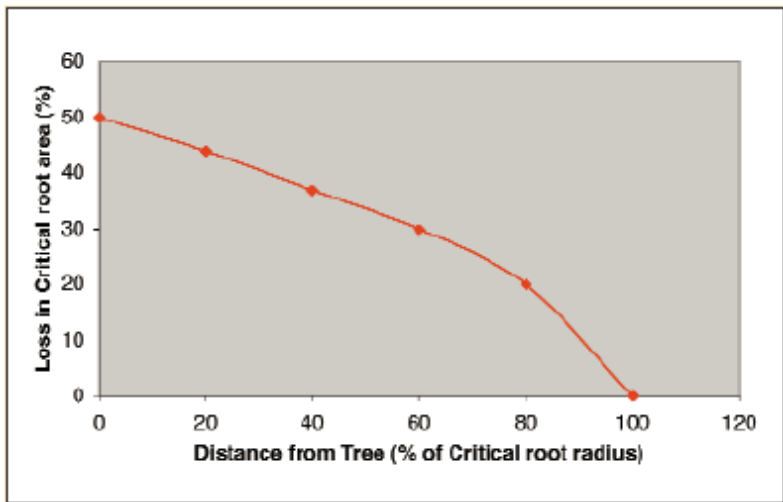
The chart shown in Figure 14 below is used to determine what percentage of a tree's Critical Root Area (CRA) will be affected by trenching type incursion. In general trees can sustain losses of up to 30% of the overall area within their CRZ without having long term detrimental results.

Figure 14. Chart giving the loss in critical root area as a function of the radial distance to the CRZ disturbance. (Coder 1996)

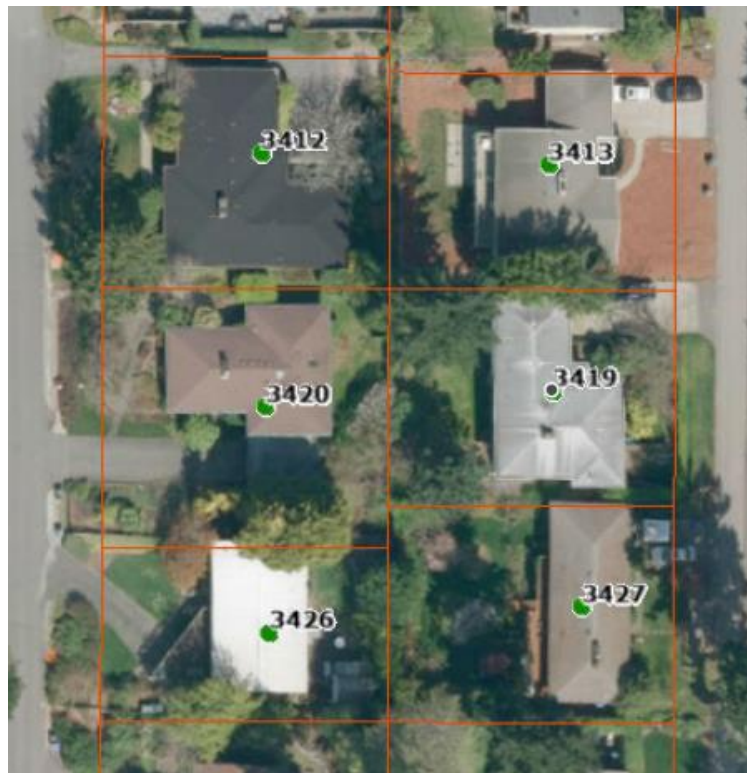
A large tree near the property line for the 3413 adjoining property to the north side was removed around 2012 most likely in preparation for selling in 2013 (Figures 1 and 2). The property at the NW corner of the subject lot changed hands in 2015. The original home was demolished another built between 2017 and 2019 (Figures 3-5). As part of this process, and before selling the house in 2022, the entire yard was re-landscaped which included installing a retaining wall along that property's east side and SE corner (Figure 6). The properties to the west, south, and SW had no noticeable changes made over the last twenty years.

Figure 2. Aerial photo circa 2012 showing the large evergreens missing in the 3413 yard.

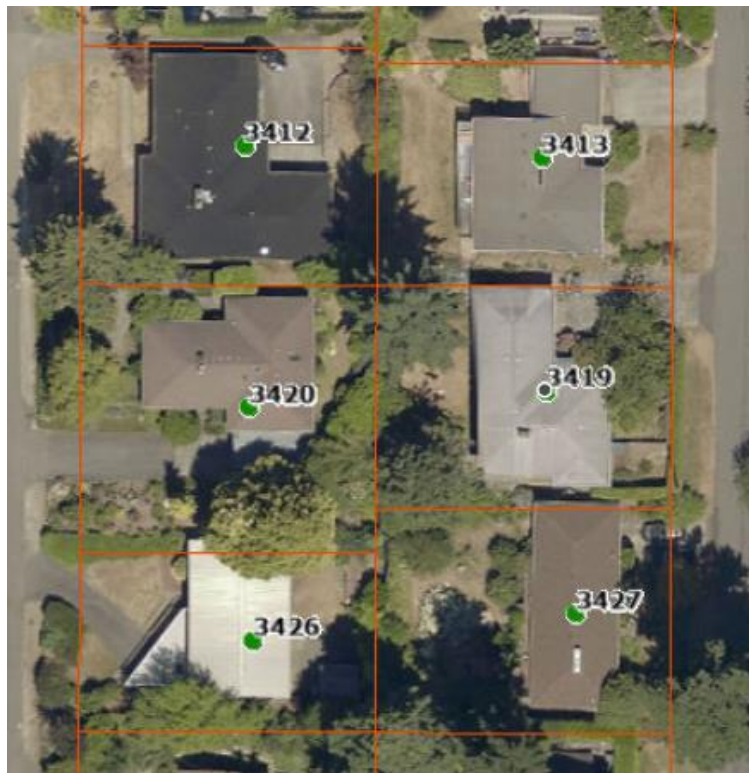
Figure 4. Aerial photo circa 2017 showing the changes occurring on the 3412 lot.

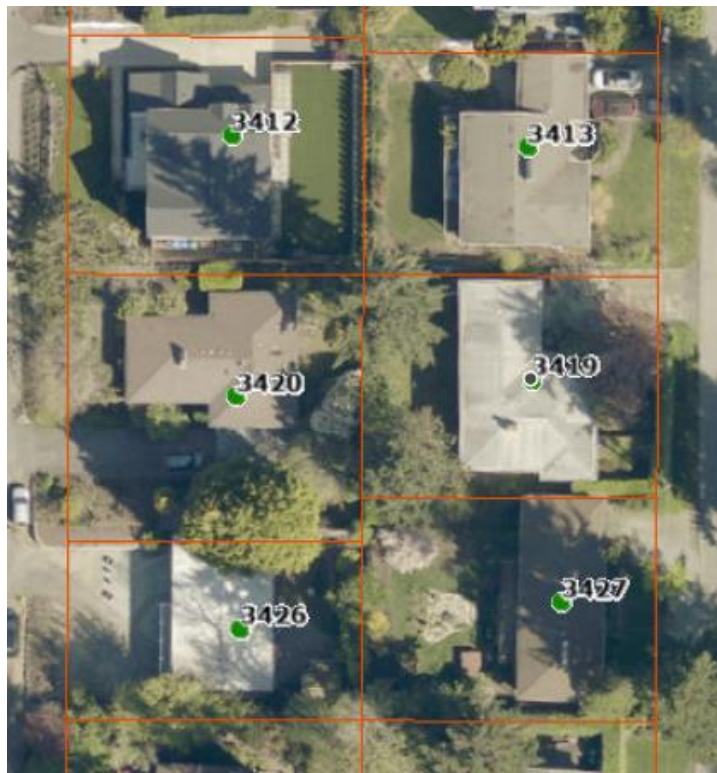
Figure 6. Aerial from 2021 showing the retaining wall(s) in place in the 3412 backyard.

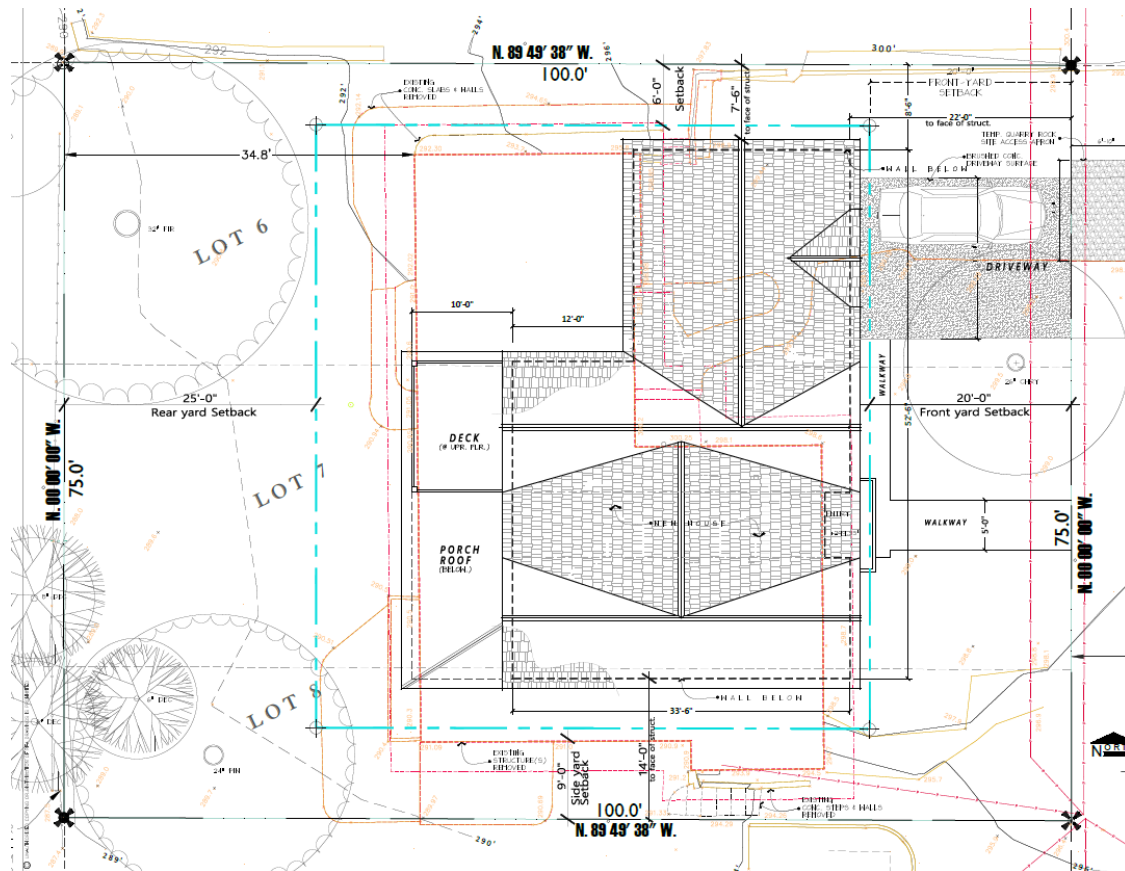
Figure 8. Excerpt from the proposed plan set showing the new layout. Note the greater distance of the end of the house to the west side trees. The circles around the trees are not fully representative of the extent of the Critical Root Zones of the subject trees.

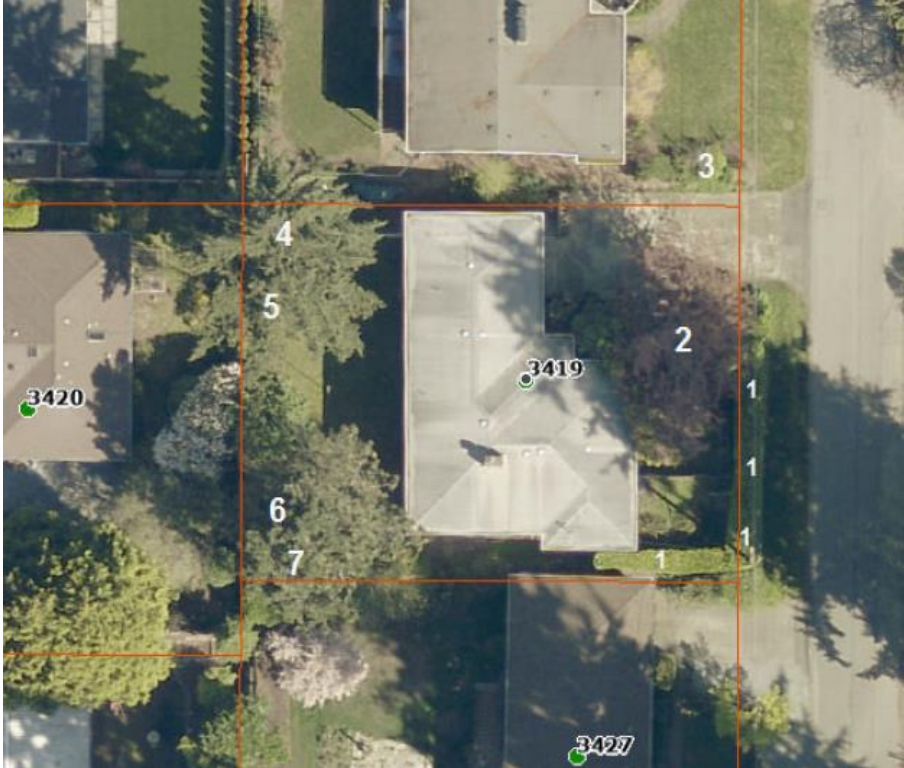
Figure 9. Aerial photo circa 2021 showing the approximate locations of the trees noted in the study (white numerals).
