January 6, 2023

Project: Pre-construction assessment for lot re-development at 3419 72nd Place SE, Mercer Island, WA. Parcel number 1300301381.

Objectives: Evaluate health of existing trees and establish criteria for the preservation of those to be retained.

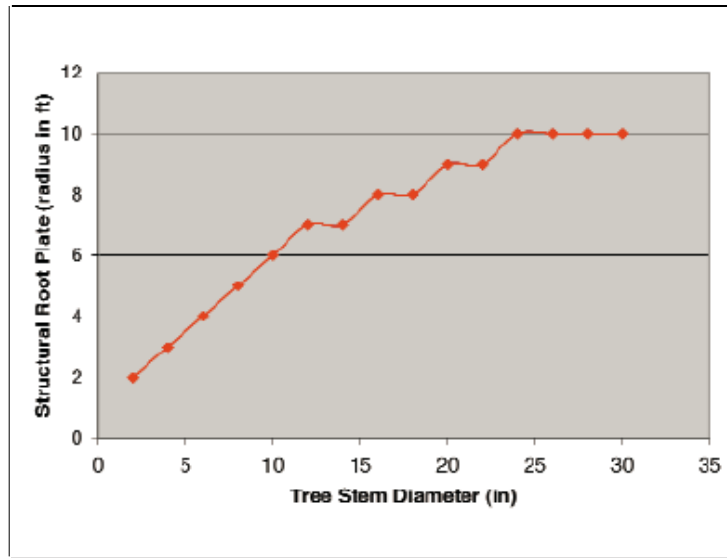
Figure 14. Size of the Structural Root Plate in relation to tree stem diameter. Note that the SRP levels off at 10' for any tree over 24" in diameter. (Coder, 1996)

Based on the plan set the #7 pine, with a full 10' radial SRP, is the only site tree that is close enough to potentially be affected by the demolition work. The SW patio sits right at the edge of its root plate. Extreme care will have to be taken when the demolition is taking place. This work should take place under arborist oversight.

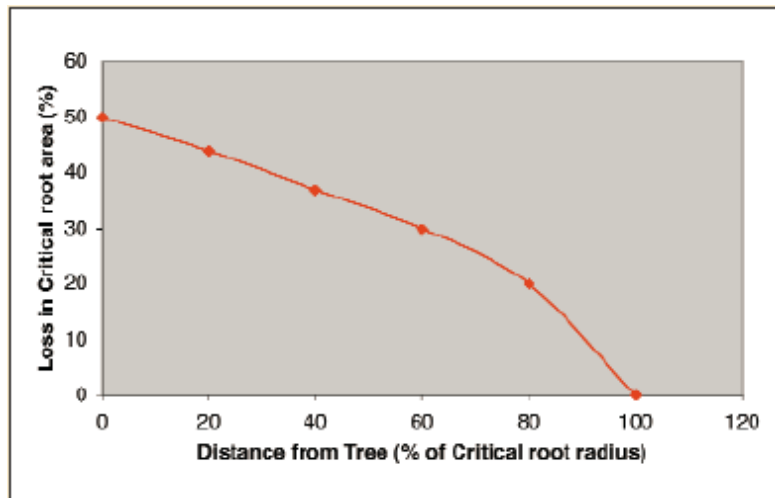
Figure 15. Chart giving the loss in critical root area as a function of the radial distance to the CRZ disturbance. (Coder 1996)

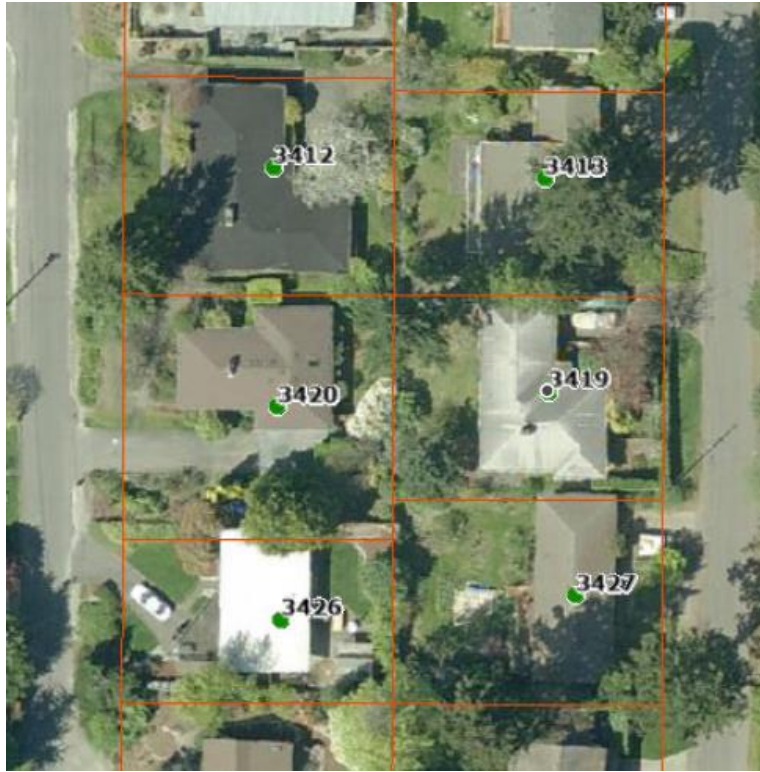
A large tree near the property line for the 3413 adjoining property to the north side was removed around 2012 most likely in preparation for selling in 2013 (Figures 1 and 2). The property at the NW corner of the subject lot changed hands in 2015. The original home was demolished another built between 2017 and 2019 (Figures 3-5). As part of this process, and before selling the house in 2022, the entire yard was re-landscaped which included installing a retaining wall along that property's east side and SE corner (Figure 6). The properties to the west, south, and SW had no noticeable changes made over the last twenty years.

Figure 1. Aerial view of the subject and surrounding properties circa 2009.

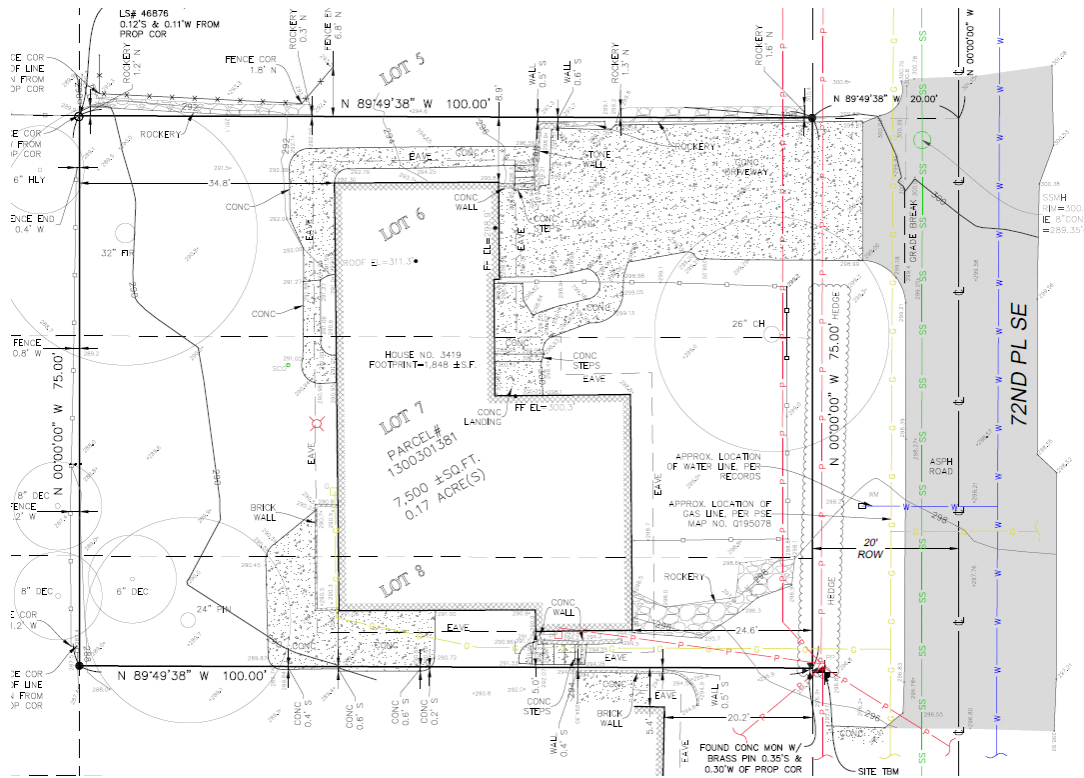
Figure 7. Excerpt from the survey showing the current layout of the property.

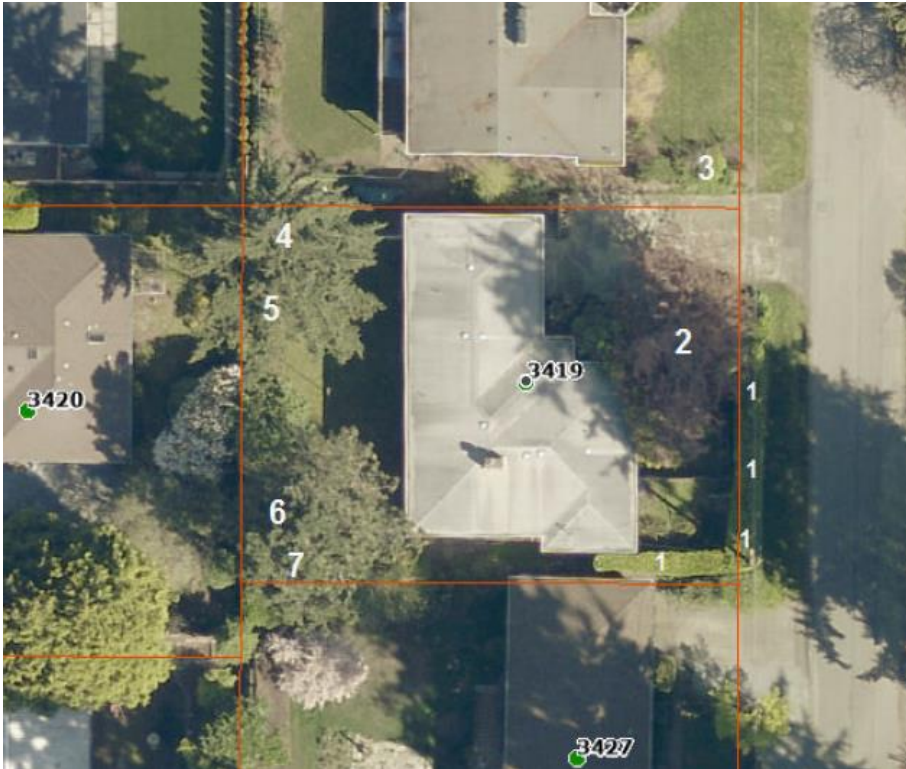
The following itemized tree list begins on the east side of the property and their numerical designations are reflected in Figure 9. Diameters were measured at the standard height of 54" above grade (DSH) during the August 2022 site visit unless otherwise noted. Those in the neighboring yards were conservatively estimated to the tree's favor. Heights were also estimated.

Figure 9. Aerial photo circa 2021 showing the approximate locations of the trees noted in the study (white numerals).
