AMERICAN FOREST  
MANAGEMENT

**ARBORIST REPORT**  
**for**  
**WW Sustainable LLC**  
**4657 86<sup>th</sup> Ave SE**  
**Mercer Island, WA**

October 10, 2022  
**UPDATED MARCH 17, 2023**

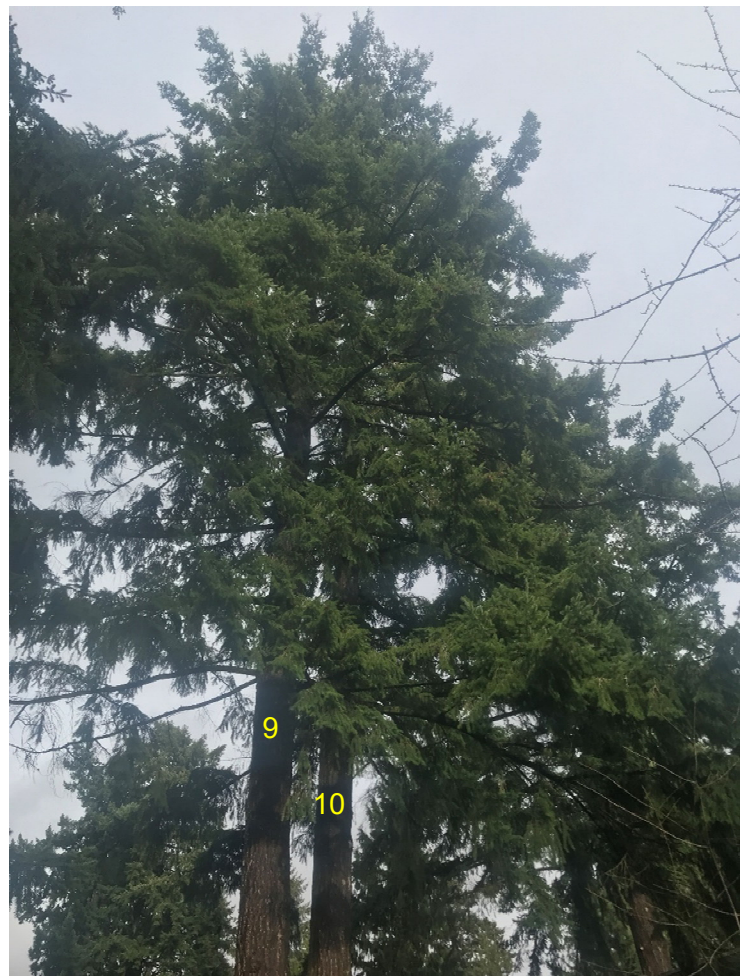
Trees #9 and 10 are Douglas-fir in good condition found near the north property line to the west of the existing house. Both are considered 'exceptional' trees with DBH of 36 and 32 inches. The shared canopy of these trees overhangs the existing house.

The lower trunks of Trees #9 and 10 viewed from the south. Note their shared canopy extends over the existing house.

The upper crowns of Trees #9 and 10 viewed from the south. Note their shared canopy extends over the existing house.
