AMERICAN FOREST
MANAGEMENT

ARBORIST REPORT
for
WW Sustainable LLC
4657 86th Ave SE
Mercer Island, WA

October 10, 2022
UPDATED MARCH 17, 2023

To: Cam Weaver
Company: Weaver Construction Co.
From: Benjamin Mark – Salish Restoration Associates
Date: 3/21/23
Re: Planned Excavation Within Driplines of Retained Trees

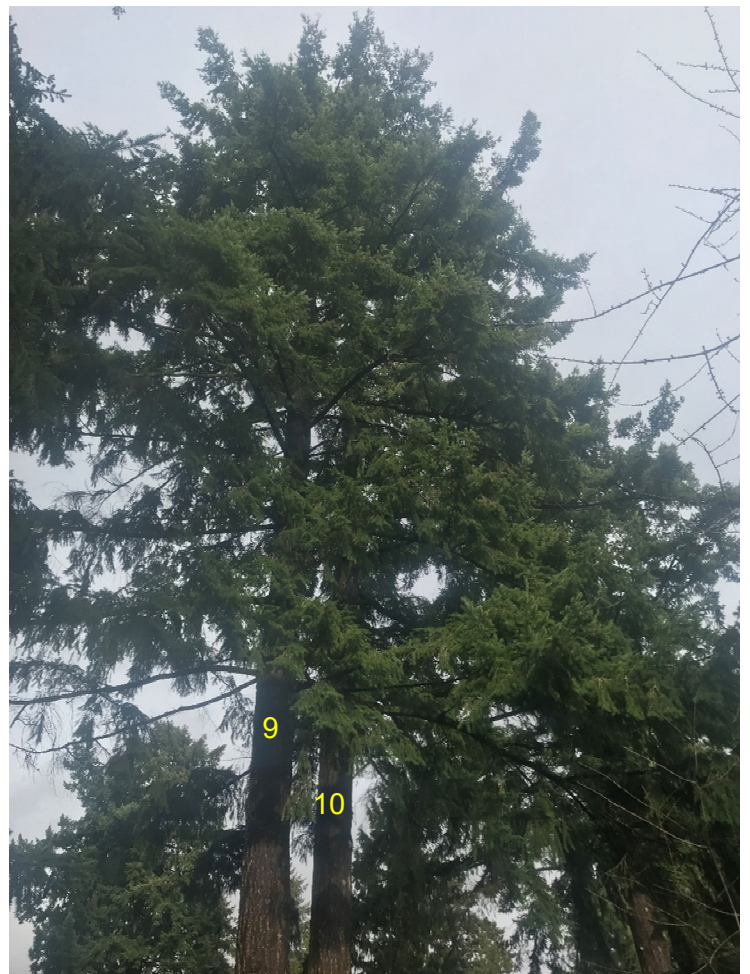
Trees #9 and 10 are Douglas-fir in good condition found near the north property line to the west of the existing house. Both are considered 'exceptional' trees with DBH of 36 and 32 inches. The shared canopy of these trees overhangs the existing house.

The lower trunks of Trees #9 and 10 viewed from the south. Note their shared canopy extends over the existing house.

The upper crowns of Trees #9 and 10 viewed from the south. Note their shared canopy extends over the existing house.

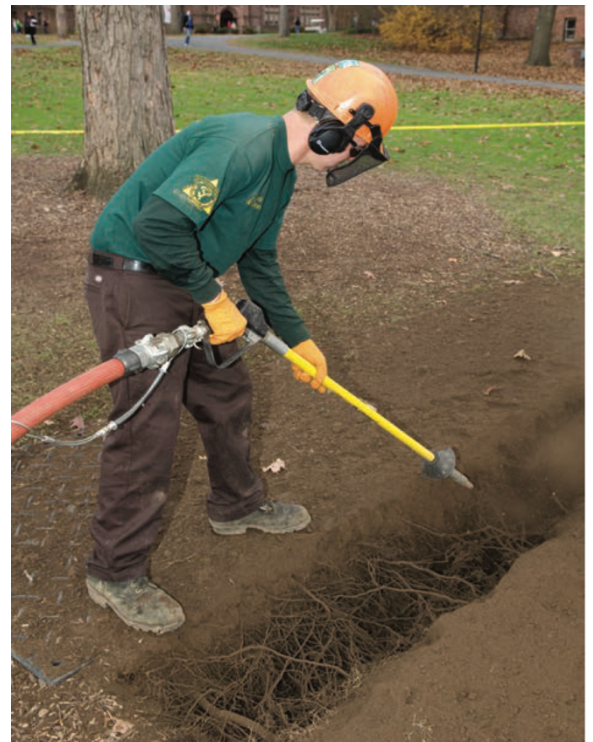
Root Disturbance Memo

Air excavation of the drainage path will allow the project arborist to assess the potential impacts to trees #9 or #10 and potentially allow for installation of the storm drain below significant structural roots without cutting them.

If all structural roots over three-inches in diameter can be preserved, the tree's structural integrity is unlikely to be affected, but some decline in vigor may be seen in the future due to loss of roots within the 'Critical Root Zone' (CRZ) of these trees.

If all tree protection guidelines specified below are closely adhered to, these trees are likely to remain viable.
