Chen Harvey

Response to Mercer Island comments letter

CHEN RESIDENCE

ARBORIST TREE PLAN

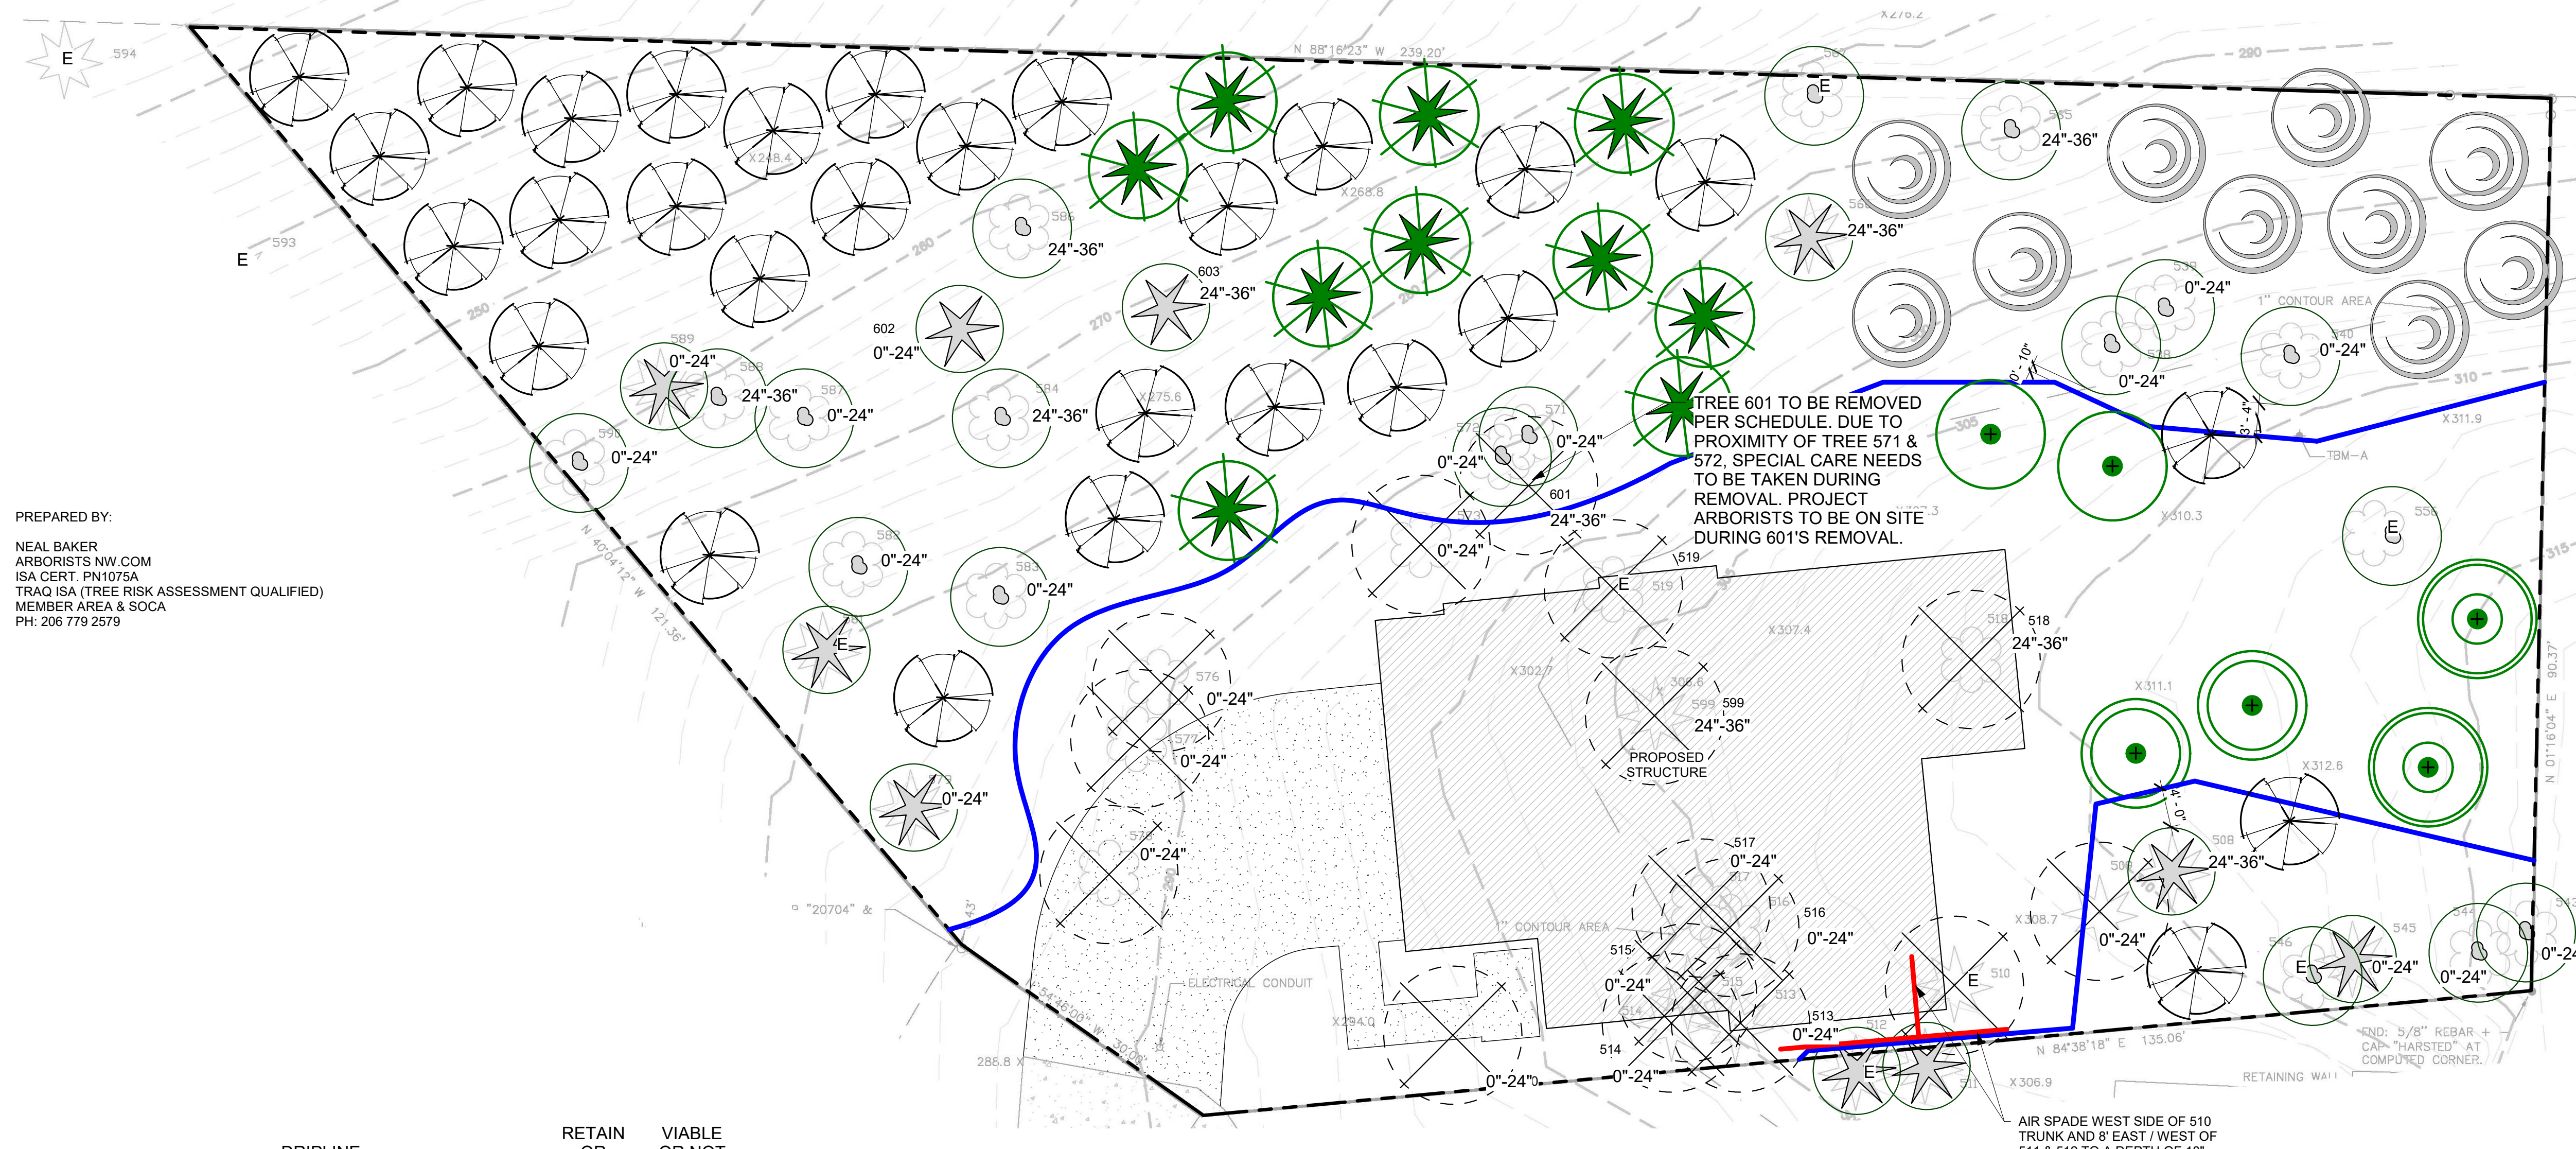
ARBORISTS SITE PLAN

The tree protection fencing has been adjusted out to 40' for tree 508. The dripline is artificially wider than normal due to damaged treetop. Tree 579 has had its dripline rescaled to the correct size
