TREE PERMIT

Project No.
Main Permit No.
Permit No. **2401-161**

Project: Assessment of three trees at 7058 82nd Avenue SE, Mercer Island, WA.
Parcel number 8732300120.

Objectives: Evaluate health of trees, their suitability of placement, and recommend solutions.

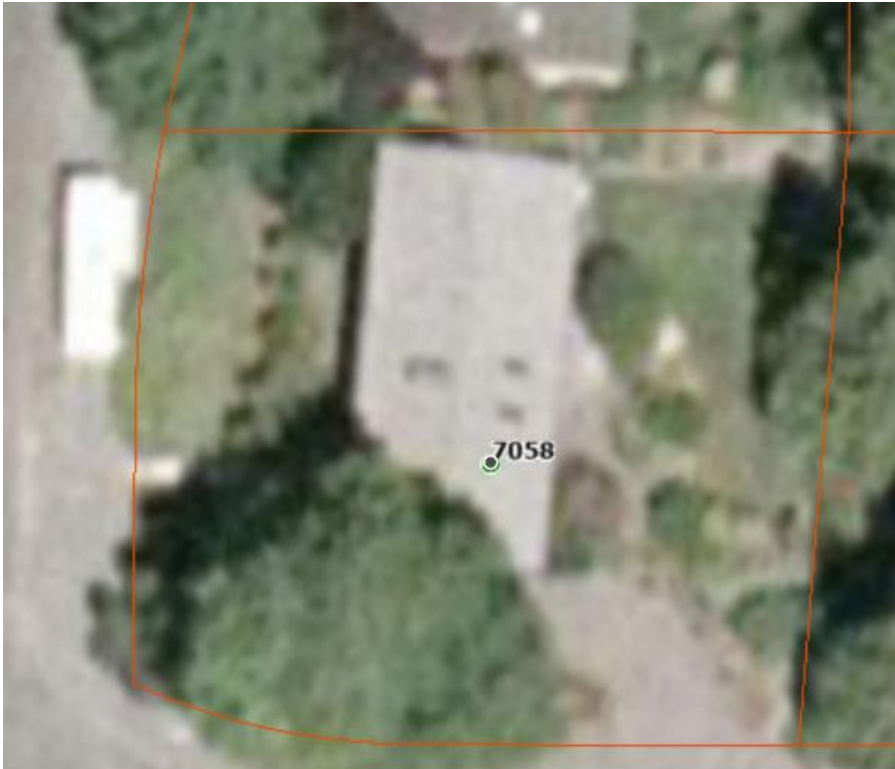
Figure 1. Aerial from 2005.

Description: The 7058 home was built in 1962 on a 13,000 square foot residential lot at the south end of Mercer Island. The subject trees were likely planted at that time. The property has passed through several owners over the last two decades. Most noticeably the house was flipped in 2006 and as part of the upgrading the carport at the south end of the house was permitted to be enclosed and what was supposed to be a small deck (153 sq ft) was added (Figures 1 and 2). The party that purchased the house after the flip sold it to the current owners in May of 2023.
