DOWNSTREAM ANALYSIS
FOR
SINGLE FAMILY RESIDENCE
3008 70TH AVENEU SE
MERCER ISLAND, WA 98040

March 10, 2024

C2MY Engineers, LLC
P.O. Box 52883
Bellevue, WA 98015-2883
Contact: Choomeng Chin
(206) 451-7856
cmchin.c2my@gmail.com

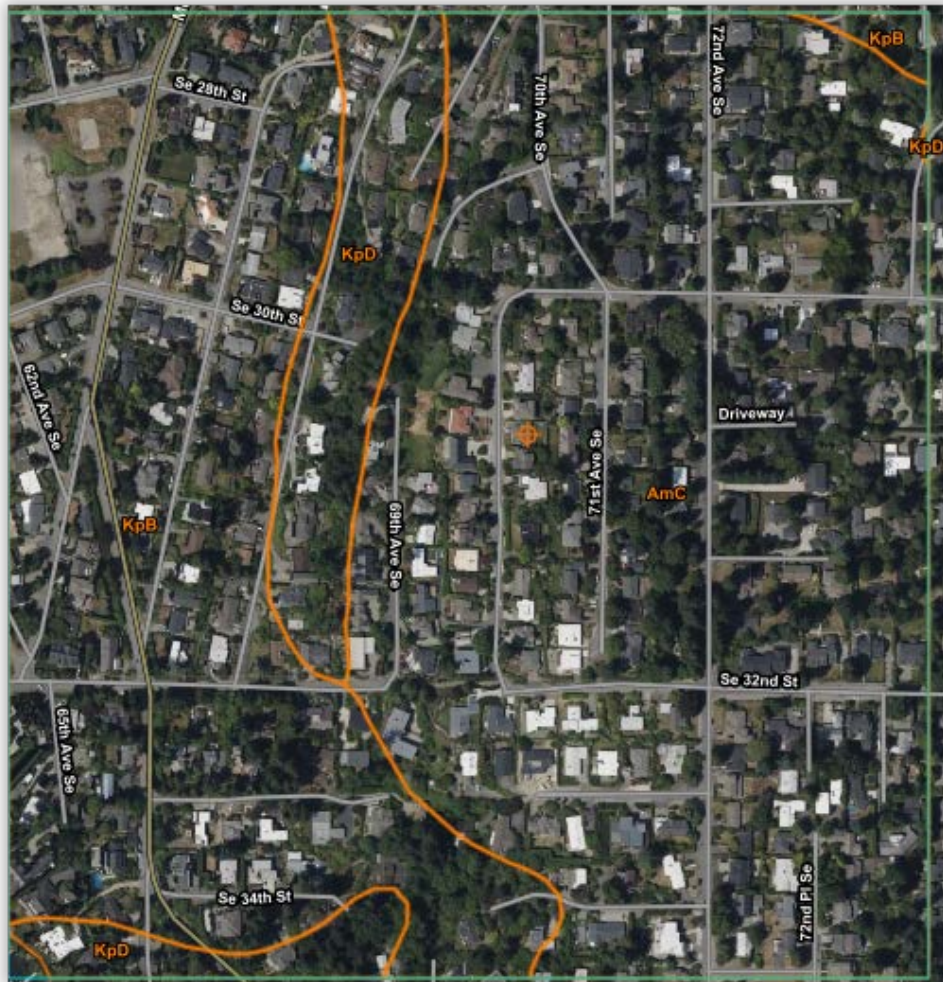
FIGURE 2: SOIL SURVEY MAP (NTS)

A review of the SCS soils map for the area (see Figure 2, SCS Soil Survey Map) indicates AmC – Arents, Alderwood materials, 6 to 15% slopes surrounded by KpD – Kitsap silt loam. These soils resemble Hydrologic Soil Group C. The soil is moderately well drained. The soil series descriptions follow Figure 2.

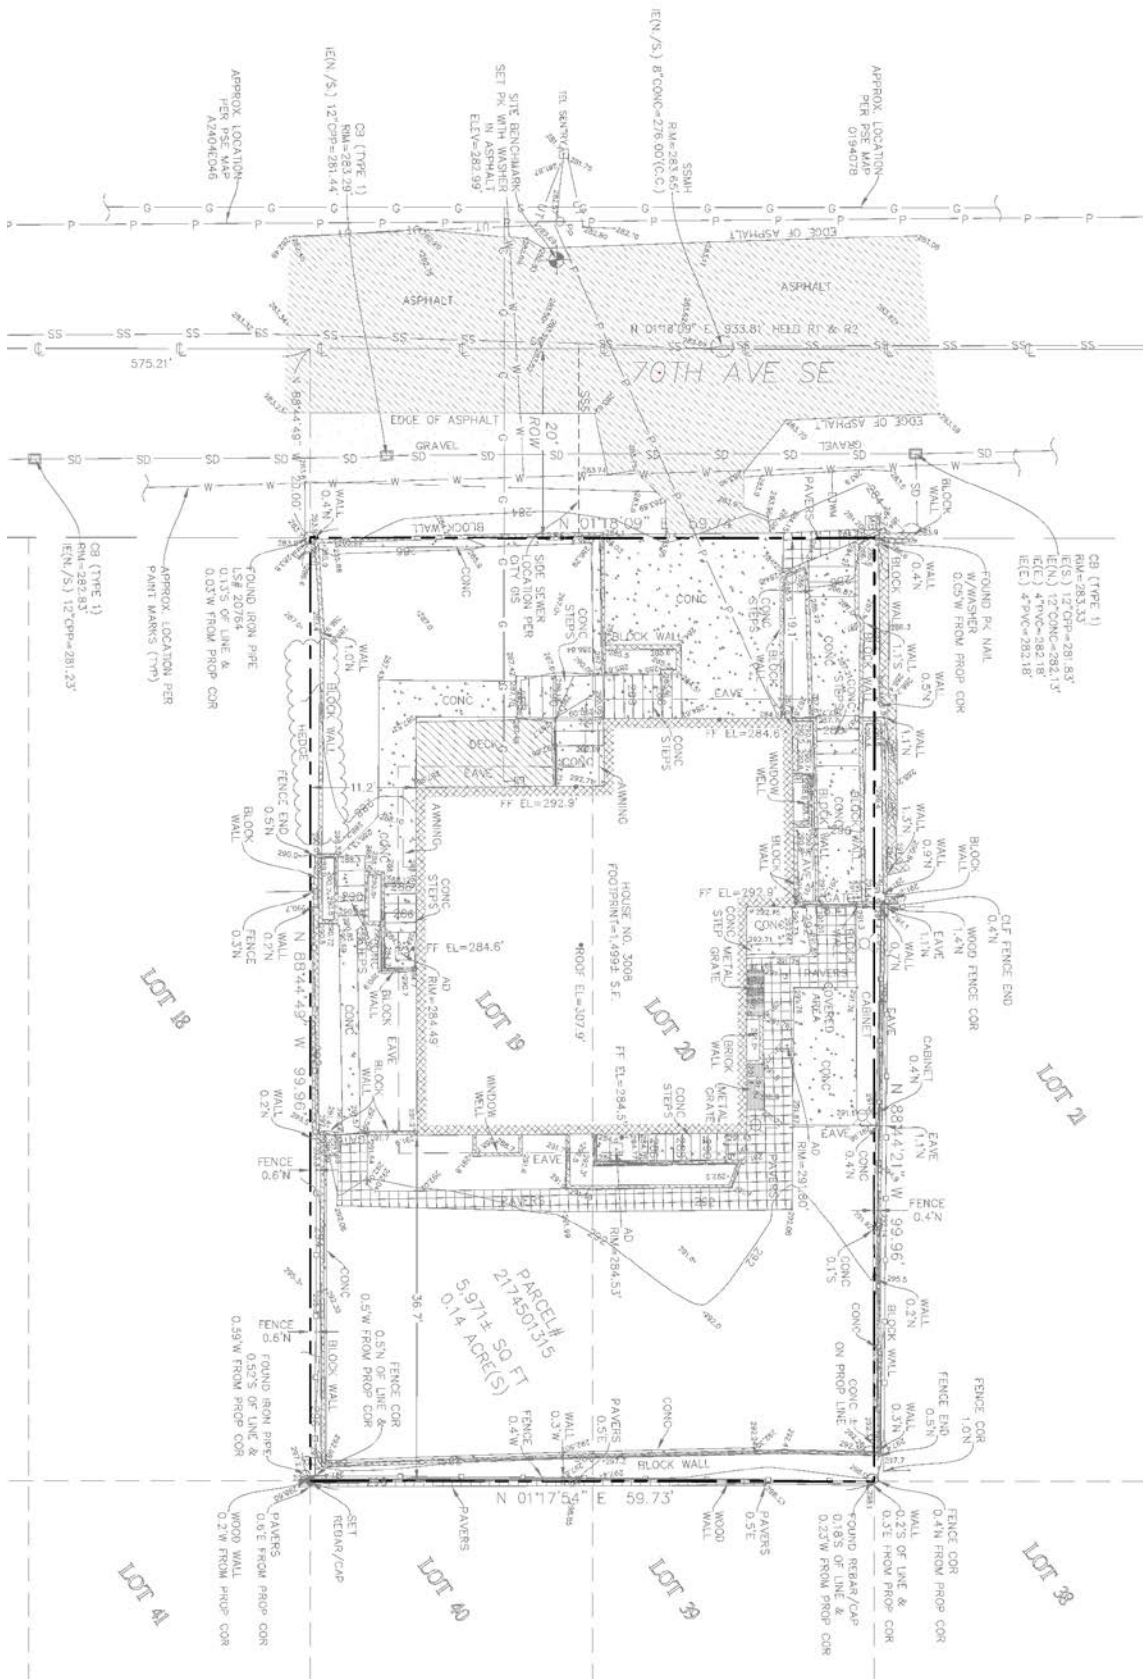
FIGURE 3: EXISTING SITE DEVELOPEMENT MAP (NTS)

Presently, the site has a single-family home with attached garage, open lawn and shrub. The lot is surrounded by single family residences at all sides and access from paved 70th Avenue SE to the west (See Figure 3 – Existing Site Development Map). A more detailed description of the existing drainage system is found in Section II, Off-site Analysis.

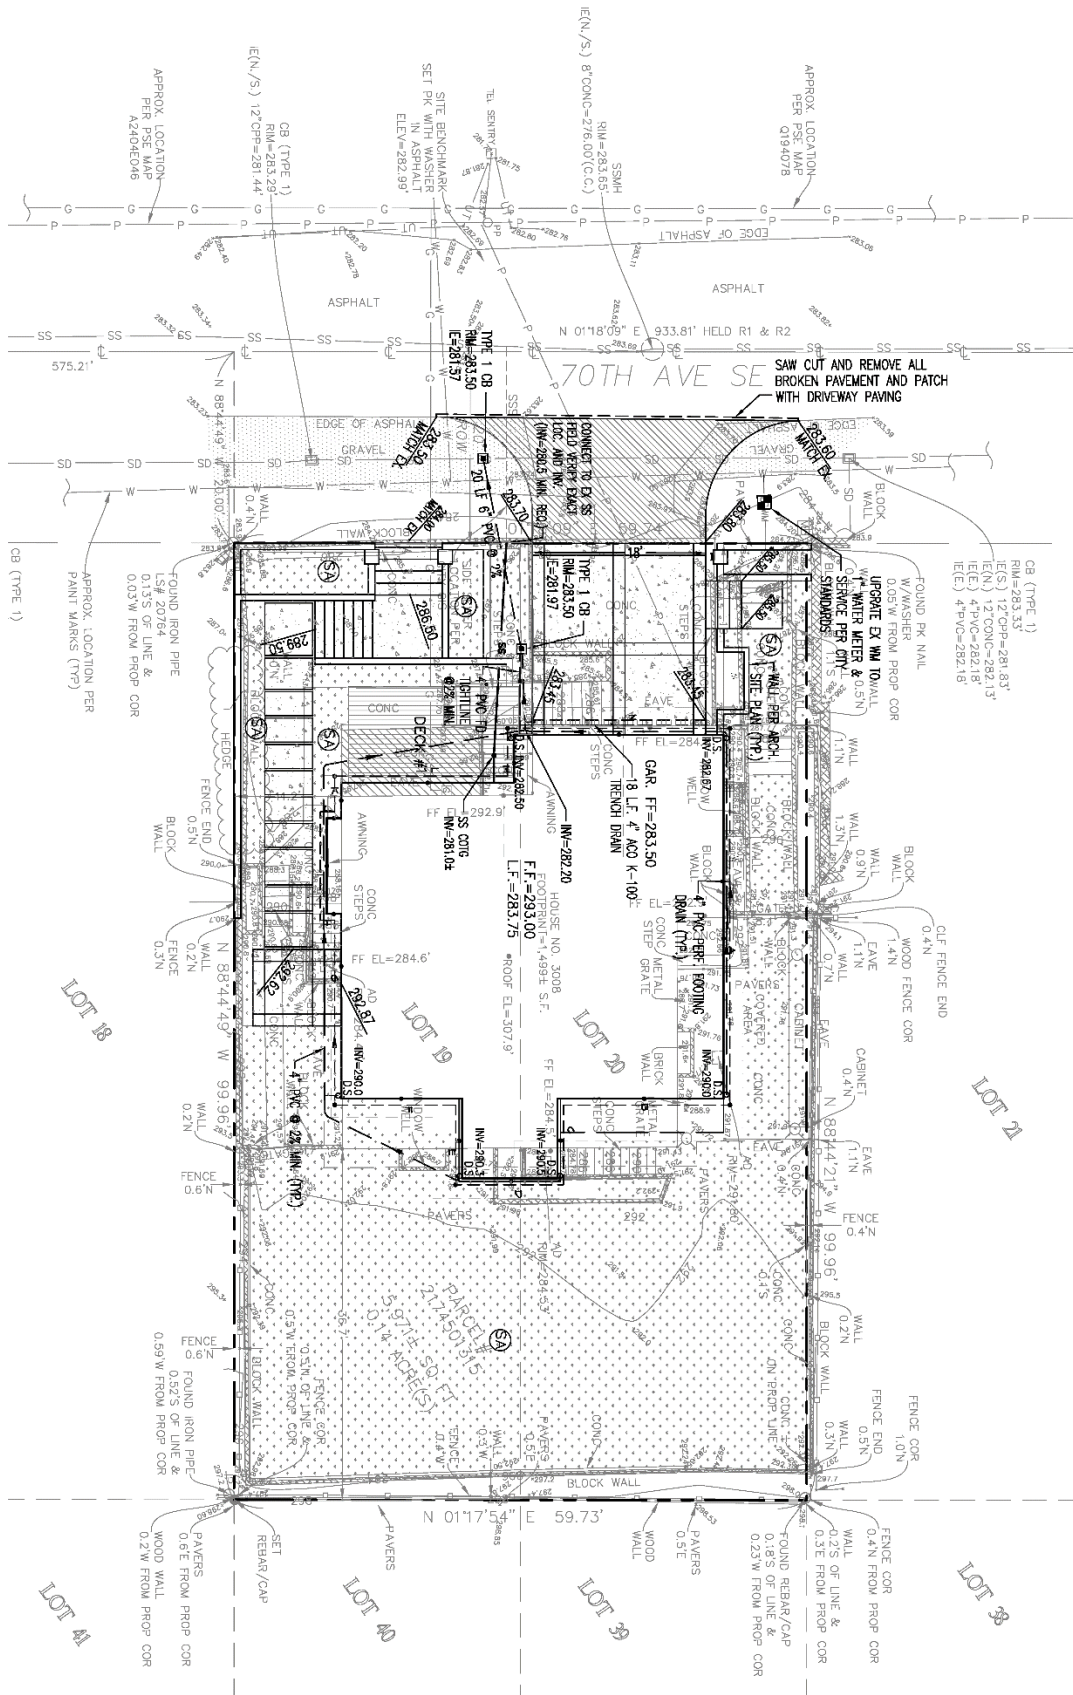
FIGURE 3A: PROPOSED SITE DEVELOPMENT MAP (NTS)

All impervious runoff for the area of the proposed development will be collected and drained to the existing conveyance system on the street. The roof runoff will be tightlined to the proposed on-site catch basin as well as the driveway drainage. The catch basin will be connected to the existing street drainage system with a new catch basin installed on existing storm main (see Figure 4 – Proposed Development Map).
