Arborist Report and Inventory

March 19th, 2024

3029 62nd Ave SE
Mercer Island, Wa

Arborist notes for Aspen homes at 3029 62nd Ave. SE., Mercer Island Washington. Time of site visit: Thursday, March 14, 2024. 1:30 PM.

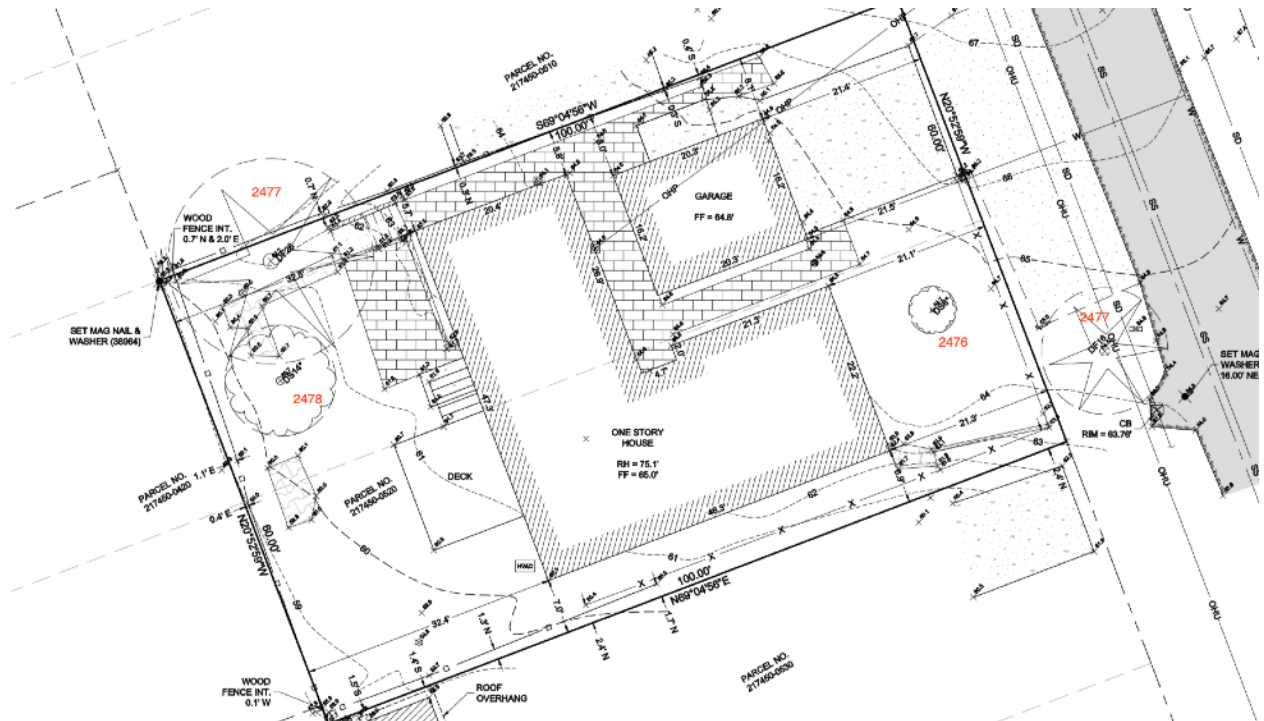
Layout of the Trees

The client has informed me that there is an intention to replace this single family residence with a new SFR and that the new footprint may increase in width by 12-14'. It is my suggestion that the client send me the map of the proposed improvements with the new data about the trees added to it and a list of the trees that they would like to remove. At this time, it looks like it will not be feasible to approach beyond the Inner Tree Protection Zone of Tree#2478.
