Project: Pre-construction assessment for lot re-development at 8110 SE 70th Street, Mercer Island, WA. Parcel number 5452800465.

Objectives: Evaluate health of existing trees and establish criteria for the preservation of those to be retained.

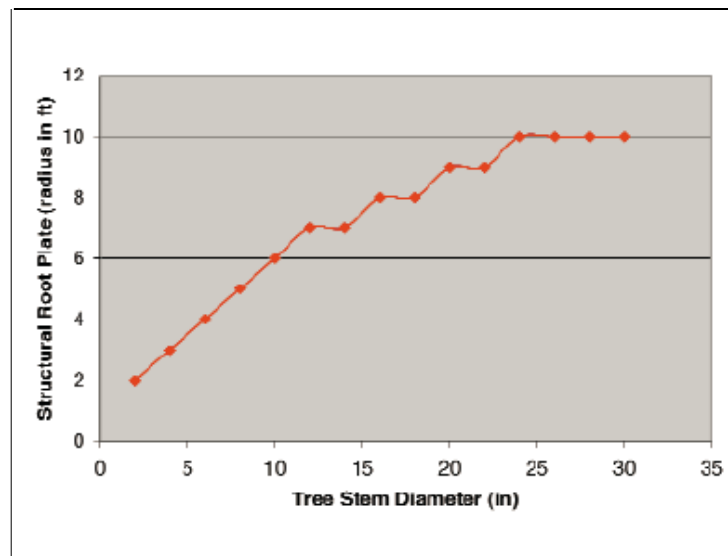
Figure 13. Size of the Structural Root Plate in relation to tree stem diameter. Note that the SRP levels off at 10' for any tree over 24" in diameter.

In the case of the #7 fir mentioned above, the excavation for the proposed foundation could come as near as 14' to the base of the tree. From Figure 13 the Structural Root Plate for a 22" DSH tree is given as 9' so the foundation demolition should be well outside this tree's SRP.

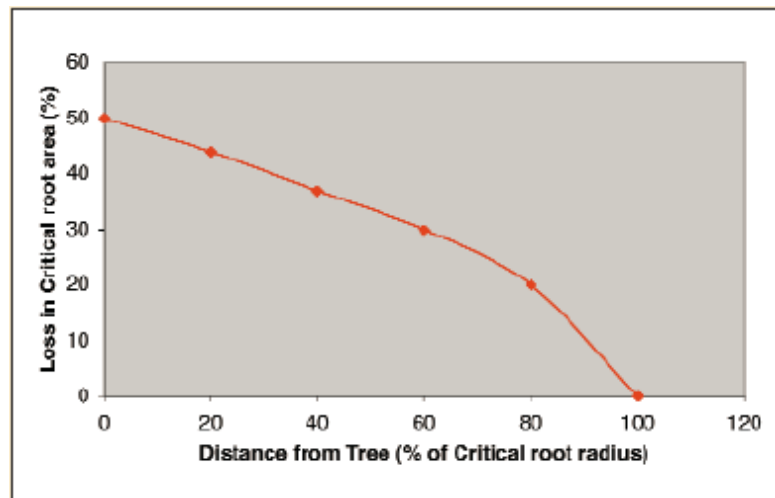
Figure 14. Chart giving the loss in critical root area as a function of the radial distance to the CRZ disturbance.

Using the #7 fir again as the example, with the foundation excavation being 14' from the tree's base and it having a 22" DSH, there will be impact at a linear distance equal to 64% of the fir's CRZ (14'/22'). The chart shows that this roughly equates to a 27% loss of the fir's Critical Root Area (CRA) putting it just within the maximum recommended impact guideline. However, if more than 8" of fill is placed over the fir's roots on its west side it will have an additive impact effect which could result in the tree's early decline.

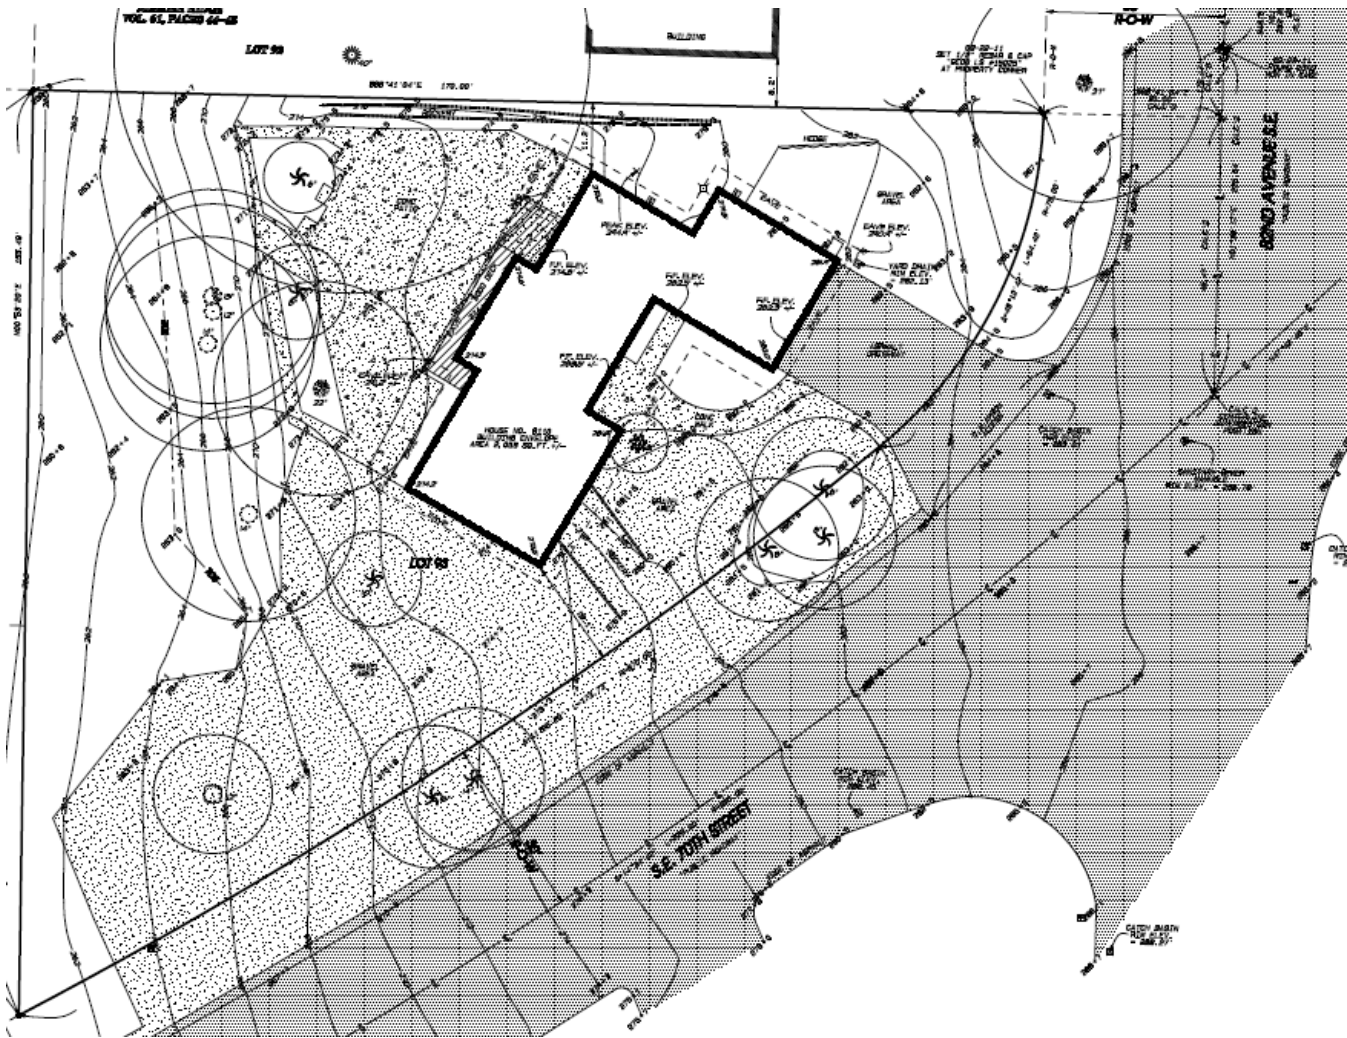
Figure 1. Excerpt from the survey plans showing footprint of existing house.

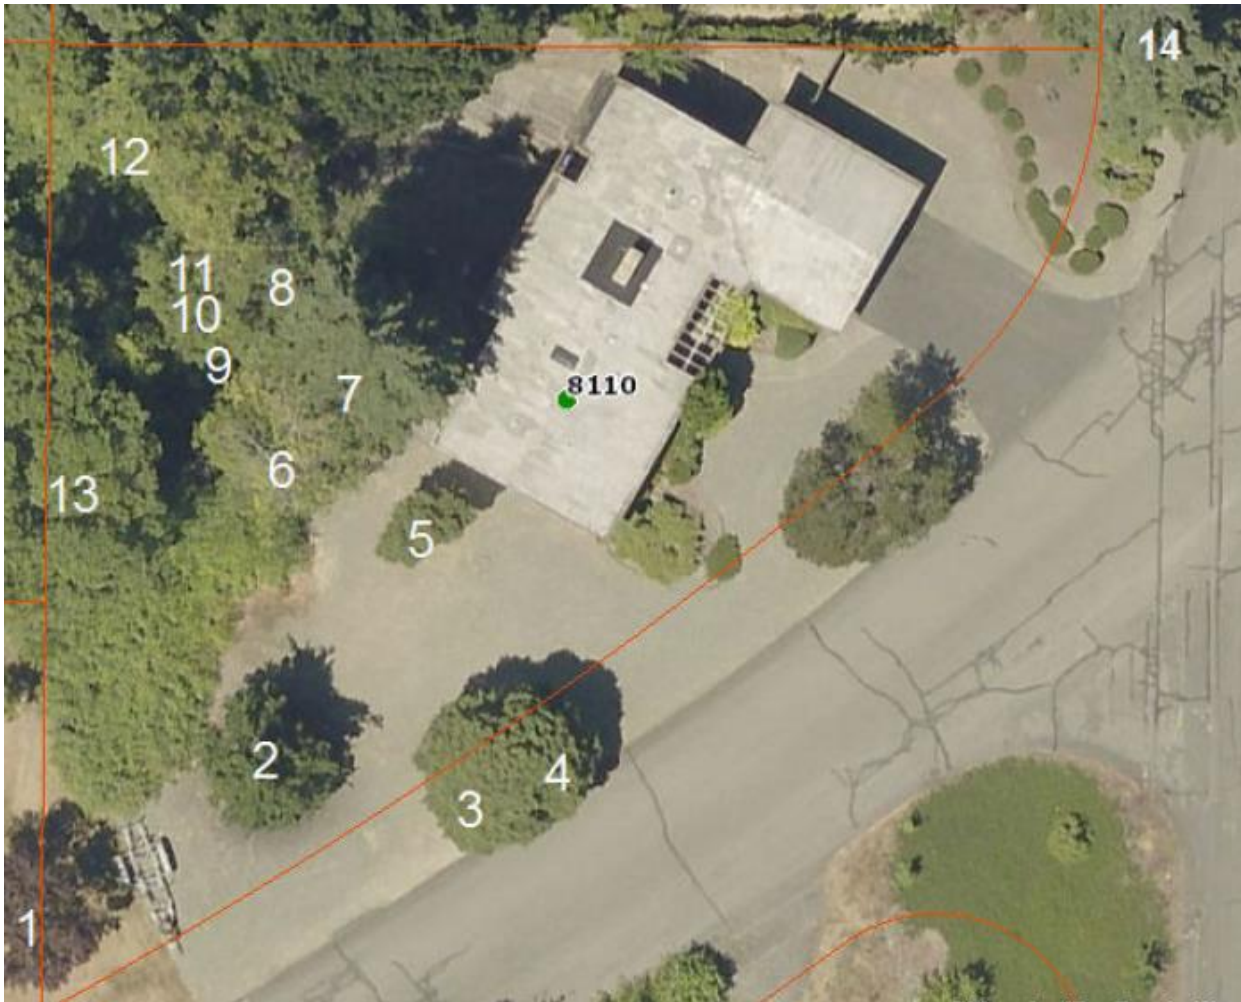
Figure 3. Aerial view of the subject property showing the approximate location of the trees listed in the description section (white numerals).
