October 24, 2020

**Project:** Pre-construction assessment for garage renovation at 4602 East Mercer Way, Mercer Island, WA. Parcel number 7558700045.

**Objectives:** Evaluate health and suitability for retention for 6 trees near the garage.

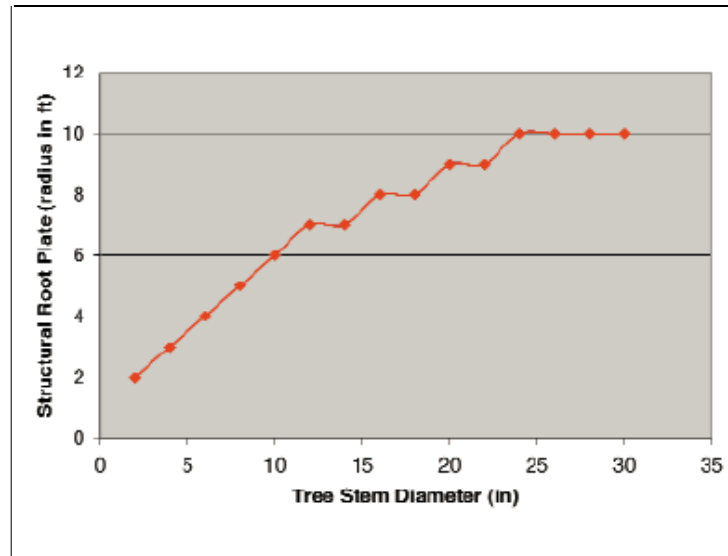
Figure 15. Size of the Structural Root Plate in relation to tree stem diameter. Note that the SRP levels off at 10' for any tree over 24" in diameter.

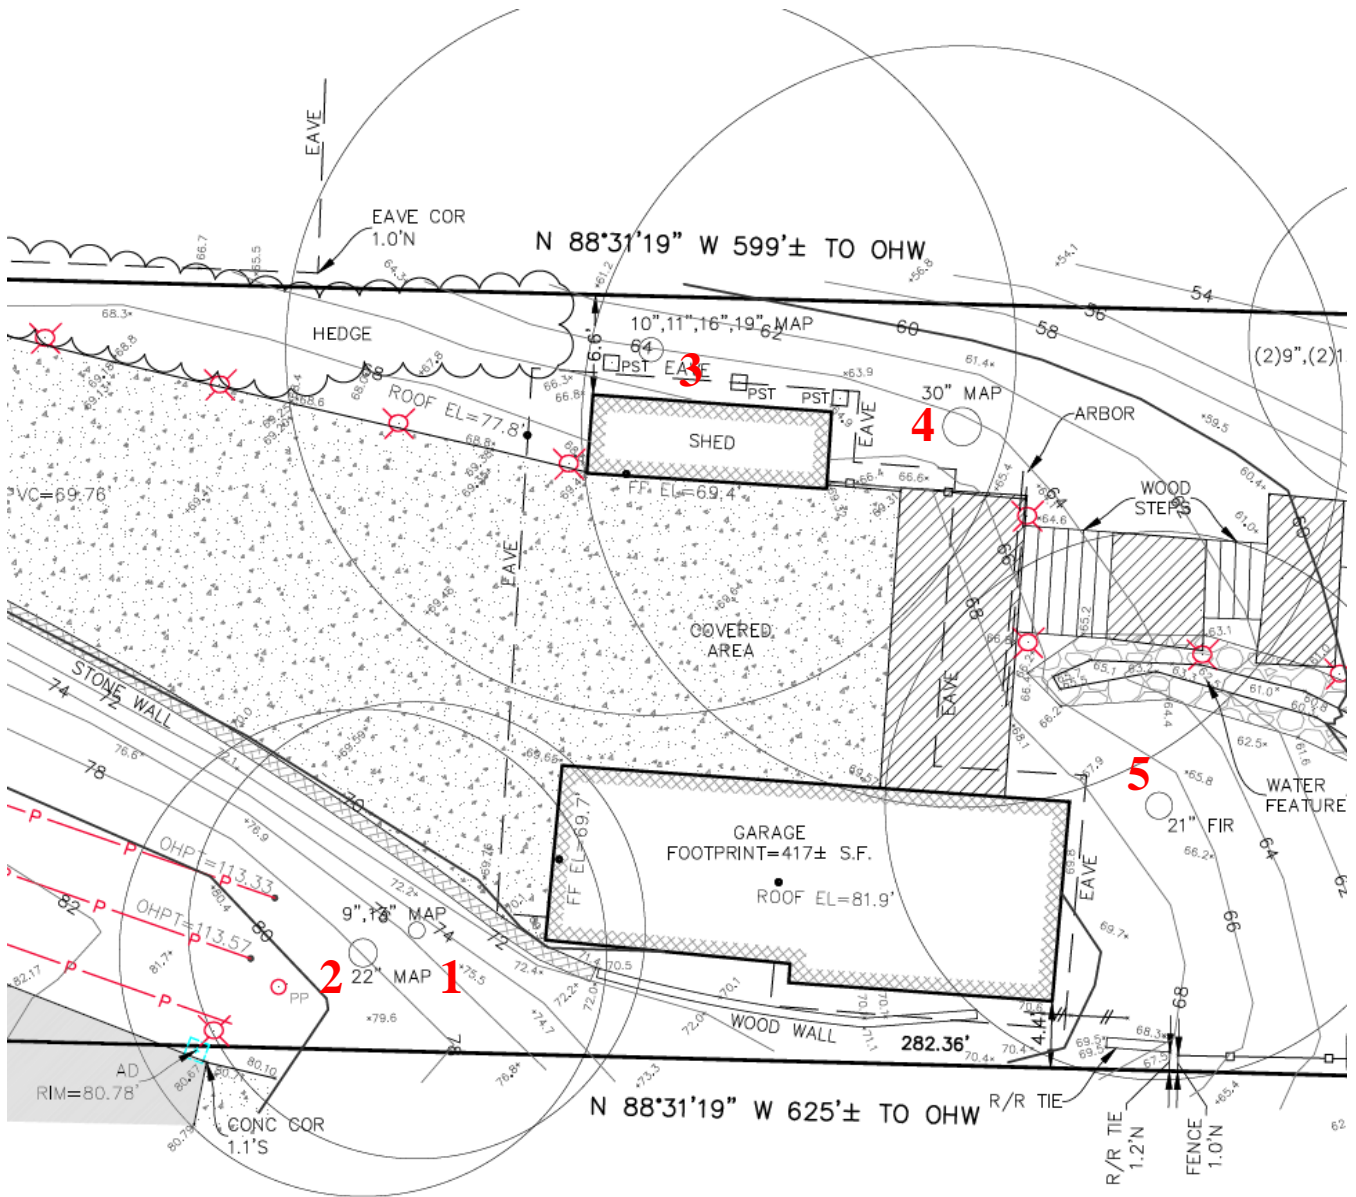
Figure 1. Excerpt from the survey plans showing footprint of existing garage. The subject trees are notated in red.

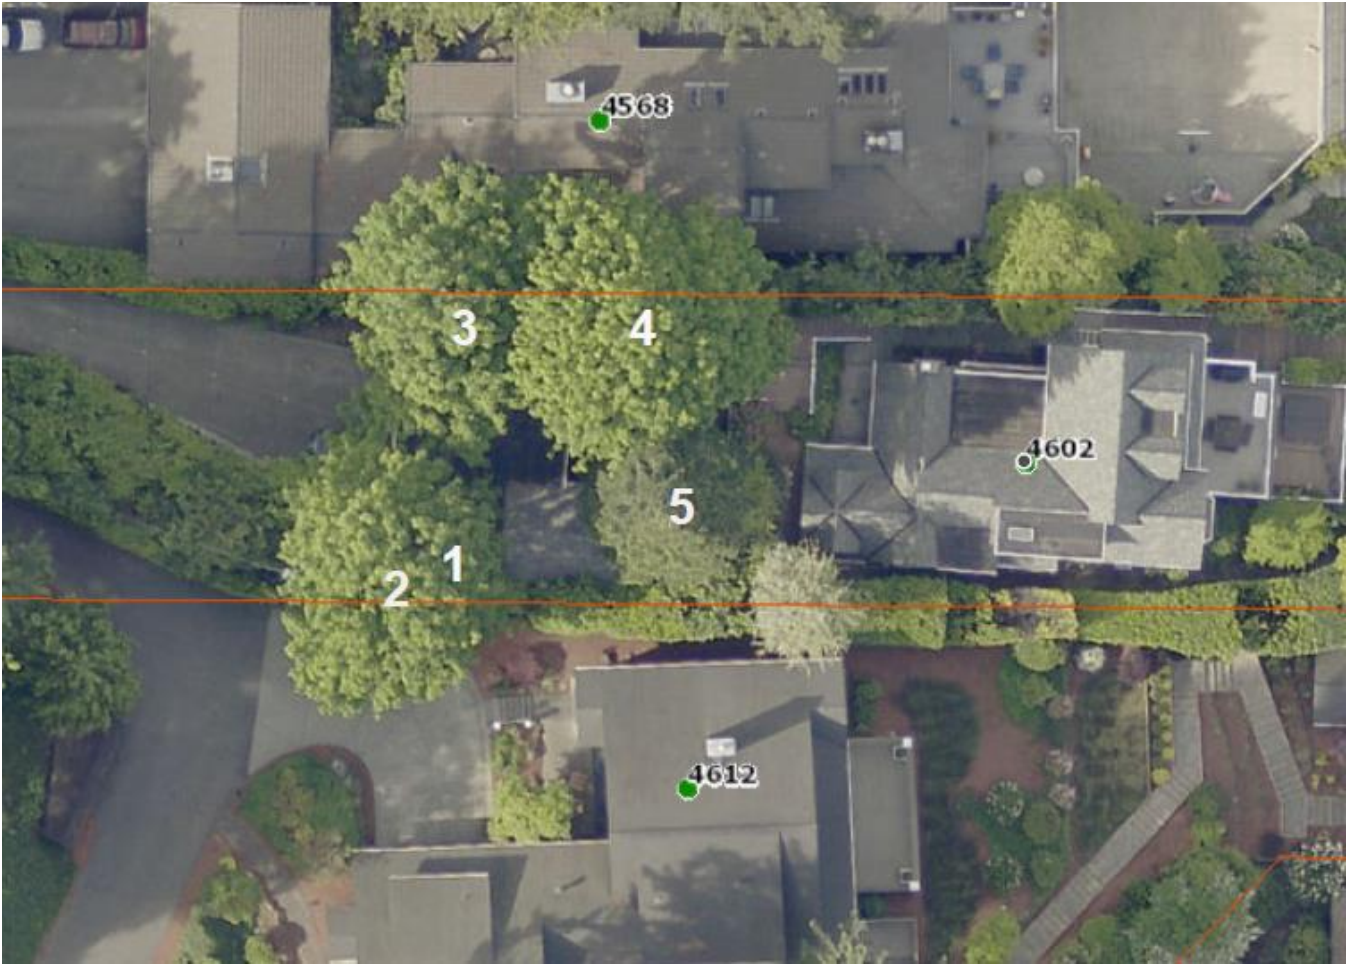
Figure 3. Aerial view of the subject property showing the approximate location of the trees listed in the description section (white numerals).
