August 16, 2022

Project: Pre-construction assessment for lot re-development at 6950 SE Maker Street, Mercer Island, WA. Parcel number 9350900620.

Objectives: Evaluate health of existing trees and establish criteria for the preservation of those to be retained.

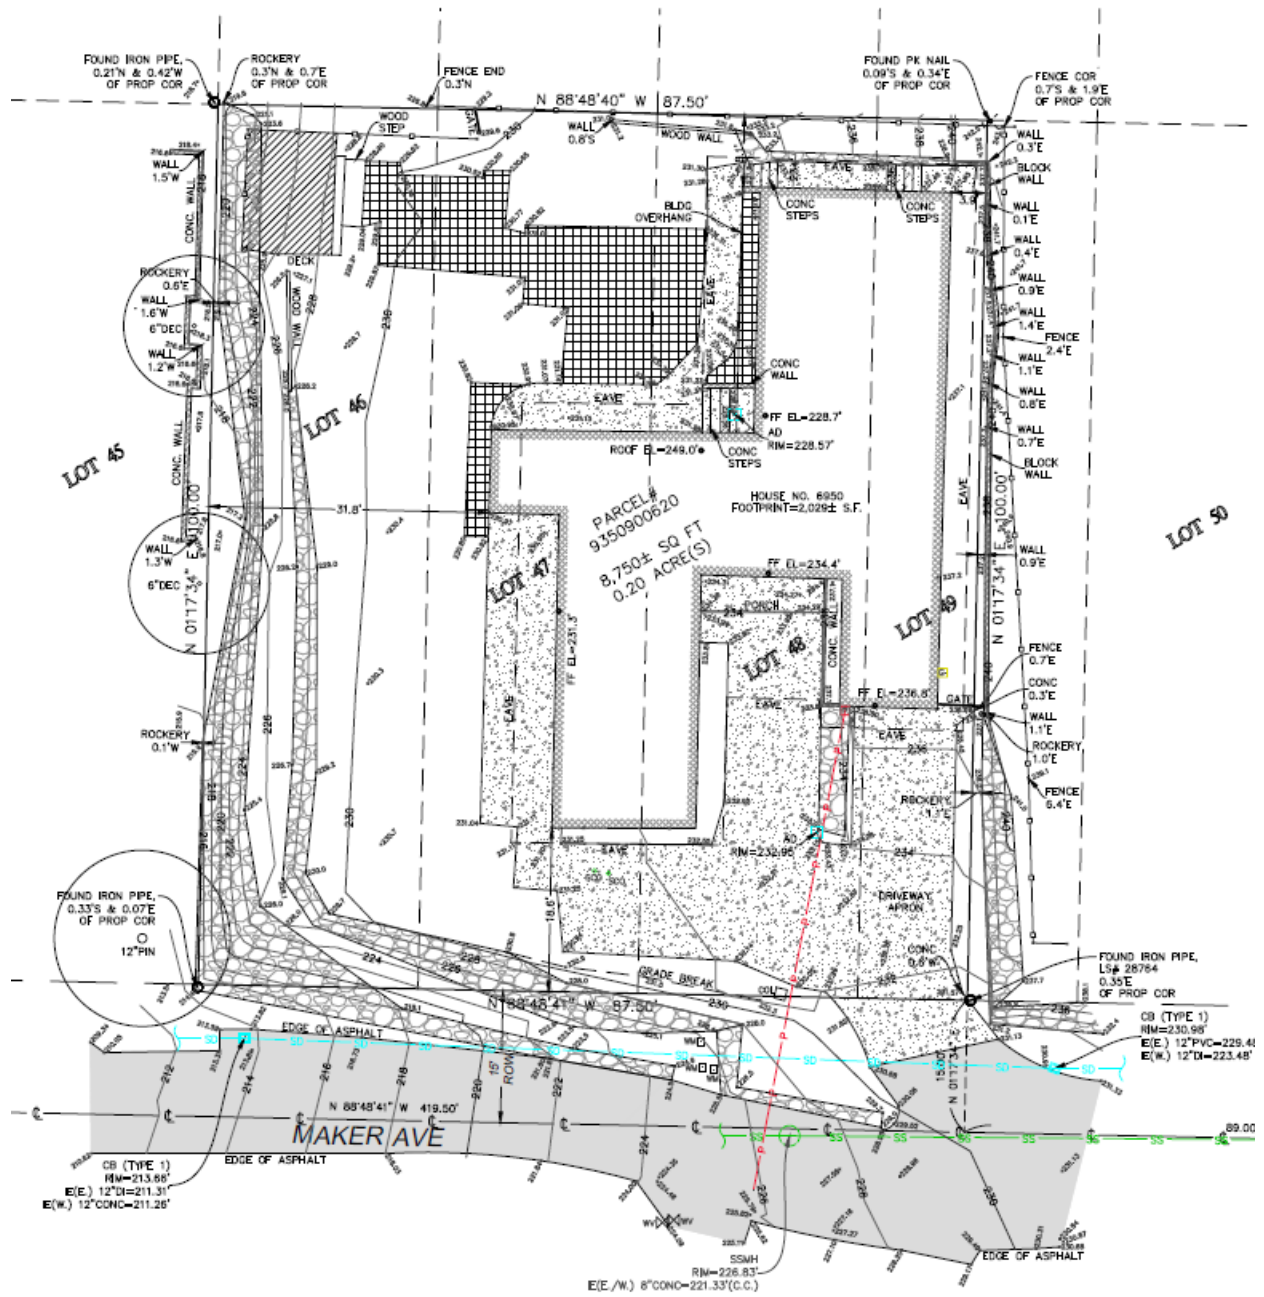
Figure 1. Excerpt from the plan set showing the current layout of the property.
