EVALUATION OF SELECTED TREES AT

**5637 E Mercer Way
Mercer Island, WA 98040**

July 14, 2015

GILLES CONSULTING

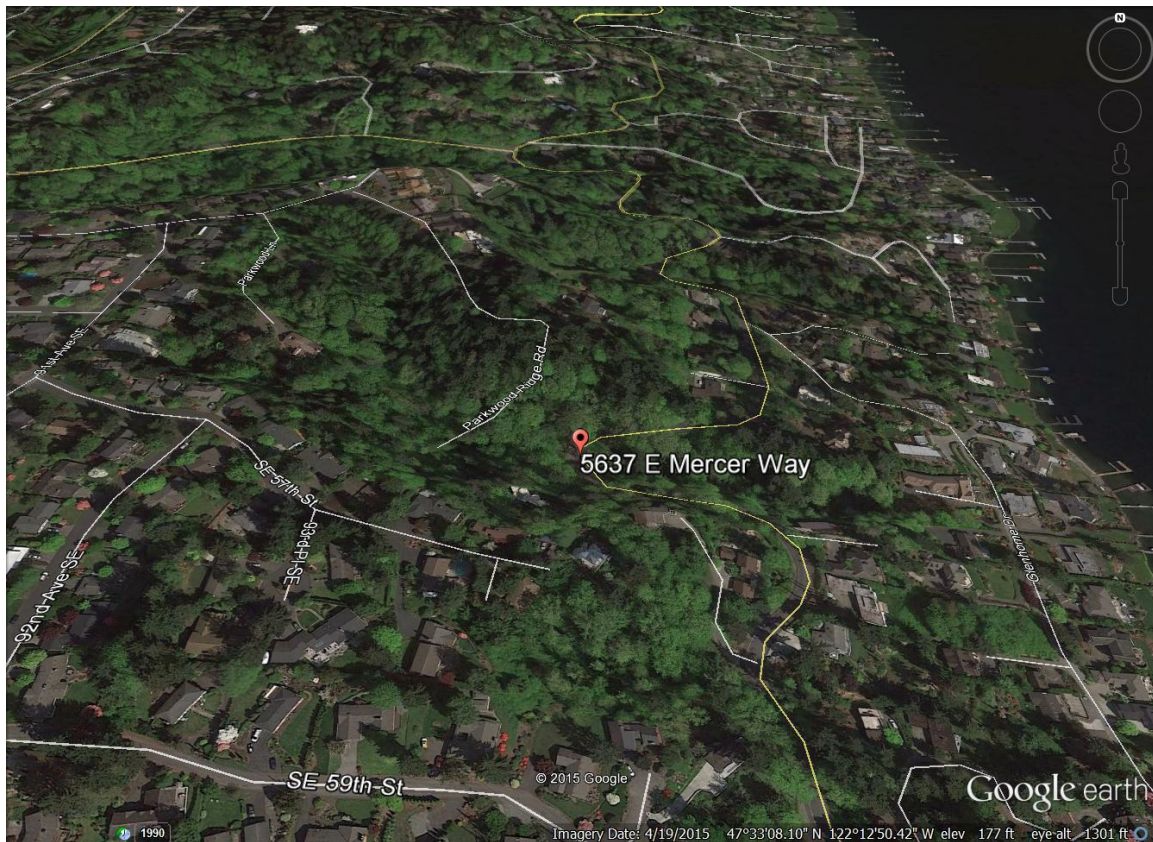
Photo # 1: A Google Earth image of the site and the surrounding community.

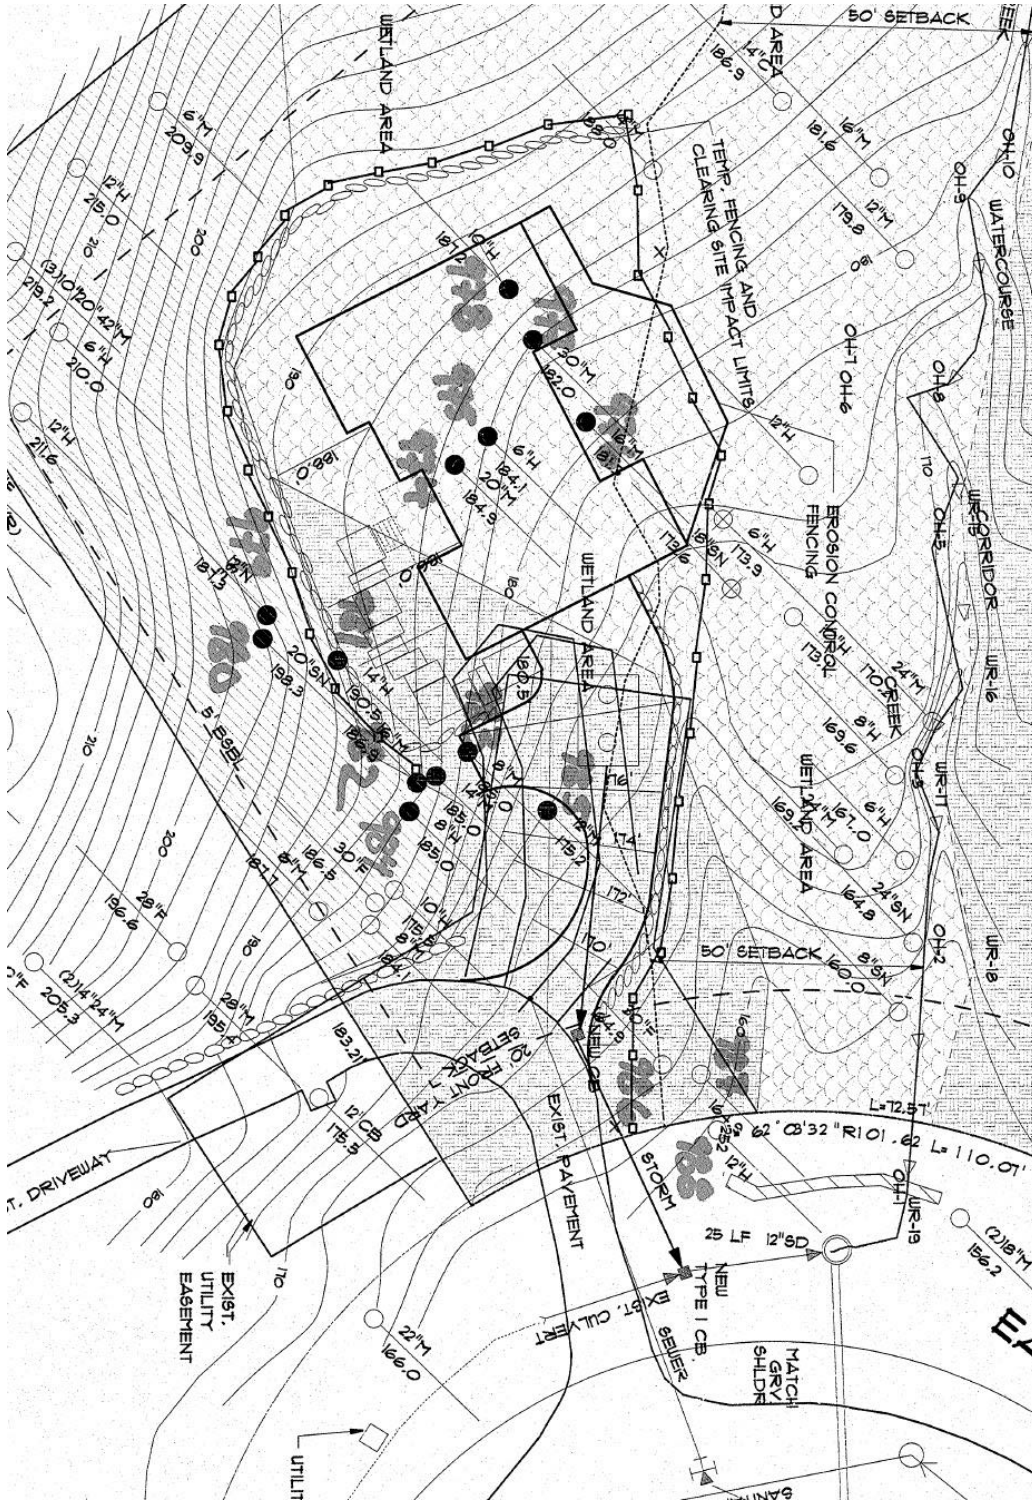
Trees within the building footprint include trees # 974, 975, 976, 977, and 978. They are recommended for removal. Trees impacted by the grading and detention vault excavation include trees # 979, 980, 981, 982, 983, 984, and 985. Trees # 986 and 987 are north of the existing driveway and north of the proposed "*Limits-of-Disturbance*" fence. This fence should adequately protect them. They can remain. Please note that trees # 974, 975, and 980 are either Dying or in Poor Condition. They are already recommended for removal for safety. Tree # 987 is the large Maple tree immediately south of the existing driveway. It has considerable decay in the lower trunks and base. Left as it is, and with the removal of the other 11 trees, this tree could be vulnerable to stronger storm forces and could fail. However, the tree may not need to be completely removed. It is my judgment that if the tree was severely reduce, say by 35% to 40%, it could remain at an acceptable level of risk. It will be important to inform the new homeowners to have the tree re-pruned once every seven to ten years for safety.

I agree that trees 974 through 985 should be removed for safety and for the construction of the new home. I recommend extending the "*Limits-of-Disturbance*" fencing to protect tree # 988 in the East Mercer Way right-of-way. The remaining trees will be adequately protected by the "*Limits-of-Disturbance*" fencing.
