REVISED TREE REPORT AT

**5637 E Mercer Way
Mercer Island, WA 98040**

January 15, 2021

Brian K. Gilles, Consulting Arborist

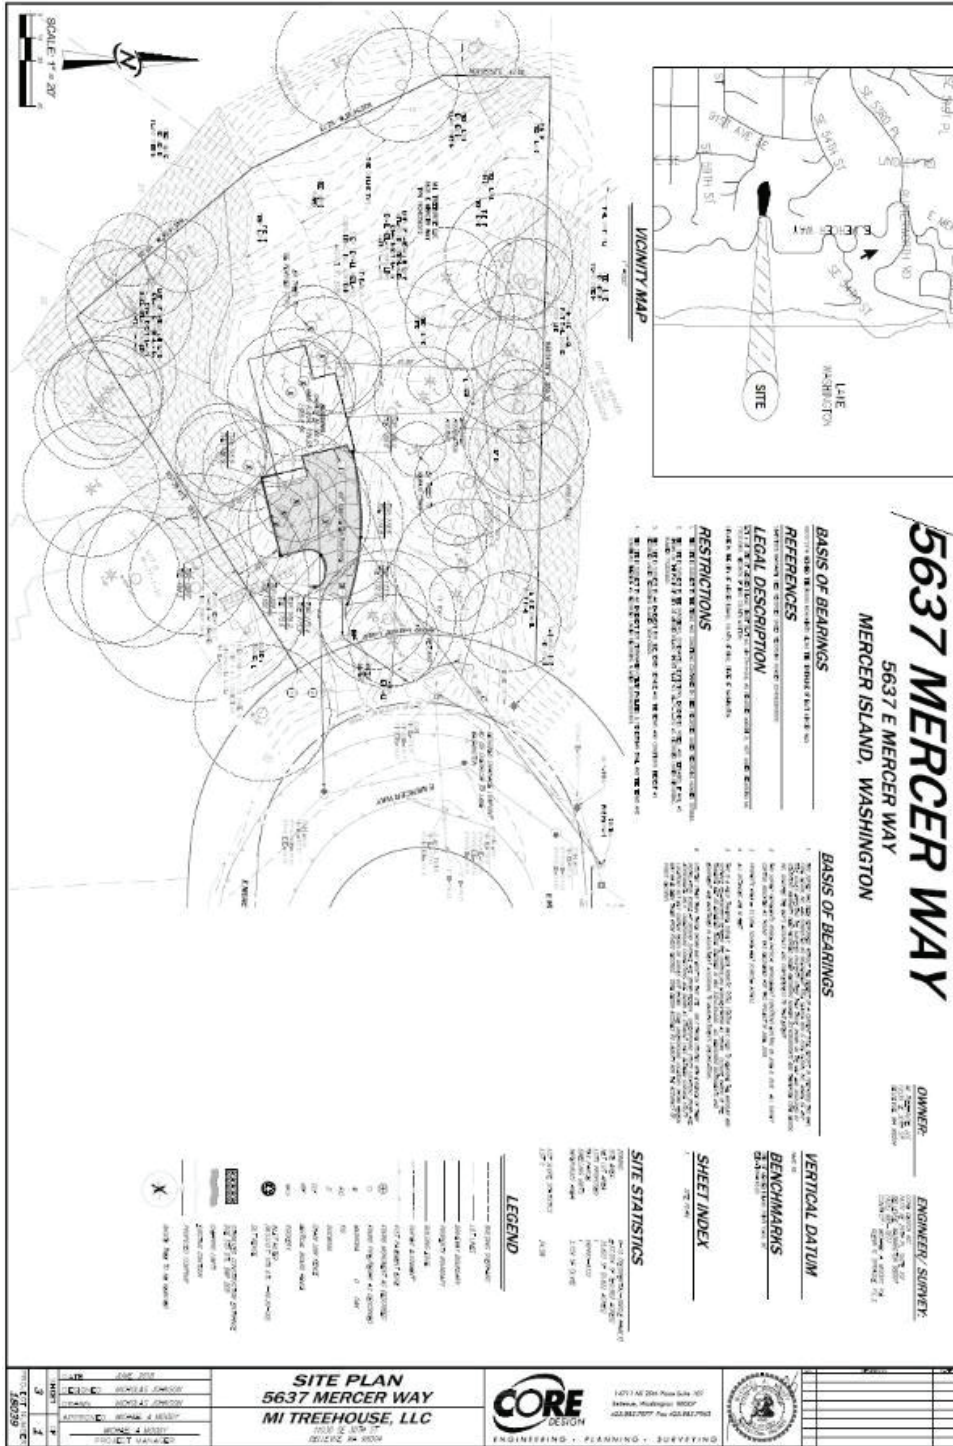
Proposed Site Plan:

Approximate Tree Protection Fence locations: - - - - -

I recommend that Trees # 974 through 985 should be removed for safety and for the construction of the new home. I recommend extending the “*Limits-of-Disturbance*” fencing to protect tree # 988 in the East Mercer Way right-of-way. The remaining trees will be adequately protected by the “*Limits-of-Disturbance*” fencing. Indicated in *Attachment 4, Tree Protection Measures* below.
