October 28, 2017

Project: Pre-construction assessment for lot re-development at 6025 77th Avenue SE, Mercer Island, WA. Parcel number 4097100075.

Objectives: Evaluate health of existing trees and establish criteria for the preservation of those to be retained.

Anthony Moran, BS
ISA Certified Arborist
Qualified Tree Risk Assessor
#PN-5847A

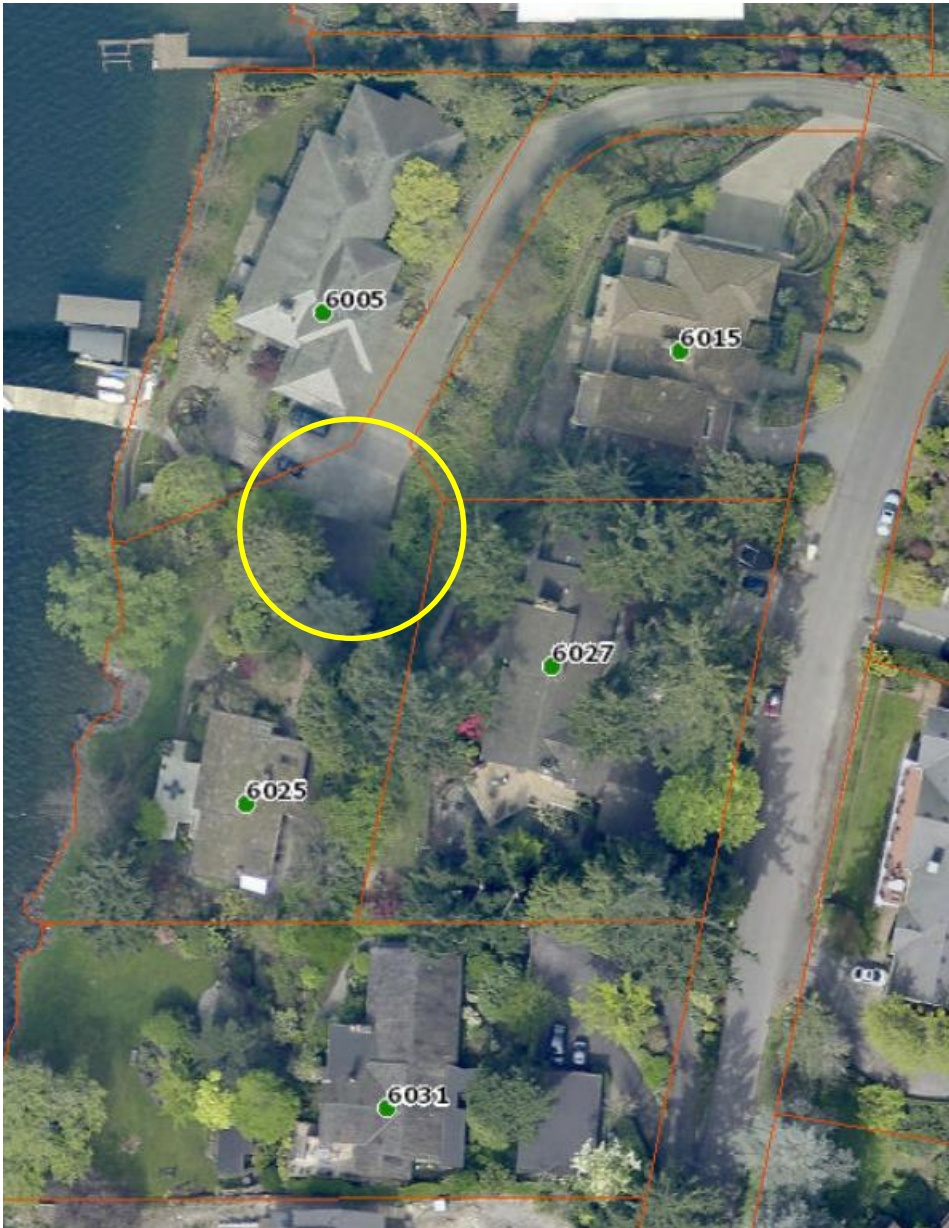
Description: The main layout of the 6025 parcel has been mostly undisturbed for more than forty years. The original home was built in 1944 along with detached garage/carport. The carport is about 40' north of the main house and sits in the 'bottleneck' of the lots shape (Figure 1). The largest of the trees currently onsite have most likely been in place since home was built. The 6005 house to the north was built in 1996 and few changes have taken place on that lot since the original construction. The 6027 house on the east side of the main part of the partial was built in 1975 and no changes have taken place since that time. The 6049 house on the south side of the subject property was recently demolished and excavation for a new house was occurring during the October 2017 site visit.

Figure 1. Aerial overview of the subject (6025) and surrounding properties. Note the carport sits directly in the center of the only viable approach to the property (yellow circled area). The entrance is only 75' wide at this point, 15' of which is close vertical along the east side.

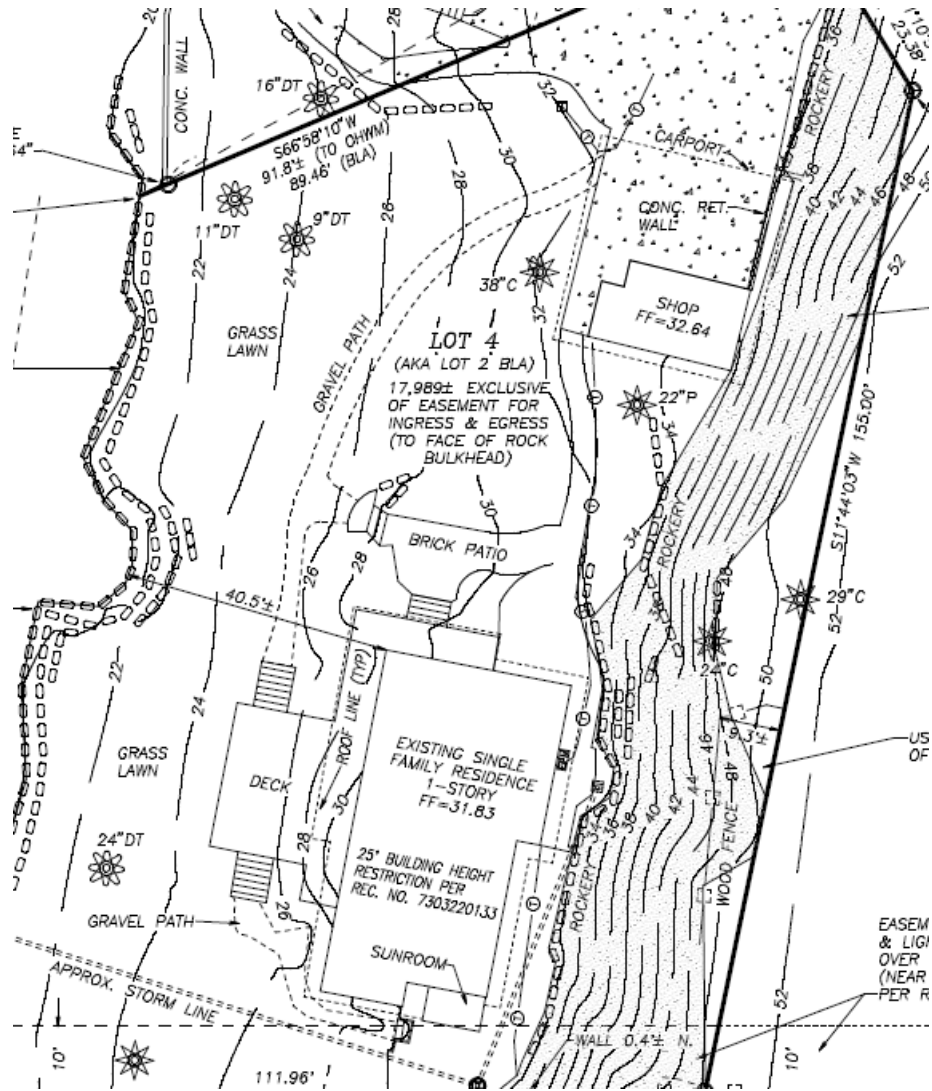
Figure 2. Excerpt from survey plans showing existing layout of property. Note step section at right (east) side of the property and location of the carport at the top of the lot.

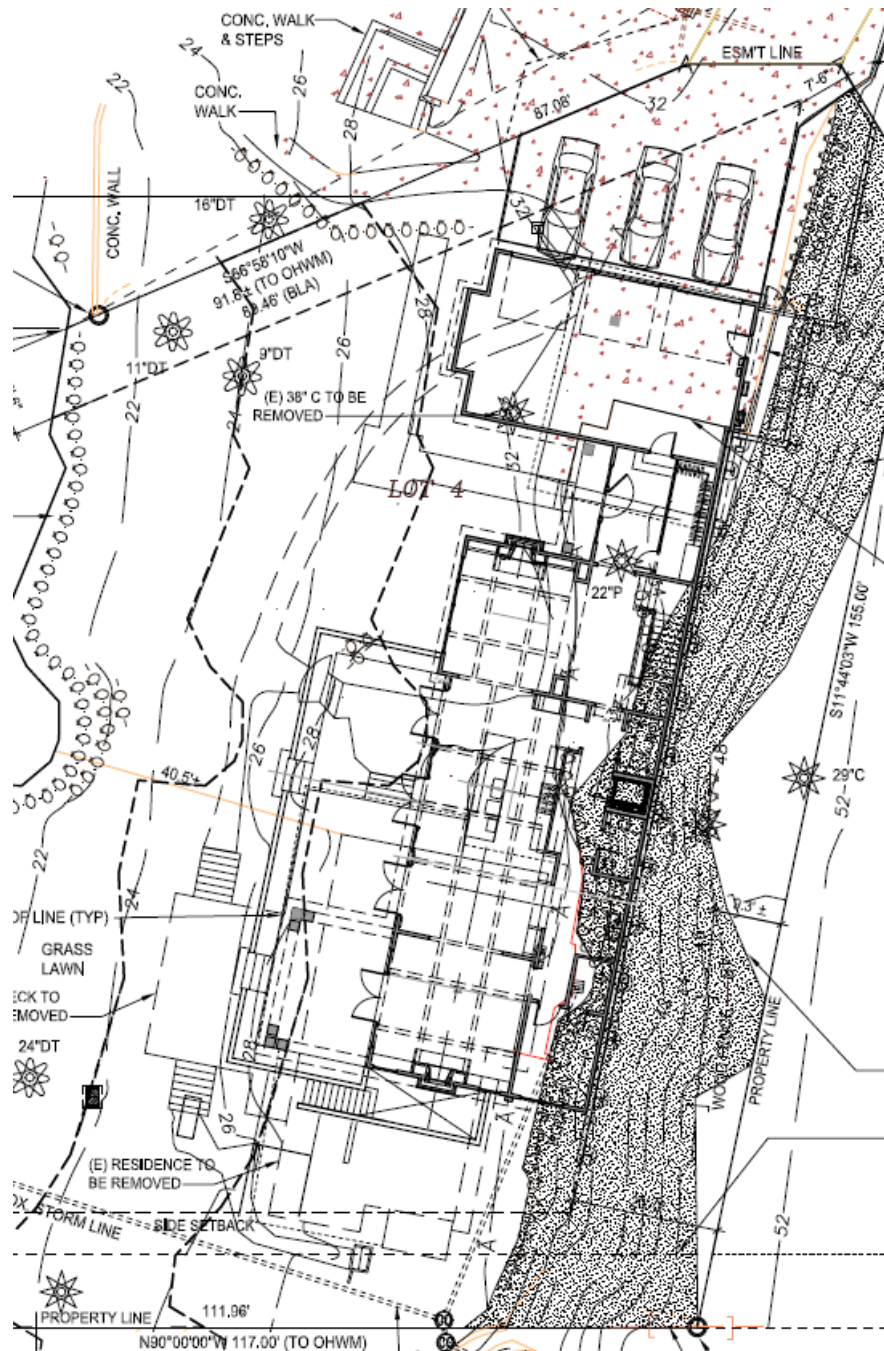
The property was purchased in May of 2017 and the new owners have proposed tearing down the existing house and replacing it with one having a somewhat different footprint (Figures 2 and 3). Superior NW Enterprise was contacted and asked to assess all the trees present on the lot as to their health, stability, and overall suitability for retention.

Figure 3. Excerpt from proposed plans showing layout for new home. The garage replacing the carport is about 15' wider than the original. The new house shifts about 10' to the east and is continuous with the garage.

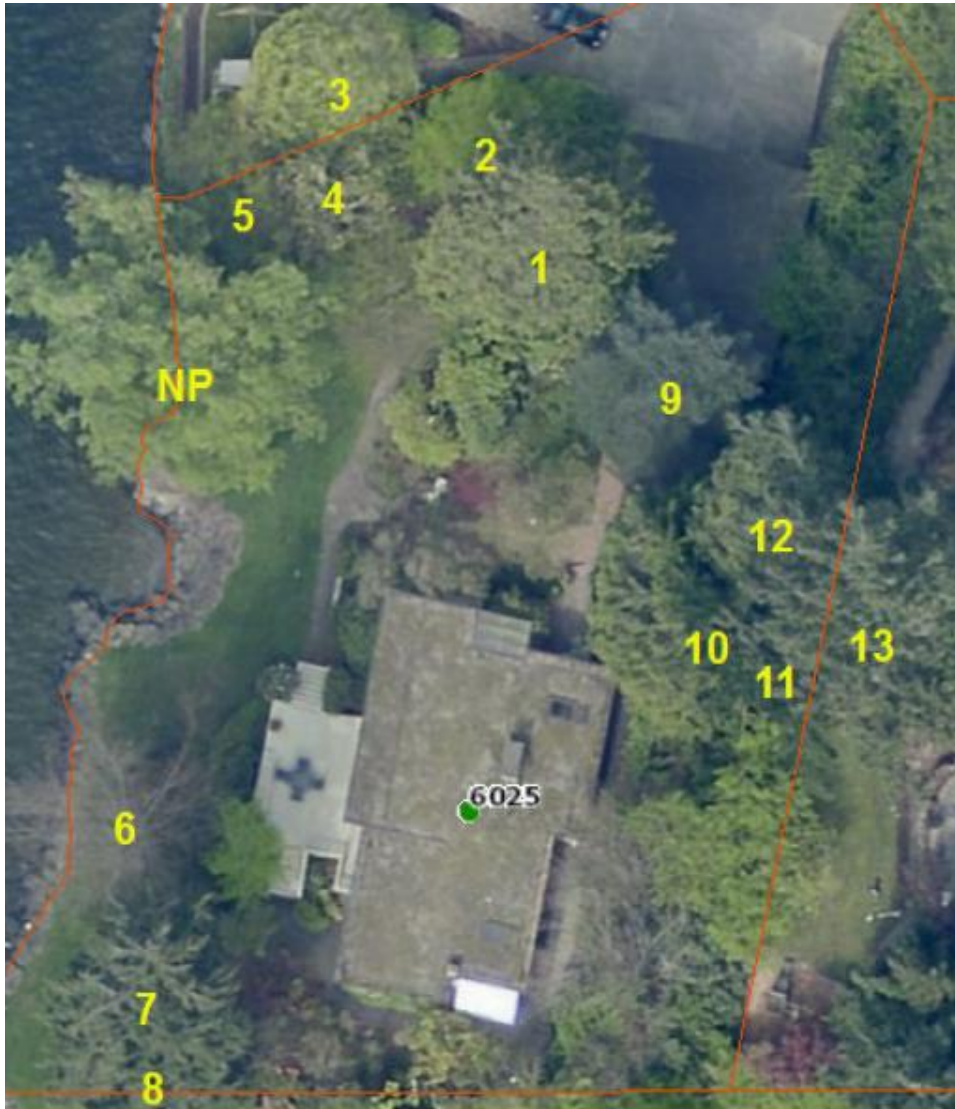
While we are maximizing tree retention, there are two trees at the north end of the property, a 35" Western Red Cedar (#1) and 22" Scots Pine (#9) that are intended to be removed for the construction of our new home. The 22" Scots Pine (#9) sits squarely within the buildable area and must be removed to enable a new house to be built. The 35" Western Red Cedar (#1) is located at the only entry to the buildable area of the lot. Per the Mercer Island city code, The 35" Western Red Cedar is considered an exceptional tree. It is located adjacent to the existing carport, which will be removed for construction. Based on the arborist report provided by certified arborist Anthony Moran, page 6, the Western Red Cedar is *"well into the decline cycle. The additional stress of any degree of construction impact will most likely result in this tree going into a rapid degeneration."* In addition, the removal of the existing carport will damage the tree roots. See page 4 of the arborist report: *"The demolition of the existing concrete could disrupt its SRP significantly."* Page 5 states:

The following itemized tree list begins in the center of the north end of the property and their numerical designations are reflected in Figure 4. Diameters were measured at the standard height of 54" above grade (DSH) during the October 2017 site visits. Caliper measurements were made at 6" above grade. Heights were estimated. Trees were tagged with 1.5" orange circular markers near the 6' level.

Figure 4. Aerial view of the subject property showing the approximate location of the trees listed in the description section (yellow numerals). Note that the #1 cedar is directly in the center of the approach to the construction area and the #9 pine will be in the middle of the proposed house. The tree labeled 'NP' was present in 2015 (time of this aerial photo) but is no longer present. There were no fresh cut signs or a fresh stump so it most likely was removed or failed in late 2015 or early 2016.
