October 11, 2018

Re: 8100 Retaining Wall Project – Tree Impact Report

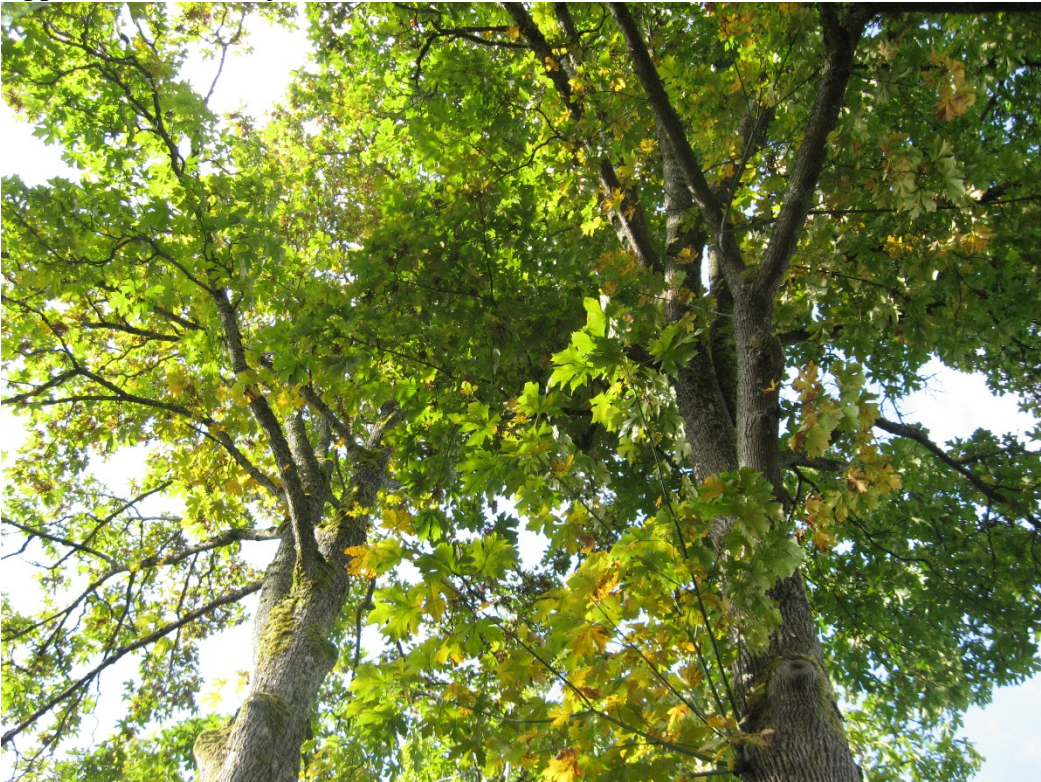
All three subject bigleaf maples trees are in fairly good condition. They have developed typical form and structure for single stem specimens. Vigor is good compared to other specimens around the Puget Sound Region. Leaves are of normal size and color with no indicators of foliar or pest issues. Trees are sound and free of any outward indicators of significant internal decay. There is an old seam on the lower trunk of Tree #1 on the south side which is not uncommon. There is a significant amount of reaction wood or adaptive growth around the seam indicating good vigor.

Upper crowns of subject trees

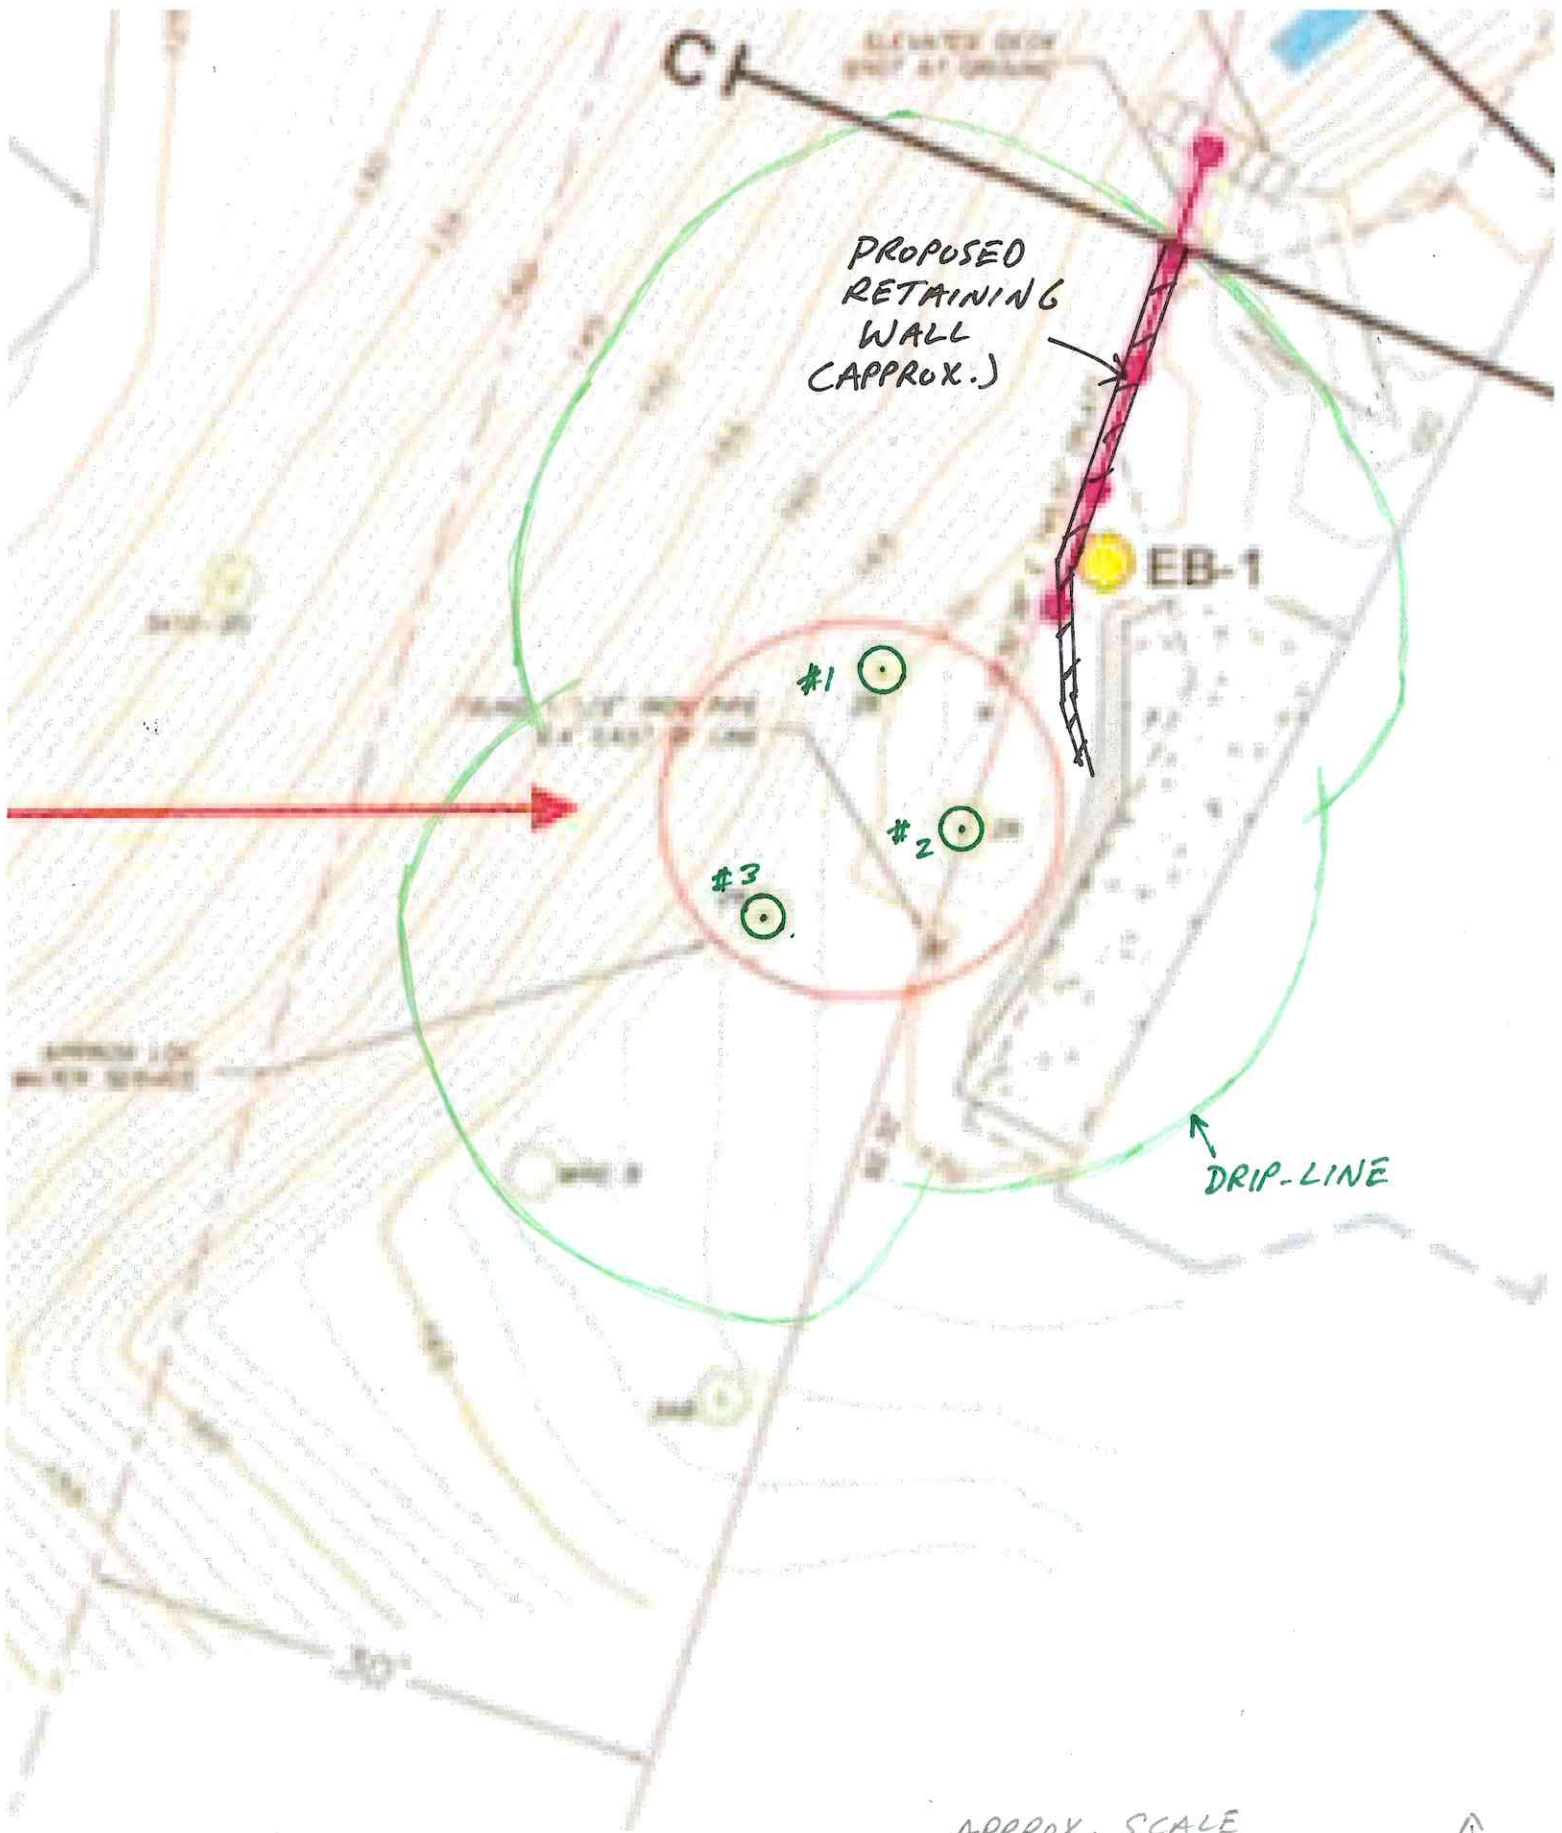
The proposed work, although within the drip-lines of Trees #1 and #2, is not expected to have any significant impact on long-term health or stability. Very few roots are expected to exist within the proposed area of excavation, due to prior existing improvements and slope. If any roots are encountered, they can be safely pruned away to provide work clearance without having any consequential impacts on tree health or stability. Before backfilling new walls, any encountered roots will be properly pruned clean at sound tissue.

PROPOSED  
RETAINING  
WALL  
(APPROX.)

#1

#2

#3

DRIP-LINE

If any roots are encountered during wall excavation work, they shall be properly pruned prior to backfilling. Roots shall be pruned with a sharp saw at sound tissue, where the bark is undamaged and completely intact with the root. This will allow the cut root to better seal off any potential decay and ultimately sprout new growth.
