Arborist Report

TO: Gary Upper, JayMarc Homes
SITE: 4150 78th Ave SE, Mercer Island, WA 98040
RE: Site Assessment and Tree Inventory
DATE: February 1, 2016
PROJECT ARBORIST: J. Casey Clapp
ISA Certified Arborist #PN-7475A
ISA Qualified Tree Risk Assessor

January 3, 2019

Project: Pre-construction assessment for lot re-development at 4150 Boulevard Place SE, Mercer Island, WA. Parcel number 3623500174.

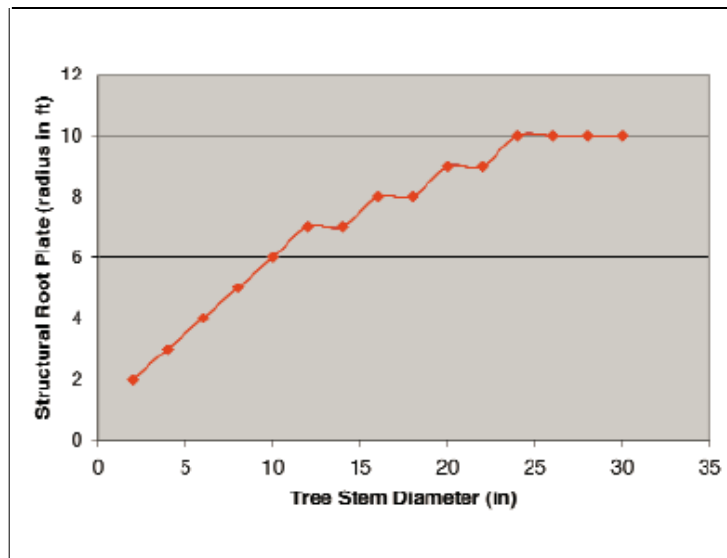
Figure 11. Size of the Structural Root Plate in relation to tree stem diameter. Note that the SRP levels off at 10' for any tree over 24" in diameter.

In this case all three firs exceed the 24" threshold and would have 10' SRPs. The cedar, having a 19" diameter, has an 8' SRP. The #33 tree is the only one of the four which has a compromised Structural Root Plate as the driveway and main drive are less than 10' away from the base of the tree.

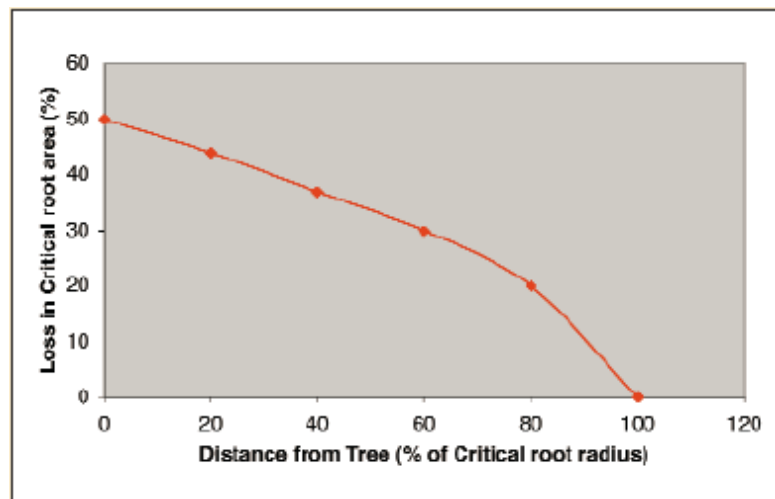
Figure 12. Chart giving the loss in critical root area as a function of the radial distance to the CRZ disturbance.

Using the #33 fir again as the example, with the existing driveway being 3.5' from the tree's base and it having a 31" DSH, there will be impact at a linear distance equal to 11% of the fir's CRZ (3.5'/31'). The chart shows that this roughly equates to a 45% loss of the fir's Critical Root Area (CRA) putting it well beyond the maximum recommended impact guideline. The main drive creates significant further limitations on the tree's CRA.
