REVISED TREE REPORT AT

**5637 E Mercer Way
Mercer Island, WA 98040**

April 7, 2021

**Bill Summers
P.O. Box 261
Medina, WA 98039**

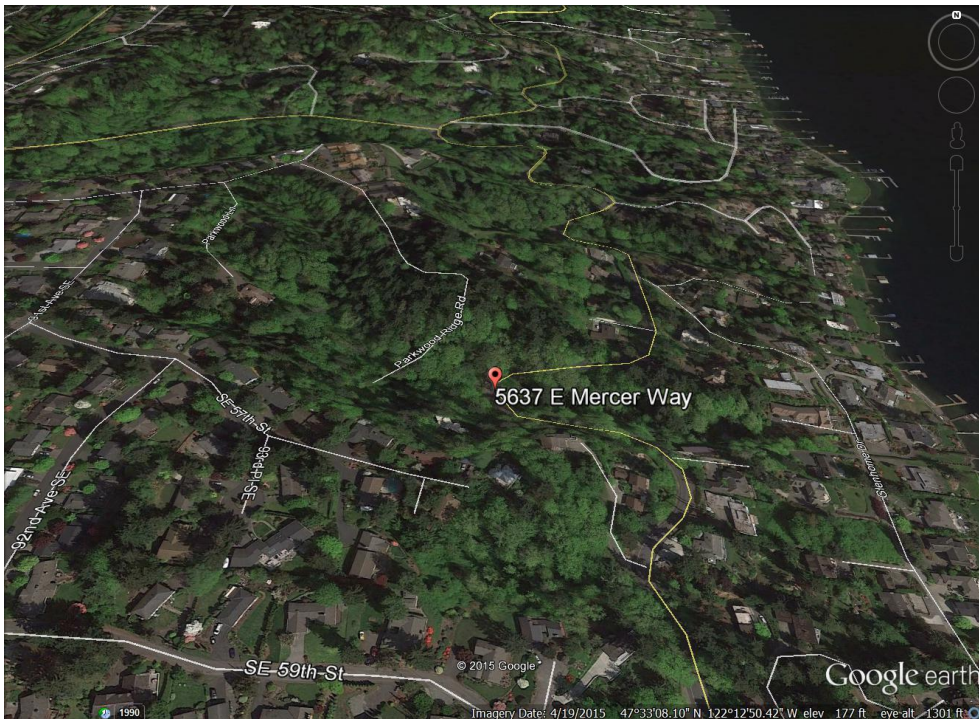
Photo # 1: A Google Earth composite image of the site and the surrounding community.

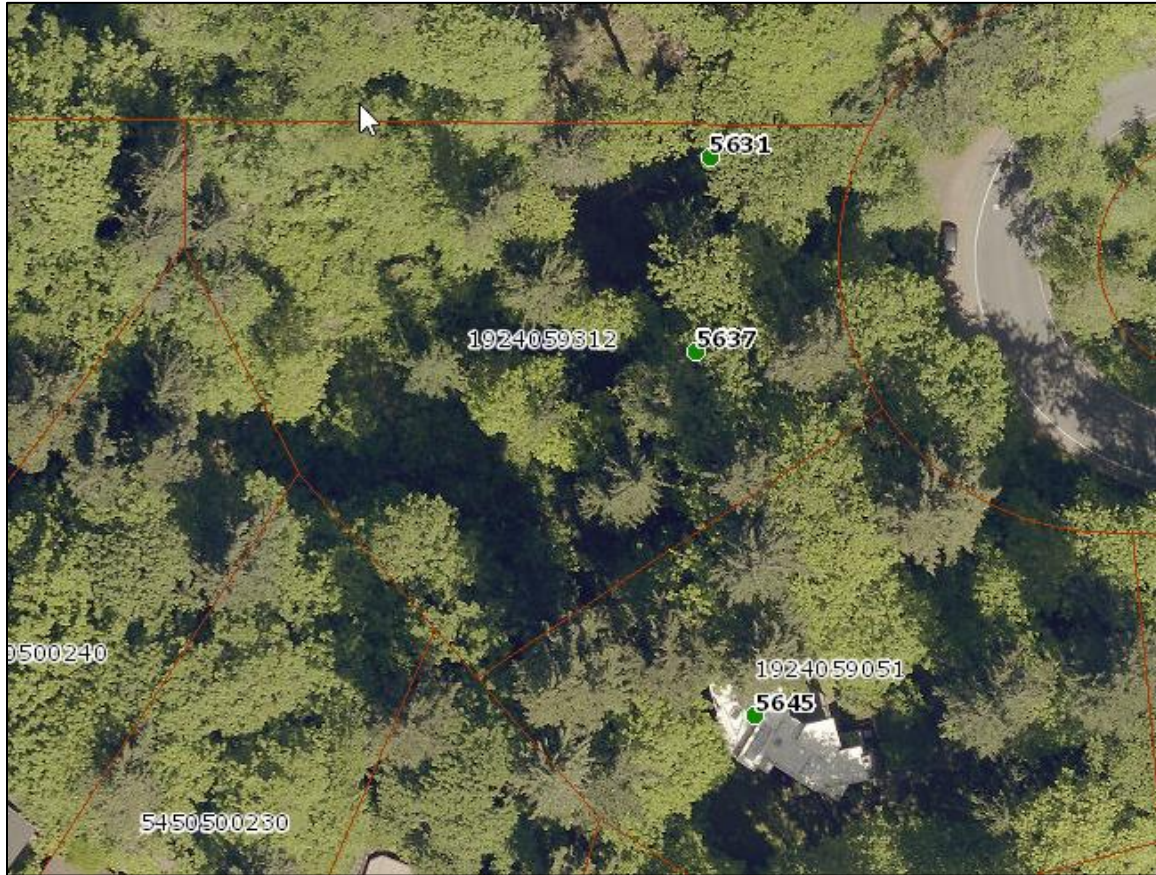
Photo # 2: A 2019 aerial photo with the property lines approximated. Taken from the King County Assessor's website.

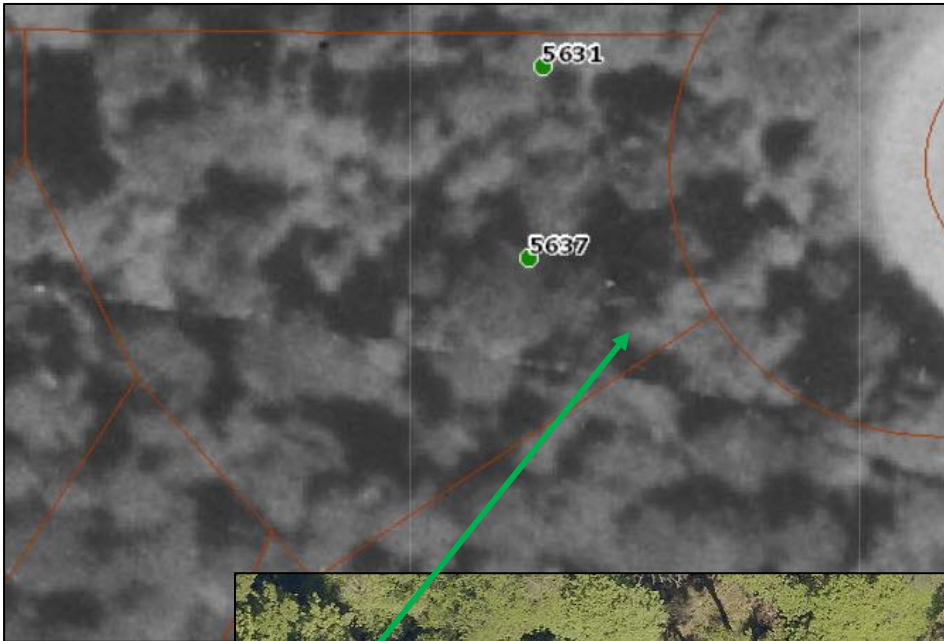
Photos # 3 & 4:
A 1936 aerial photo of the property in black and white. And, a 2019 color photo of the property.

Both photos taken from the King County Assessor's website.

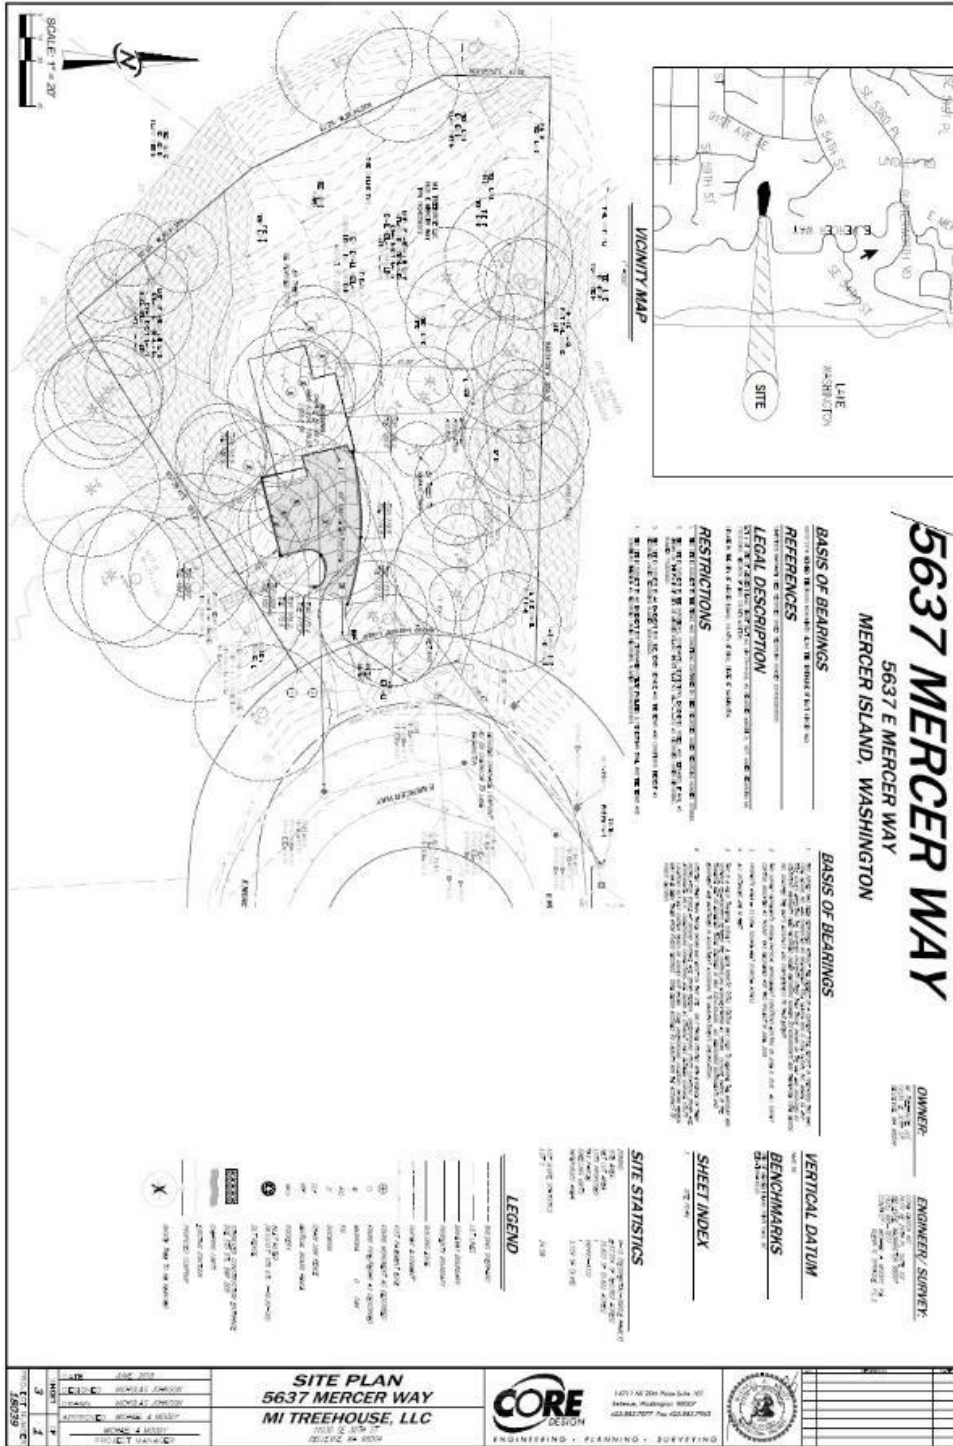
Proposed Site Plan:

Approximate Tree Protection Fence locations: - - - - -

I recommend that Trees # 974 through 985 should be removed for safety and for the construction of the new home. I recommend extending the “*Limits-of-Disturbance*” fencing to protect tree # 988 in the East Mercer Way right-of-way. The remaining trees will be adequately protected by the “*Limits-of-Disturbance*” fencing. Indicated in *Attachment 4, Tree Protection Measures* below.
