**Title: 3003 77th Ave Project – Mercer South Park Project
Full Tree Inventory and Health Assessment
Level 2 Basic Tree Risk Assessment
3003 77th Ave SE
Mercer Island, Washington**

Date: July 15, 2020; updated July 24, 2020

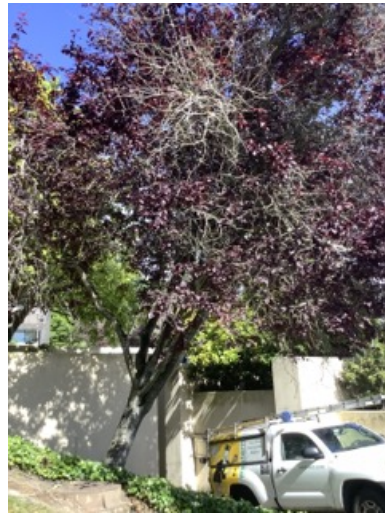
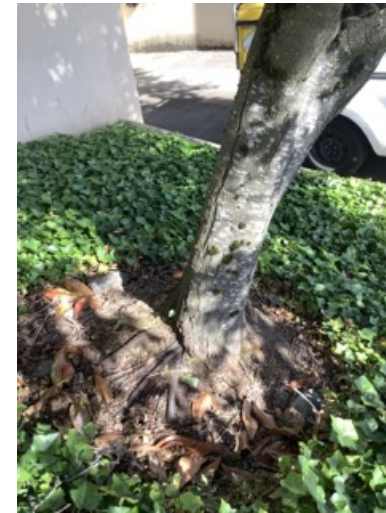
Tree	Species	DBH (in)	Drip Rad.	CRZ (ft)	Vigor	Structure	Risk	Pres Value	Recommendations
201	Plum <i>Prunus sp</i>	11.0	12.0	11.0	Fair	Fair to Good	Low	Low	
Notes/ Defects	The tree is on a slope next to a drain. It is leaning north and there is some twig dieback.

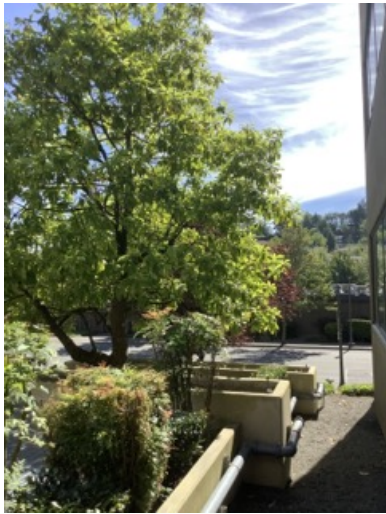
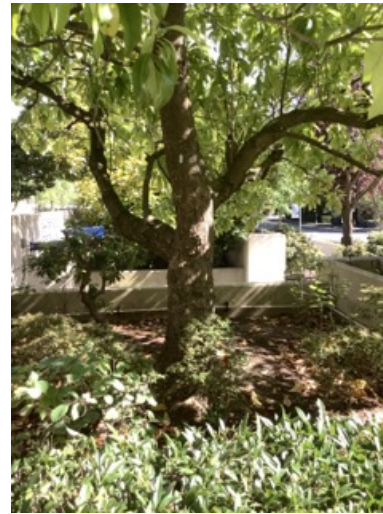
Tree	Species	DBH (in)	Drip Rad.	CRZ (ft)	Vigor	Structure	Risk	Pres Value	Recommendations
202	Southern magnolia <i>Magnolia grandiflora</i>	16.5	11.0	16.5	Good	Good	Low	Low	
Notes/ Defects	The tree is growing in a planting area next to garage. The foliage is slightly chlorotic.

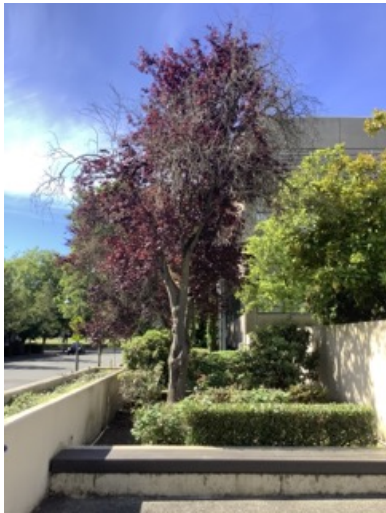
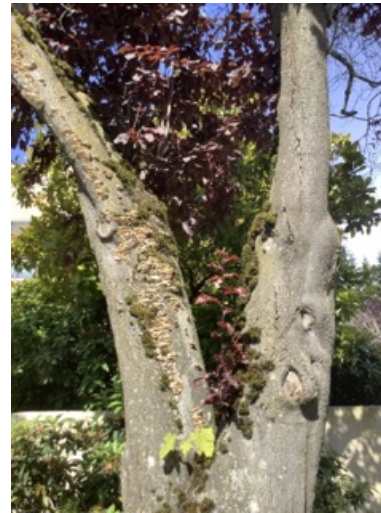
Tree	Species	DBH (in)	Drip Rad.	CRZ (ft)	Vigor	Structure	Risk	Pres Value	Recommendations
203	Plum <i>Prunus sp</i>	17.5	9.0	17.5	Poor to Fair	Fair	Low	Low	
Notes/ Defects	The tree is growing in a planting area. There is a fungus growing on the trunk and there is some branch dieback.

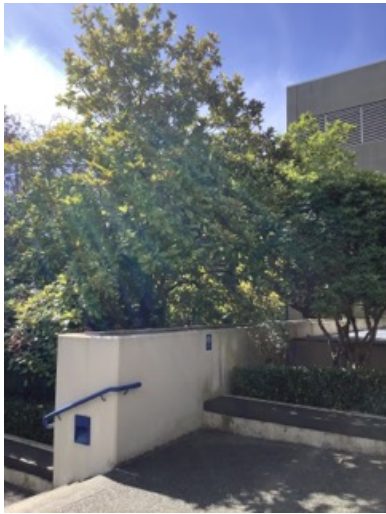
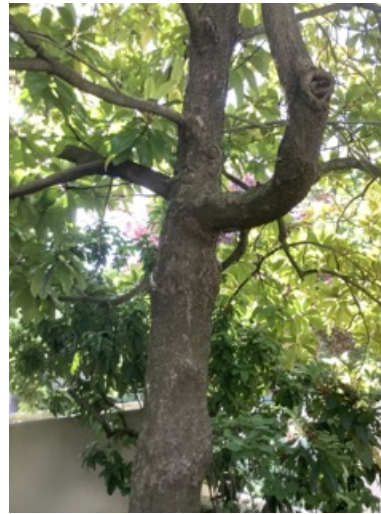
Tree	Species	DBH (in)	Drip Rad.	CRZ (ft)	Vigor	Structure	Risk	Pres Value	Recommendations
204	Magnolia <i>Magnolia species</i>	9.3	13.0	9.3	Good	Good	Low	Low	
Notes/ Defects	The tree is growing in a planting area. There are several roots on the surface.

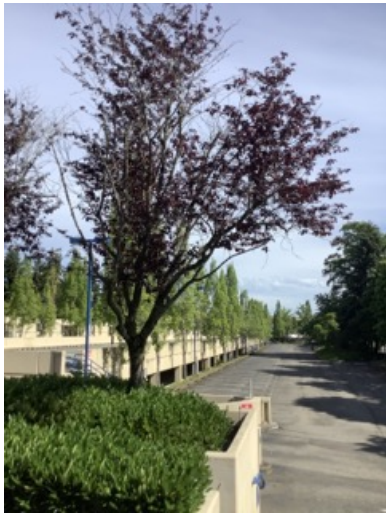
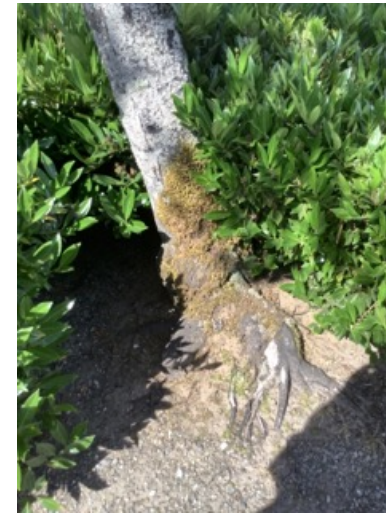
Tree	Species	DBH (in)	Drip Rad.	CRZ (ft)	Vigor	Structure	Risk	Pres Value	Recommendations
205	Plum <i>Prunus sp</i>	9.0	7.0	9.0	Poor to Fair	Fair	Low	Low	
Notes/ Defects	There is some branch dieback.

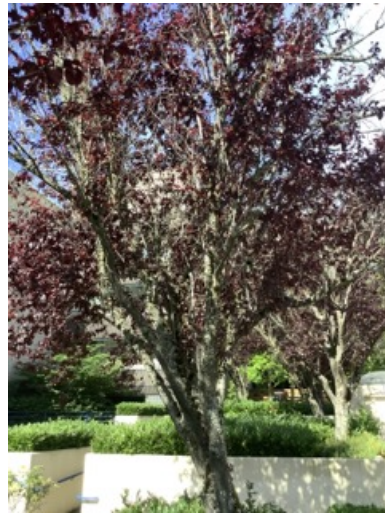
Tree	Species	DBH (in)	Drip Rad.	CRZ (ft)	Vigor	Structure	Risk	Pres Value	Recommendations
206	Plum <i>Prunus sp</i>	12.9	8.0	12.9	Poor	Fair to Good	Low	Low	Retain
Notes/ Defects	The crown is almost half dead. The tree is growing in a raised planting box.

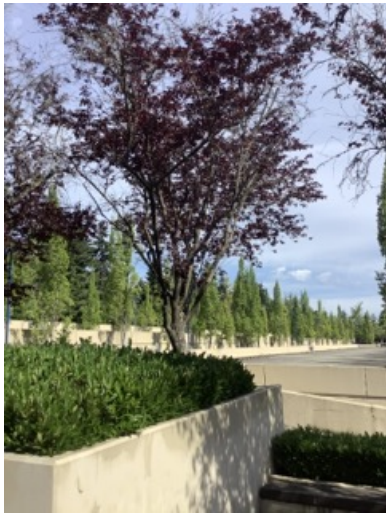
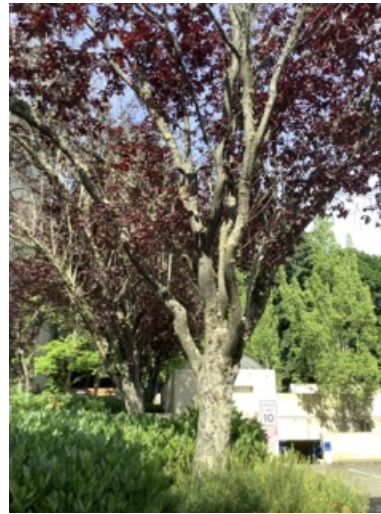
Tree	Species	DBH (in)	Drip Rad.	CRZ (ft)	Vigor	Structure	Risk	Pres Value	Recommendations
207	Plum <i>Prunus sp</i>	10.1	9.0	10.1	Poor to Fair	Fair to Good	Low	Low	
Notes/ Defects	The tree has major branch dieback.

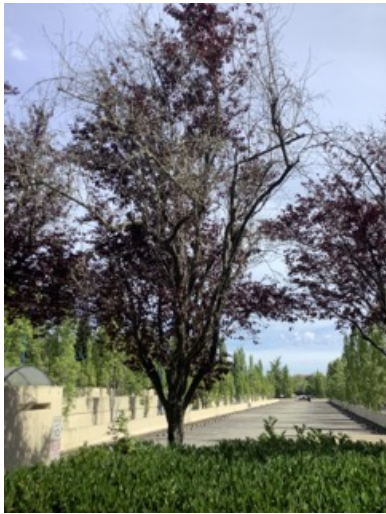
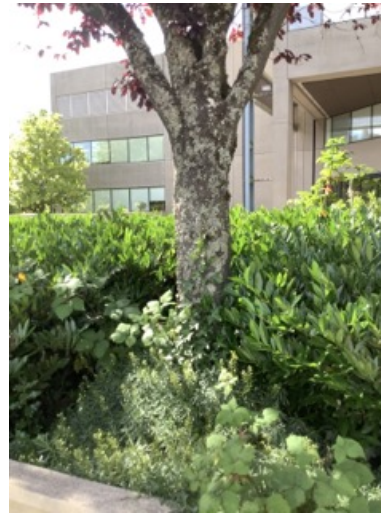
Tree	Species	DBH (in)	Drip Rad.	CRZ (ft)	Vigor	Structure	Risk	Pres Value	Recommendations
208	Plum <i>Prunus sp</i>	11.6	8.0	11.6	Poor to Fair	Fair	Low	Low	
Notes/ Defects	The tree has major branch dieback.

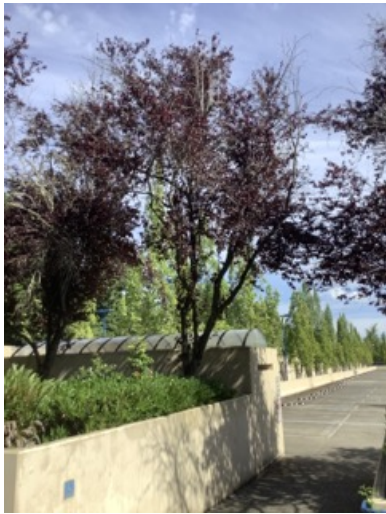
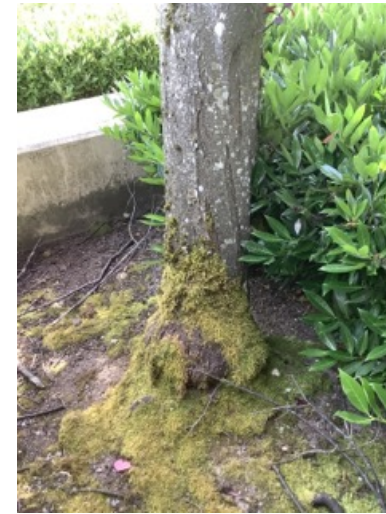
Tree	Species	DBH (in)	Drip Rad.	CRZ (ft)	Vigor	Structure	Risk	Pres Value	Recommendations
209	Plum <i>Prunus sp</i>		8.0	11.5	Poor to Fair	Fair to Good	Low	Low	
Notes/ Defects	The tree has major branch dieback.

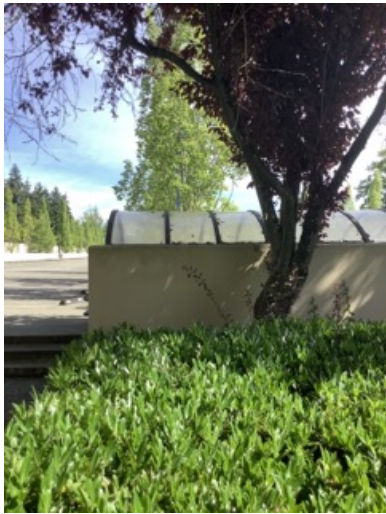
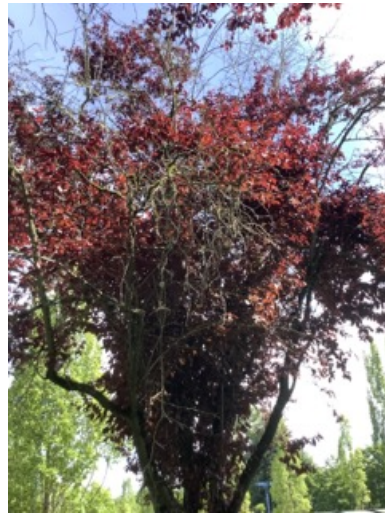
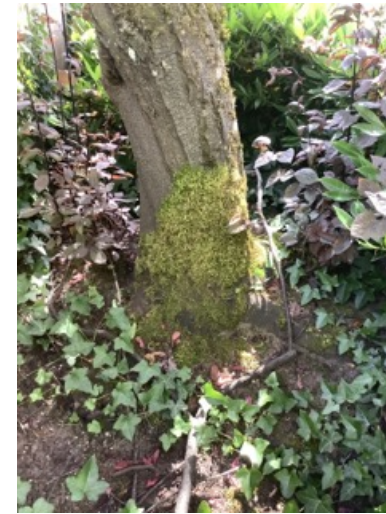
Tree	Species	DBH (in)	Drip Rad.	CRZ (ft)	Vigor	Structure	Risk	Pres Value	Recommendations
210	Plum <i>Prunus sp</i>	13.8	11.0	13.8	Poor to Fair	Fair to Good	Low	Low	
Notes/ Defects	The tree has branch dieback. It is close to the wall next to the planting area.

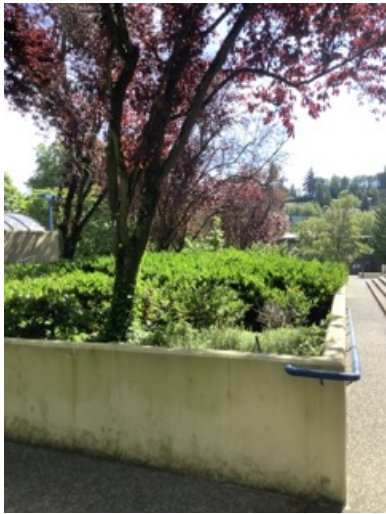
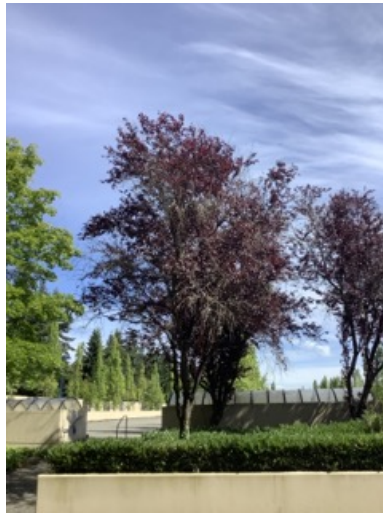
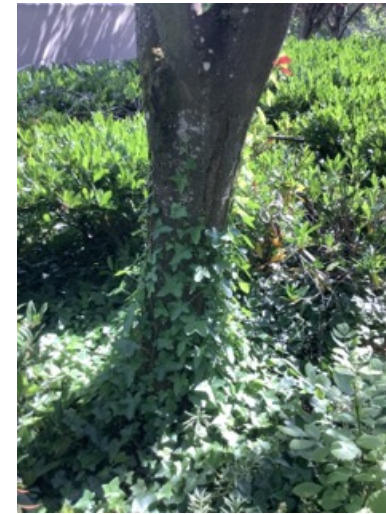
Tree	Species	DBH (in)	Drip Rad.	CRZ (ft)	Vigor	Structure	Risk	Pres Value	Recommendations
211	Plum <i>Prunus sp</i>	10.2	10.0	10.2	Fair	Fair to Good	Low	Low	
Notes/ Defects	The tree has some branch dieback.

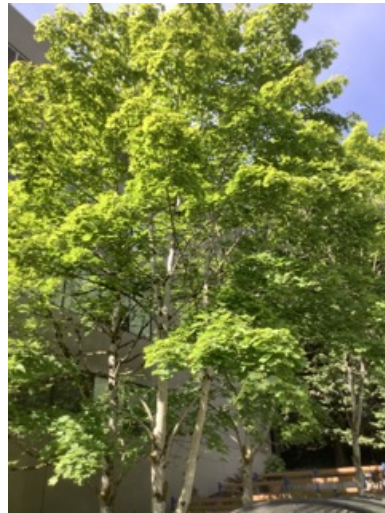
Tree	Species	DBH (in)	Drip Rad.	CRZ (ft)	Vigor	Structure	Risk	Pres Value	Recommendations
212	Norway maple <i>Acer platanoides</i>	10.2	14.0	10.2	Good	Good	Low	Medium	
Notes/ Defects	The tree is in a group of five maples. It does not have any visible defects.

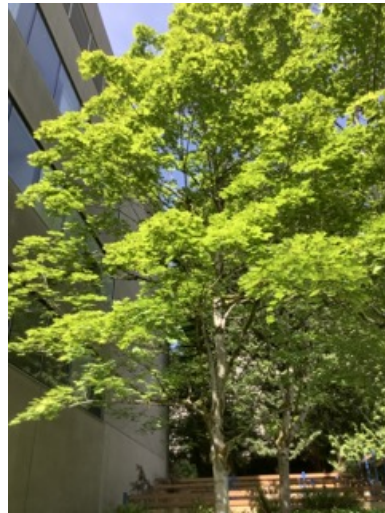
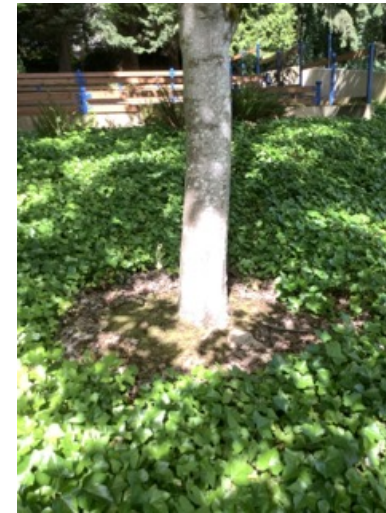
Tree	Species	DBH (in)	Drip Rad.	CRZ (ft)	Vigor	Structure	Risk	Pres Value	Recommendations
213	Norway maple <i>Acer platanoides</i>	9.9	14.0	9.9	Good	Good	Low	Medium	
Notes/ Defects	The is the largest tree in the group. It is healthy with a good shape.

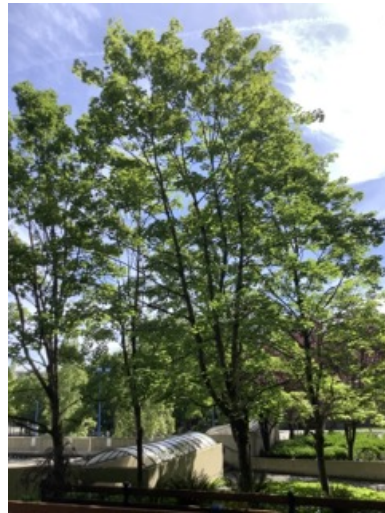
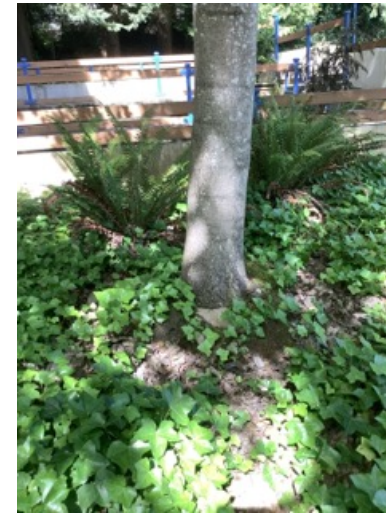
Tree	Species	DBH (in)	Drip Rad.	CRZ (ft)	Vigor	Structure	Risk	Pres Value	Recommendations
214	Norway maple <i>Acer platanoides</i>	10.4	13.0	10.4	Fair	Fair	Low	Low	
Notes/ Defects	The tree has several codominant stems and low branch density.

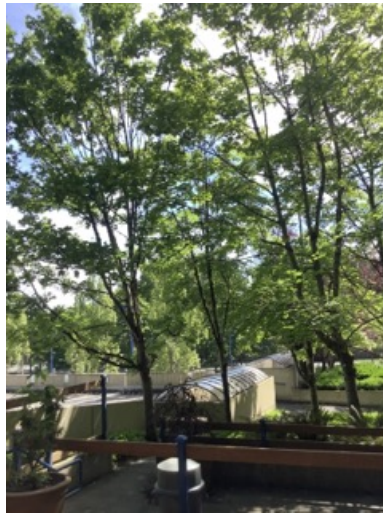
Tree	Species	DBH (in)	Drip Rad.	CRZ (ft)	Vigor	Structure	Risk	Pres Value	Recommendations
215	Norway maple <i>Acer platanoides</i>	6.5	8.0	6.5	Fair	Fair	Low	Low	
Notes/ Defects	This is the smallest tree in the group. It has a small crown.

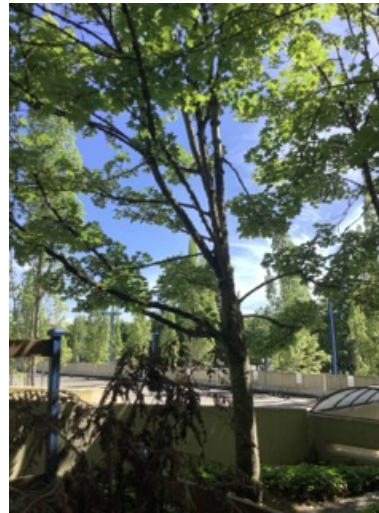
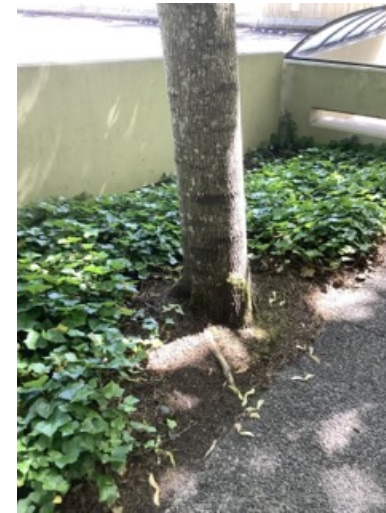
Tree	Species	DBH (in)	Drip Rad.	CRZ (ft)	Vigor	Structure	Risk	Pres Value	Recommendations
216	Norway maple <i>Acer platanoides</i>	9.9	10.5	9.9	Fair to Good	Fair	Low	Low	
Notes/ Defects	The crown is asymmetrical to the north and it has a slight lean in the same direction.

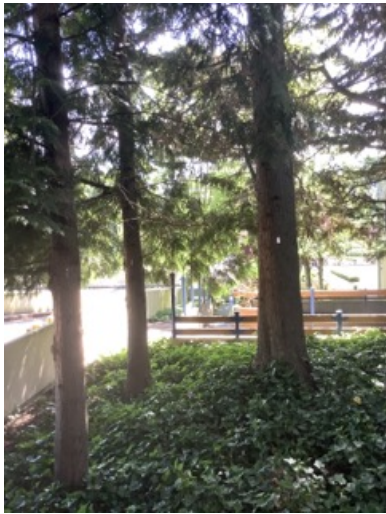
Tree	Species	DBH (in)	Drip Rad.	CRZ (ft)	Vigor	Structure	Risk	Pres Value	Recommendations
217	Western red cedar <i>Thuja plicata</i>	10.8	11.0	10.8	Good	Fair to Good	Low	Low	
Notes/ Defects	The tree is in a group of five cedars. English ivy is the dominant ground cover and encroaching on the crown of some trees.

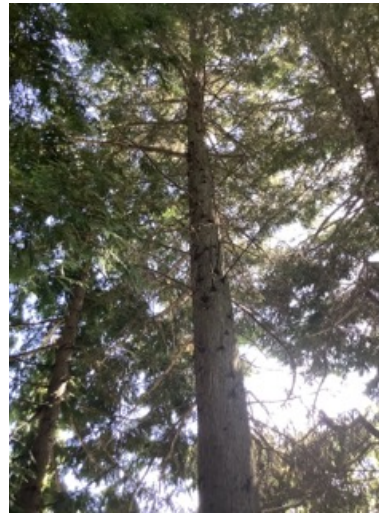
Tree	Species	DBH (in)	Drip Rad.	CRZ (ft)	Vigor	Structure	Risk	Pres Value	Recommendations
218	Western red cedar <i>Thuja plicata</i>	19.4	12.0	19.4	Good	Fair to Good	Low	Medium	
Notes/ Defects	This is the largest tree in the group.

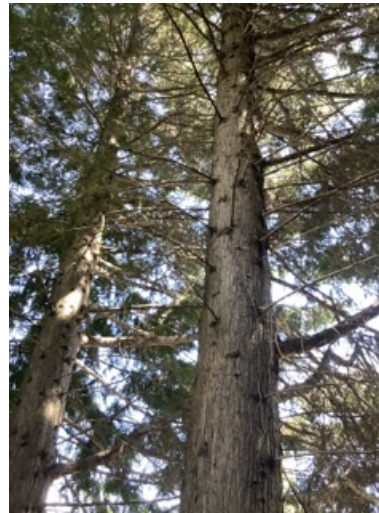
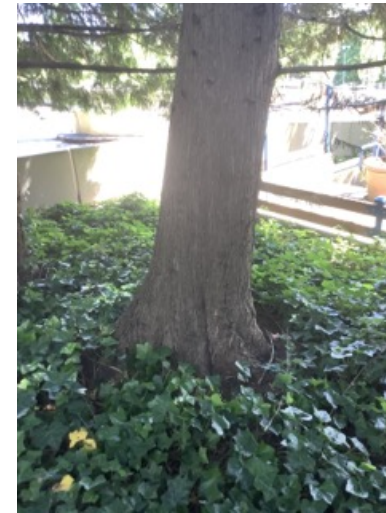
Tree	Species	DBH (in)	Drip Rad.	CRZ (ft)	Vigor	Structure	Risk	Pres Value	Recommendations
219	Western red cedar <i>Thuja plicata</i>	19.2	11.0	19.2	Good	Fair to Good	Low	Medium	
Notes/ Defects	The tree has a slight lean east.

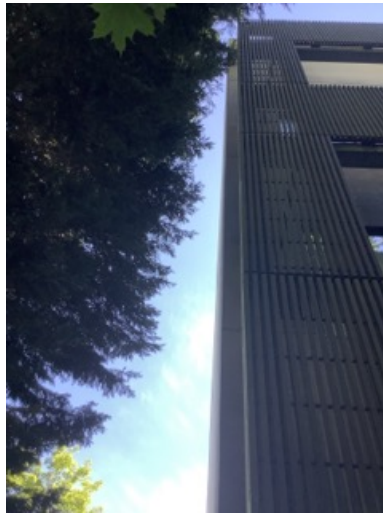
Tree	Species	DBH (in)	Drip Rad.	CRZ (ft)	Vigor	Structure	Risk	Pres Value	Recommendations
220	Western red cedar <i>Thuja plicata</i>	19.5	11.0	19.5	Good	Fair to Good	Low	Medium	
Notes/ Defects	The crown is starting to encroach on the building wall.

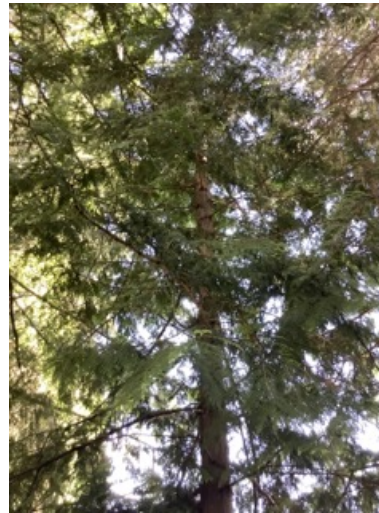
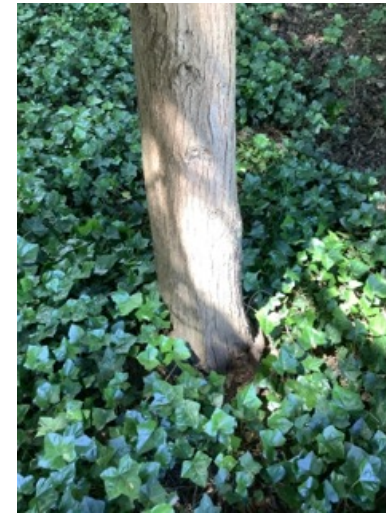
Tree	Species	DBH (in)	Drip Rad.	CRZ (ft)	Vigor	Structure	Risk	Pres Value	Recommendations
221	Western red cedar <i>Thuja plicata</i>	9.1	8.0	9.1	Good	Fair to Good	Low	Low	
Notes/ Defects	This is a healthy small tree.

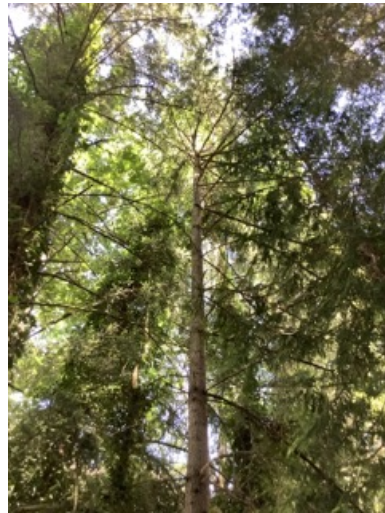
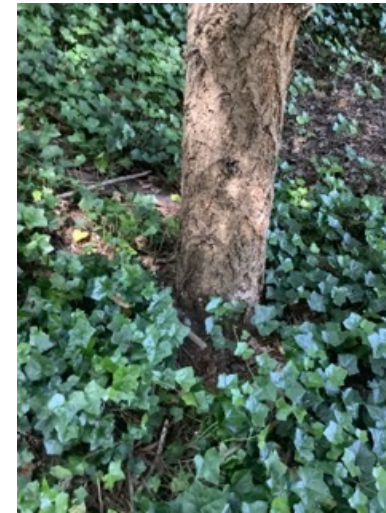
Tree	Species	DBH (in)	Drip Rad.	CRZ (ft)	Vigor	Structure	Risk	Pres Value	Recommendations
222	Douglas fir <i>Pseudotsuga menziesii</i>	11.8	6.0	11.8	Poor	Poor	Low	Low	
Notes/ Defects	The crown has very few branches and there is a new leader at the top.

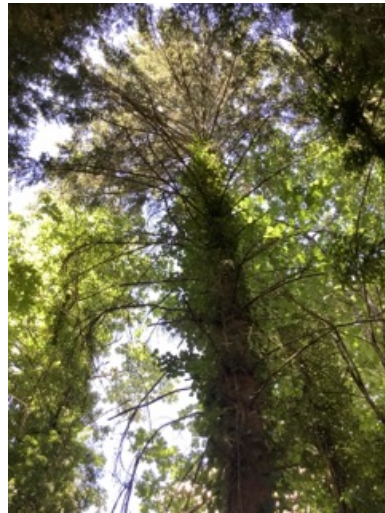
Tree	Species	DBH (in)	Drip Rad.	CRZ (ft)	Vigor	Structure	Risk	Pres Value	Recommendations
223	Douglas fir <i>Pseudotsuga menziesii</i>	19.5	13.0	19.5	Fair	Fair	Low	Medium	
Notes/ Defects	The lower crown is being choked out by ivy.

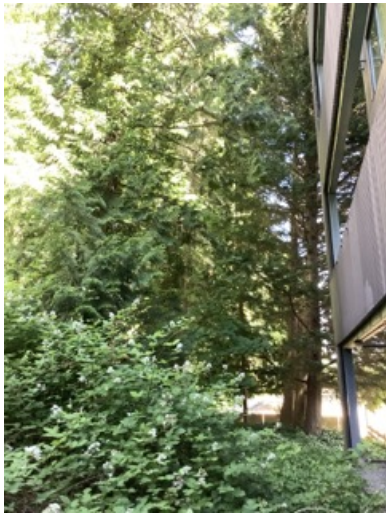
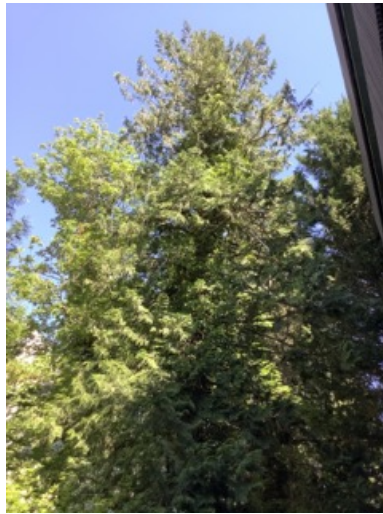
Tree	Species	DBH (in)	Drip Rad.	CRZ (ft)	Vigor	Structure	Risk	Pres Value	Recommendations
224	Western red cedar <i>Thuja plicata</i>	25.4	11.0	25.4	Fair	Fair to Good	Low	Medium	
Notes/ Defects	There is ivy throughout the crown and the top is thinning.

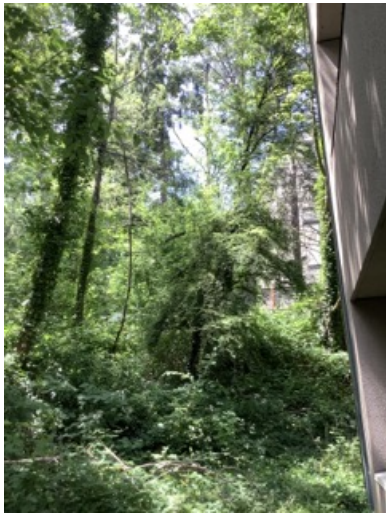
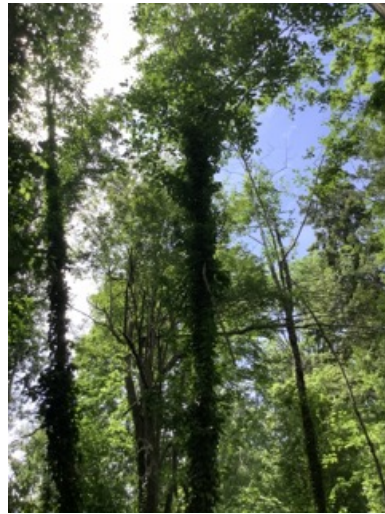
Tree	Species	DBH (in)	Drip Rad.	CRZ (ft)	Vigor	Structure	Risk	Pres Value	Recommendations
225	Red alder <i>Alnus rubra</i>	9.0	9.0	9.0	Fair	Fair	Low	Low	
Notes/ Defects	The tree has poor taper and ivy is choking out the lower crown.

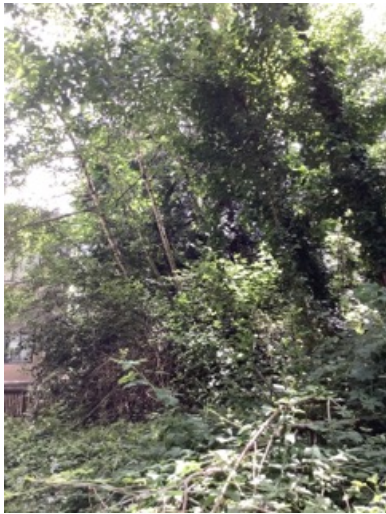
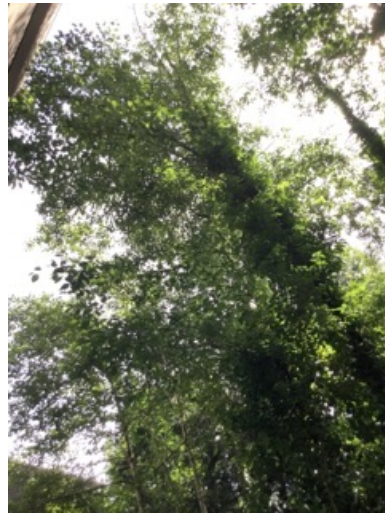
Tree	Species	DBH (in)	Drip Rad.	CRZ (ft)	Vigor	Structure	Risk	Pres Value	Recommendations
226	Red alder <i>Alnus rubra</i>	8.5	8.0	8.5	Fair to Good	Fair	Low	Low	
Notes/ Defects	The tree is leaning towards the building and the lower crown is choked out by ivy.

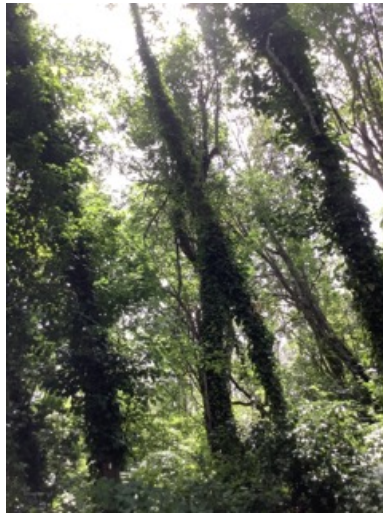
Tree	Species	DBH (in)	Drip Rad.	CRZ (ft)	Vigor	Structure	Risk	Pres Value	Recommendations
227	Scouler's willow <i>Salix scouleriana</i>	18.0	7.0	18.0	Poor to Fair	Fair	Low	Low	
Notes/ Defects	The crown is choked out by ivy and there are some dead stems and decay in the trunk.

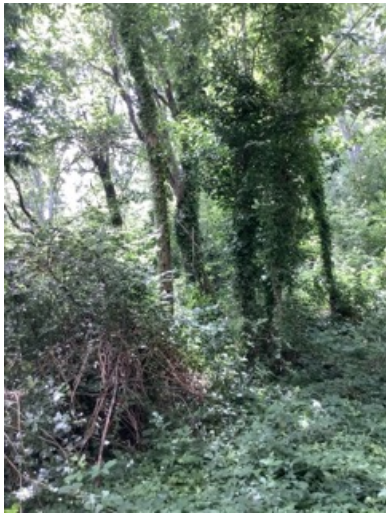
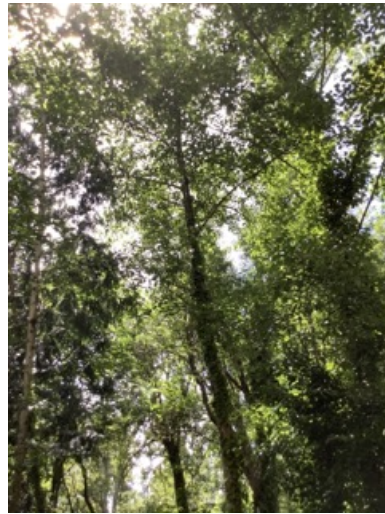
Tree	Species	DBH (in)	Drip Rad.	CRZ (ft)	Vigor	Structure	Risk	Pres Value	Recommendations
228	Red alder <i>Alnus rubra</i>	8.0	9.0	8.0	Fair to Good	Poor to Fair	Low	Low	
Notes/ Defects	The tree has a slight lean towards the building. It has ivy on the trunk.

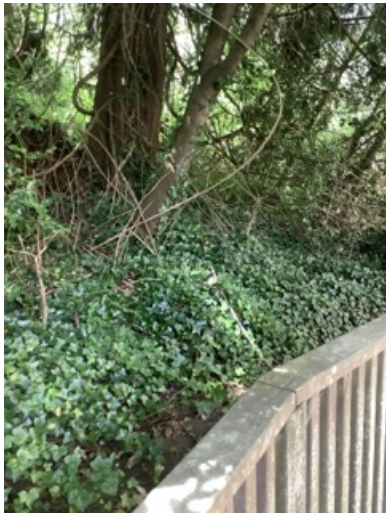
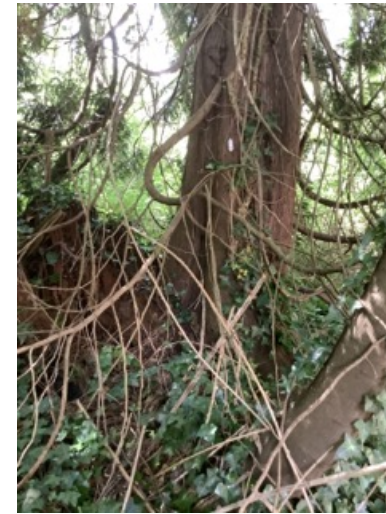
Tree	Species	DBH (in)	Drip Rad.	CRZ (ft)	Vigor	Structure	Risk	Pres Value	Recommendations
229	Western red cedar <i>Thuja plicata</i>	28.0	17.0	28.0	Poor	Good	Low	Medium	
Notes/ Defects	Ivy is choking out the crown and the top is thinning. The trunk has good taper and the tree is stable.

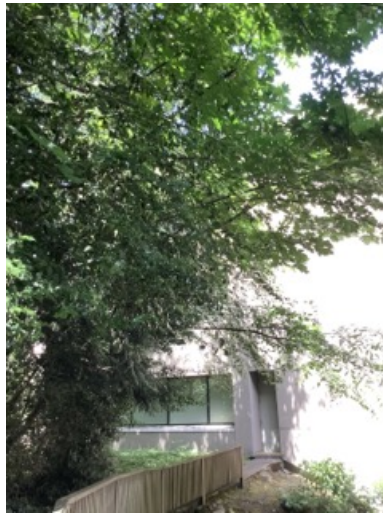
Tree	Species	DBH (in)	Drip Rad.	CRZ (ft)	Vigor	Structure	Risk	Pres Value	Recommendations
230	Bigleaf maple <i>Acer macrophyllum</i>	7.8	13.5	7.8	Good	Poor to Fair	Low	Low	
Notes/ Defects	This is a short leaning tree.

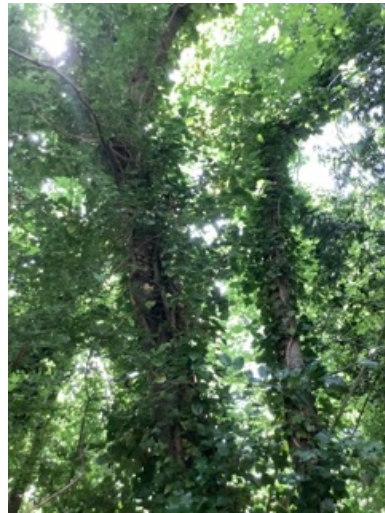
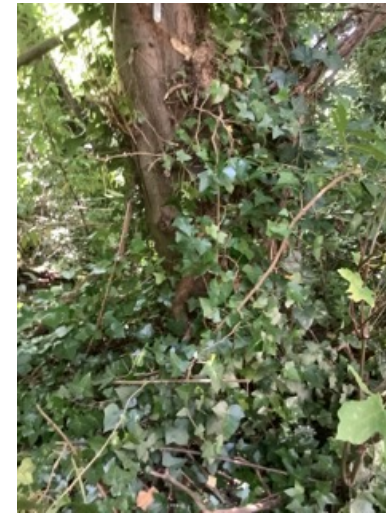
Tree	Species	DBH (in)	Drip Rad.	CRZ (ft)	Vigor	Structure	Risk	Pres Value	Recommendations
234	Red alder <i>Alnus rubra</i>		13.0	14.4	Fair	Fair to Good	Low	Low	
Notes/ Defects	Ivy is choking out the crown.

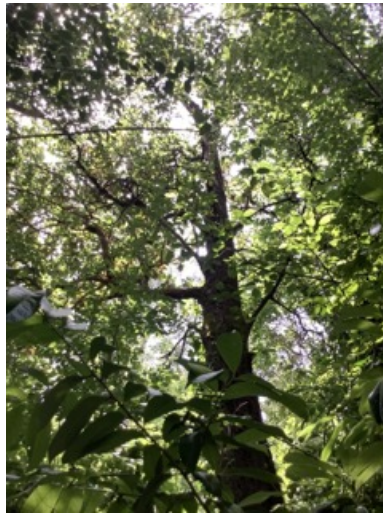
Tree	Species	DBH (in)	Drip Rad.	CRZ (ft)	Vigor	Structure	Risk	Pres Value	Recommendations
236	Pacific madrone <i>Arbutus menziesii</i>	14.0	10.0	14.0	Poor to Fair	Fair to Good	Low	Medium	
Notes/ Defects	The tree is in decline. It is leaning away from the building and not likely to strike any target.

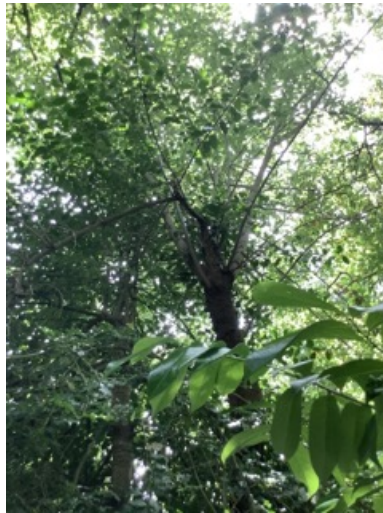
Tree	Species	DBH (in)	Drip Rad.	CRZ (ft)	Vigor	Structure	Risk	Pres Value	Recommendations
237	Scouler's willow <i>Salix scouleriana</i>	9.5	7.0	9.5	Fair	Poor to Fair	Low	Low	
Notes/ Defects	The tree has a broken top with new leaders.

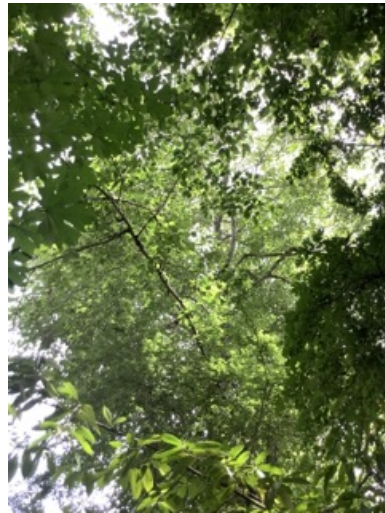
Tree	Species	DBH (in)	Drip Rad.	CRZ (ft)	Vigor	Structure	Risk	Pres Value	Recommendations
238	Red alder <i>Alnus rubra</i>	18.0	18.0	18.0	Good	Fair to Good	Low	Low	
Notes/ Defects	This is a healthy tree in good condition.

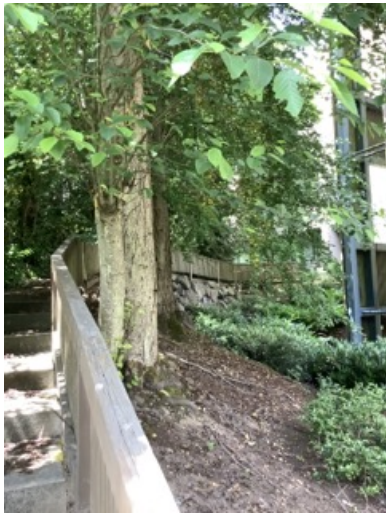
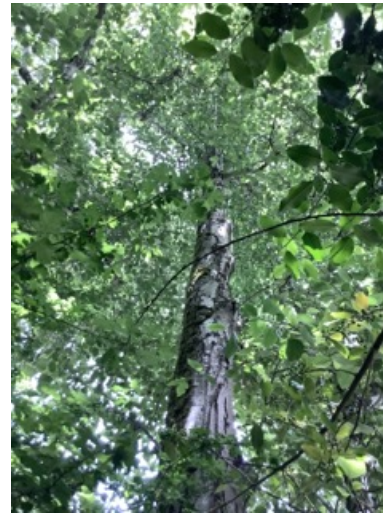
Tree	Species	DBH (in)	Drip Rad.	CRZ (ft)	Vigor	Structure	Risk	Pres Value	Recommendations
239	Red alder <i>Alnus rubra</i>	16.5	17.0	16.5	Good	Fair	Low	Low	
Notes/ Defects	The tree has a single trunk with a nice shape.

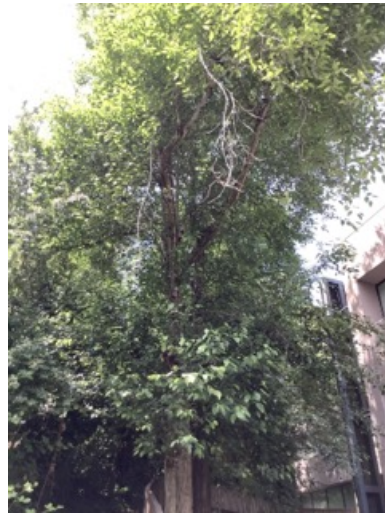
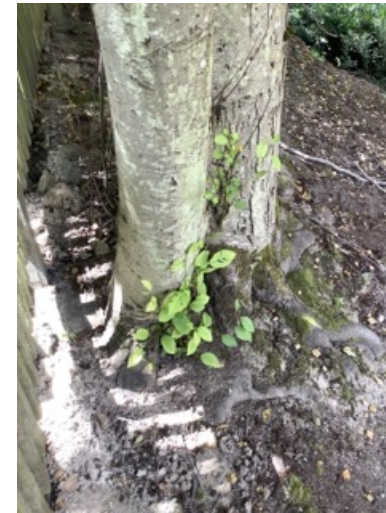
Tree	Species	DBH (in)	Drip Rad.	CRZ (ft)	Vigor	Structure	Risk	Pres Value	Recommendations
240	Red alder <i>Alnus rubra</i>	9.0	10.0	9.0	Fair	Poor to Fair	Low	Low	
Notes/ Defects	This is a small leaning tree.

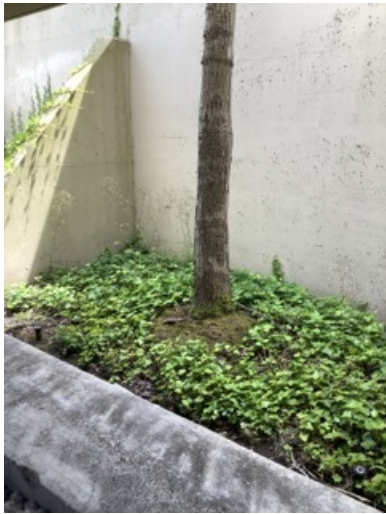
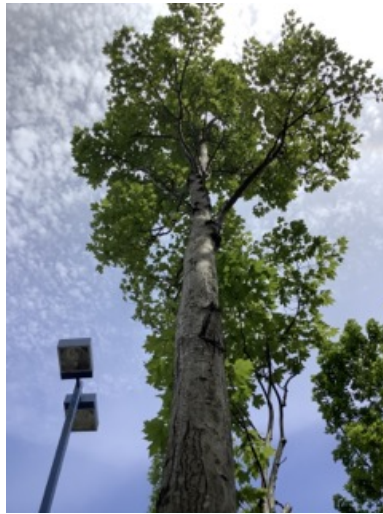
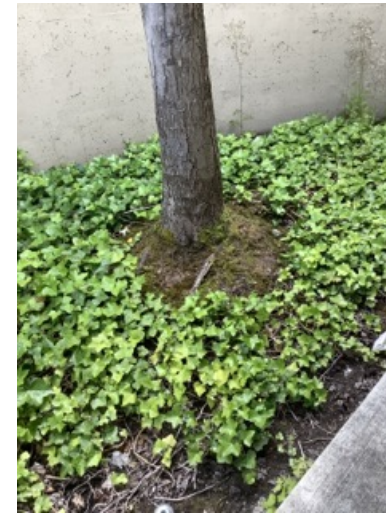
Tree	Species	DBH (in)	Drip Rad.	CRZ (ft)	Vigor	Structure	Risk	Pres Value	Recommendations
241	Armstrong maple <i>Acer x freemanii</i> 'Armstrong'	9.2	6.0	9.2	Fair to Good	Good	Low	Low	
Notes/ Defects	This is the primary tree species in the planting area of the parking lot. Each planting strip row is an almost continuous line from one end of the parking area to the other.

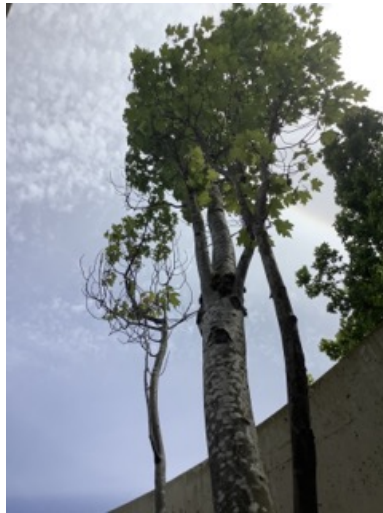
Tree	Species	DBH (in)	Drip Rad.	CRZ (ft)	Vigor	Structure	Risk	Pres Value	Recommendations
242	Armstrong maple <i>Acer x freemanii</i> 'Armstrong'	7.2	6.0	7.2	Fair to Good	Good	Low	Low	
Notes/ Defects	There is some dieback in the crown. The irrigation system is operating.

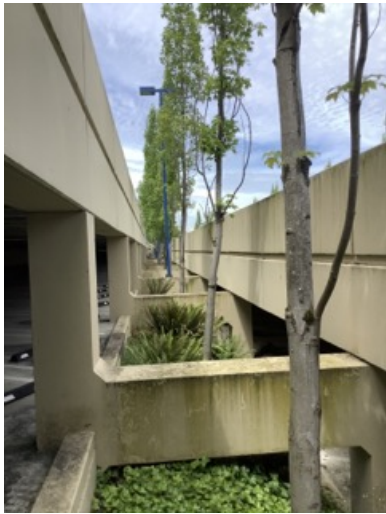
Tree	Species	DBH (in)	Drip Rad.	CRZ (ft)	Vigor	Structure	Risk	Pres Value	Recommendations
243	Armstrong maple <i>Acer x freemanii</i> 'Armstrong'	6.4	5.0	6.4	Fair to Good	Good	Low	Low	
Notes/ Defects	The tree has a full length crown.

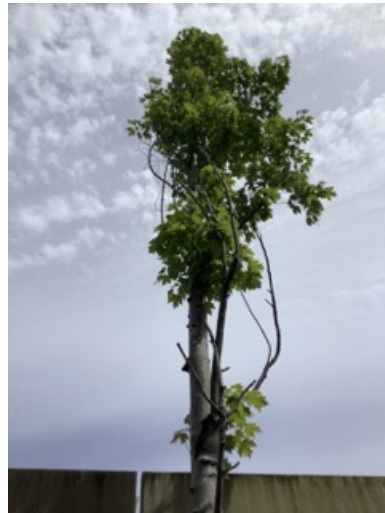
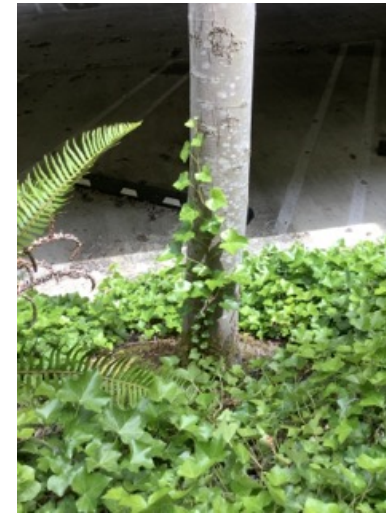
Tree	Species	DBH (in)	Drip Rad.	CRZ (ft)	Vigor	Structure	Risk	Pres Value	Recommendations
244	Armstrong maple <i>Acer x freemanii</i> 'Armstrong'	5.6	5.0	5.6	Fair	Good	Low	Low	
Notes/ Defects	The tree has a weak crown with some dieback.

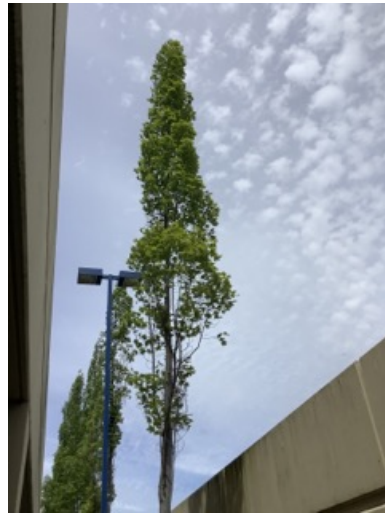
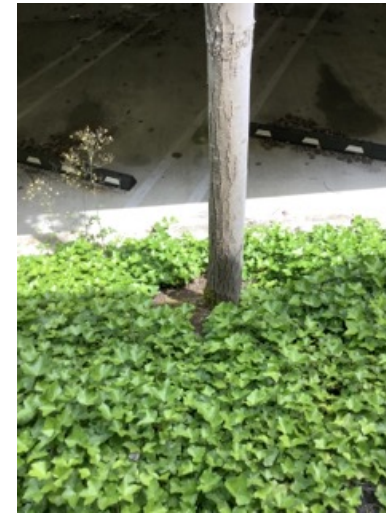
Tree	Species	DBH (in)	Drip Rad.	CRZ (ft)	Vigor	Structure	Risk	Pres Value	Recommendations
245	Armstrong maple <i>Acer x freemanii</i> 'Armstrong'	6.4	5.0	6.4	Fair to Good	Good	Low	Low	
Notes/ Defects	There is some minor dieback in the lower crown.

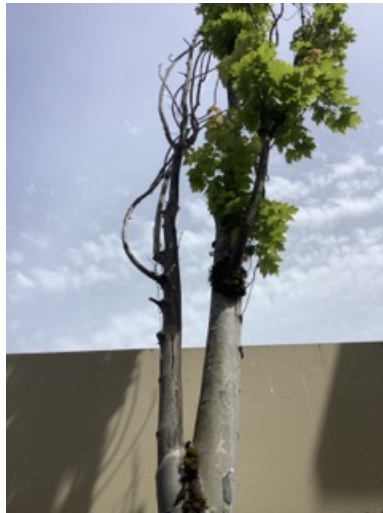
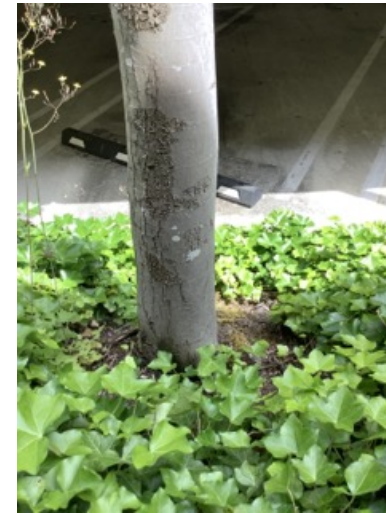
Tree	Species	DBH (in)	Drip Rad.	CRZ (ft)	Vigor	Structure	Risk	Pres Value	Recommendations
246	Armstrong maple <i>Acer x freemanii</i> 'Armstrong'	6.3	5.0	6.3	Fair	Fair	Low	Low	
Notes/ Defects	One of the codominant stems is dead.

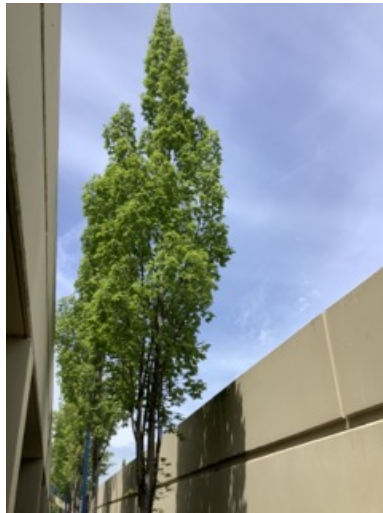
Tree	Species	DBH (in)	Drip Rad.	CRZ (ft)	Vigor	Structure	Risk	Pres Value	Recommendations
247	Armstrong maple <i>Acer x freemanii</i> 'Armstrong'		5.0	6.9	Good	Good	Low	Low	
Notes/ Defects	The tree has a full length and healthy crown.

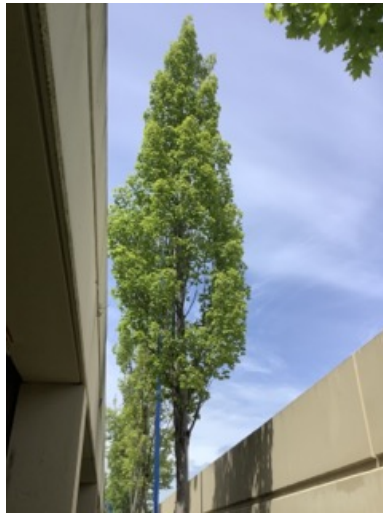
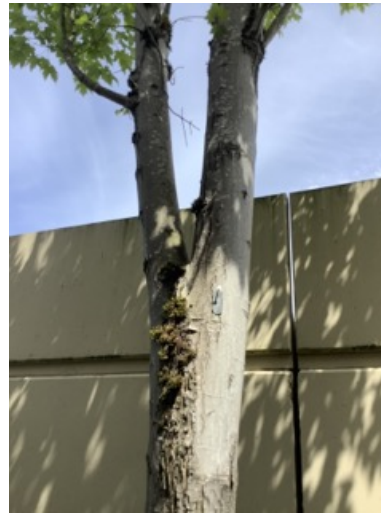
Tree	Species	DBH (in)	Drip Rad.	CRZ (ft)	Vigor	Structure	Risk	Pres Value	Recommendations
248	Armstrong maple <i>Acer x freemanii</i> 'Armstrong'	8.8	5.0	8.8	Good	Good	Low	Low	
Notes/ Defects	The tree has a full length and healthy crown.

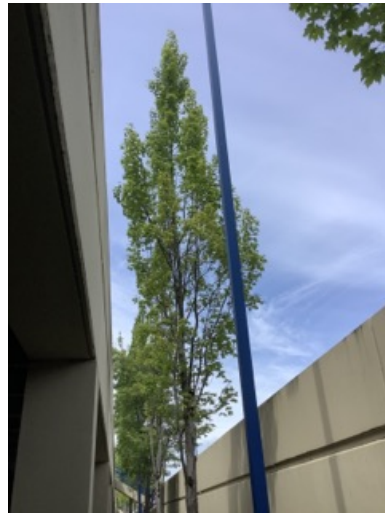
Tree	Species	DBH (in)	Drip Rad.	CRZ (ft)	Vigor	Structure	Risk	Pres Value	Recommendations
249	Armstrong maple <i>Acer x freemanii</i> 'Armstrong'	6.5	5.0	6.5	Fair to Good	Good	Low	Low	
Notes/ Defects	The tree has a full length and healthy crown.

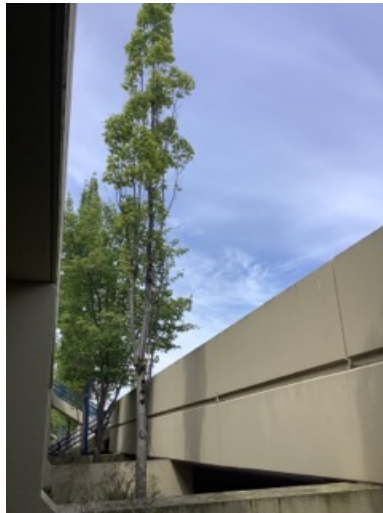
Tree	Species	DBH (in)	Drip Rad.	CRZ (ft)	Vigor	Structure	Risk	Pres Value	Recommendations
250	Armstrong maple <i>Acer x freemanii</i> 'Armstrong'	6.2	5.0	6.2	Poor to Fair	Good	Low	Low	
Notes/ Defects	The tree has a weak crown with some dieback.

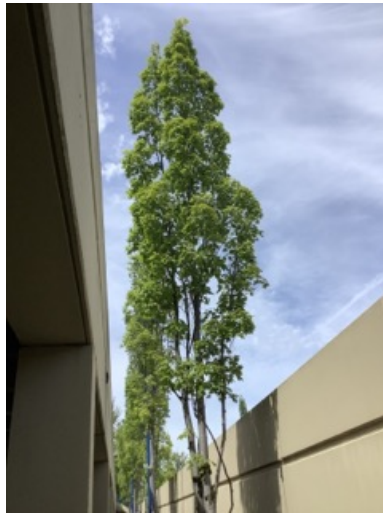
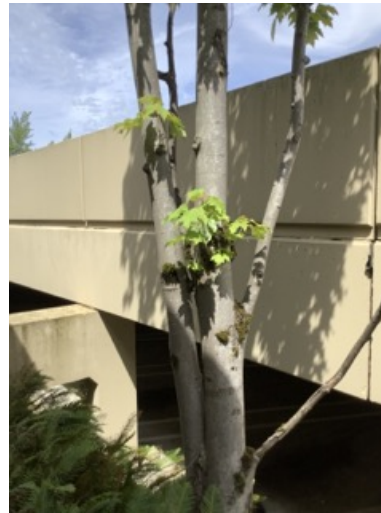
Tree	Species	DBH (in)	Drip Rad.	CRZ (ft)	Vigor	Structure	Risk	Pres Value	Recommendations
255	Armstrong maple <i>Acer x freemanii</i> 'Armstrong'		5.0	7.9	Fair to Good	Good	Low	Low	
Notes/ Defects	The crown has some minor dieback.

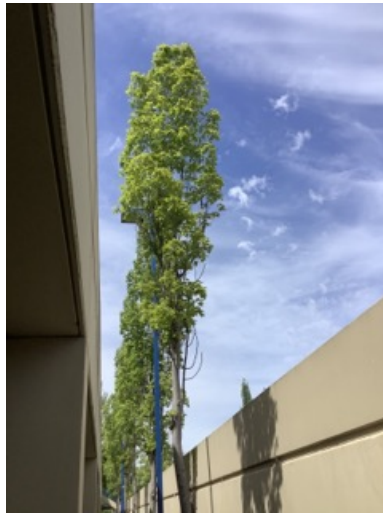
Tree	Species	DBH (in)	Drip Rad.	CRZ (ft)	Vigor	Structure	Risk	Pres Value	Recommendations
256	Armstrong maple <i>Acer x freemanii</i> 'Armstrong'	6.1	5.0	6.1	Fair to Good	Good	Low	Low	
Notes/ Defects	There is some minor dieback in the crown.

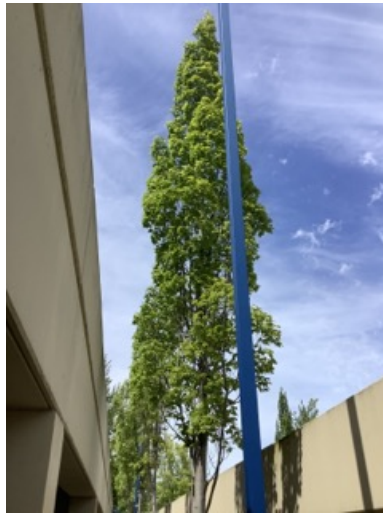
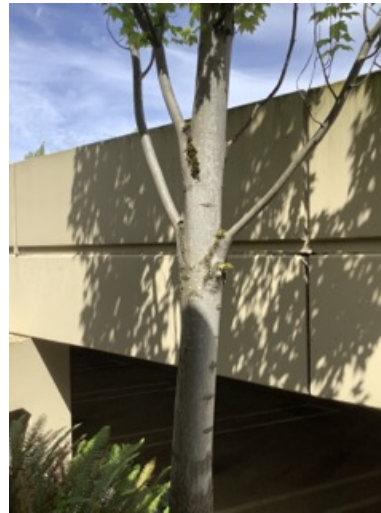
Tree	Species	DBH (in)	Drip Rad.	CRZ (ft)	Vigor	Structure	Risk	Pres Value	Recommendations
257	Armstrong maple <i>Acer x freemanii</i> 'Armstrong'	7.3	5.0	7.3	Good	Good	Low	Low	
Notes/ Defects	A tall tree with a healthy crown.

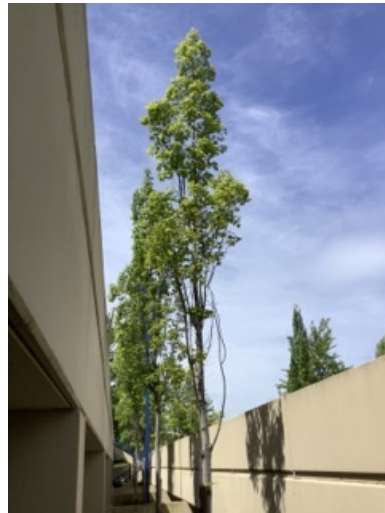
Tree	Species	DBH (in)	Drip Rad.	CRZ (ft)	Vigor	Structure	Risk	Pres Value	Recommendations
258	Armstrong maple <i>Acer x freemanii</i> 'Armstrong'	6.3	5.0	6.3	Good	Good	Low	Low	
Notes/ Defects	The crown is weak with some dieback.

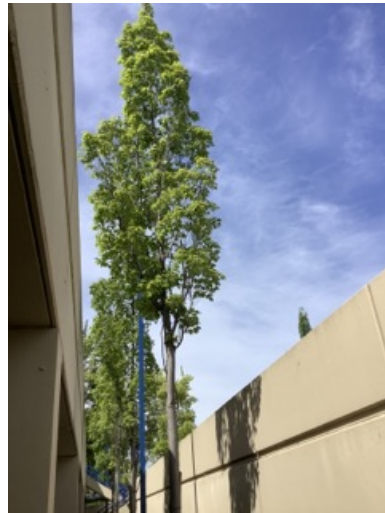
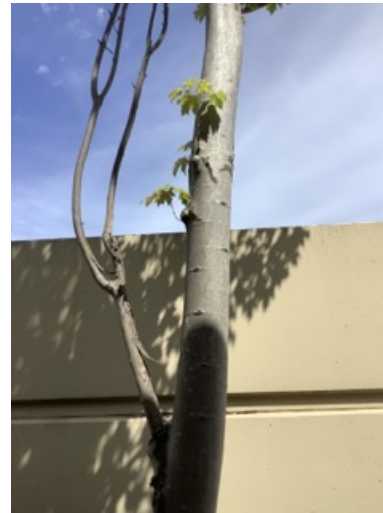
Tree	Species	DBH (in)	Drip Rad.	CRZ (ft)	Vigor	Structure	Risk	Pres Value	Recommendations
259	Armstrong maple <i>Acer x freemanii</i> 'Armstrong'	6.3	5.0	6.3	Fair to Good	Good	Low	Low	
Notes/ Defects	The tree has some minor dieback in the crown.

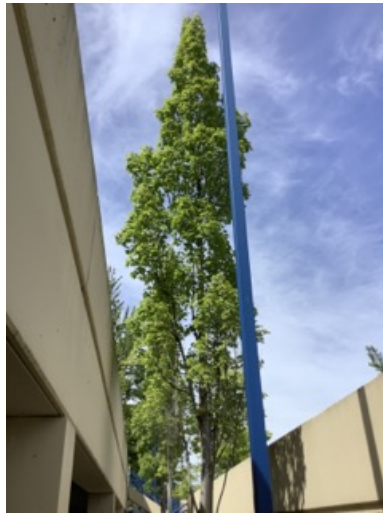
Tree	Species	DBH (in)	Drip Rad.	CRZ (ft)	Vigor	Structure	Risk	Pres Value	Recommendations
260	Armstrong maple <i>Acer x freemanii</i> 'Armstrong'	7.0	5.0	7.0	Fair to Good	Good	Low	Low	
Notes/ Defects	There is some minor dieback in the crown.

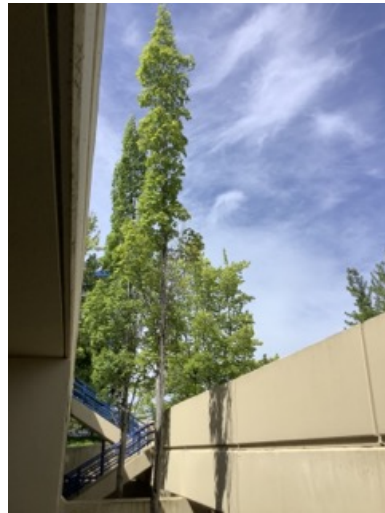
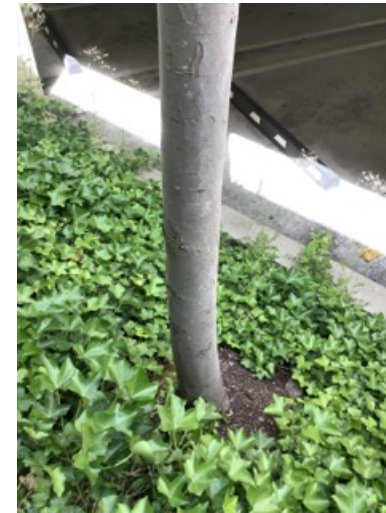
Tree	Species	DBH (in)	Drip Rad.	CRZ (ft)	Vigor	Structure	Risk	Pres Value	Recommendations
261	Armstrong maple <i>Acer x freemanii</i> 'Armstrong'	5.1	5.0	5.1	Poor to Fair	Good	Low	Low	
Notes/ Defects	The tree has a small crown with minor dieback.

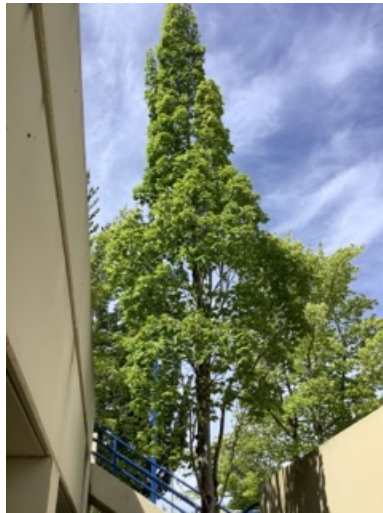
Tree	Species	DBH (in)	Drip Rad.	CRZ (ft)	Vigor	Structure	Risk	Pres Value	Recommendations
262	Armstrong maple <i>Acer x freemanii</i> 'Armstrong'	7.2	5.0	7.2	Poor to Fair	Good	Low	Low	
Notes/ Defects	The tree has a small crown with minor dieback.

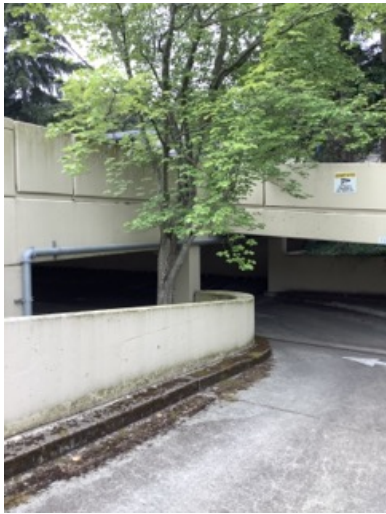
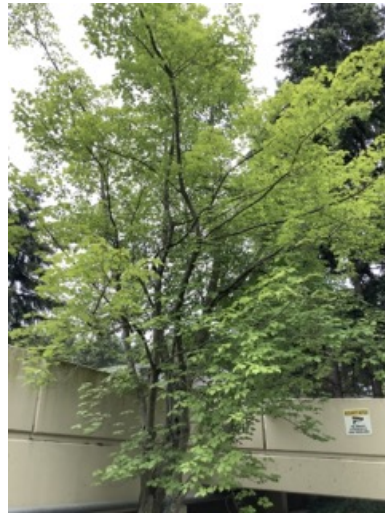
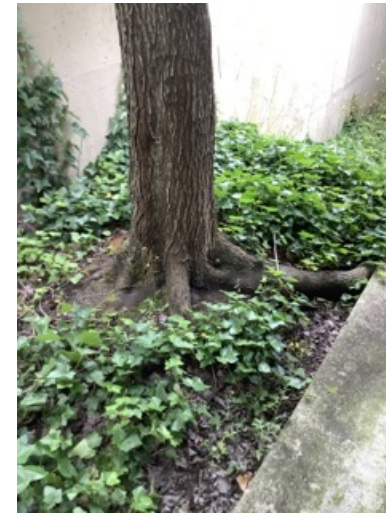
Tree	Species	DBH (in)	Drip Rad.	CRZ (ft)	Vigor	Structure	Risk	Pres Value	Recommendations
263	Armstrong maple <i>Acer x freemanii</i> 'Armstrong'	12.4	13.0	12.4	Good	Fair to Good	Low	Low	
Notes/ Defects	There are large surface roots and the crown has been trained to grow away from the parking garage wall.

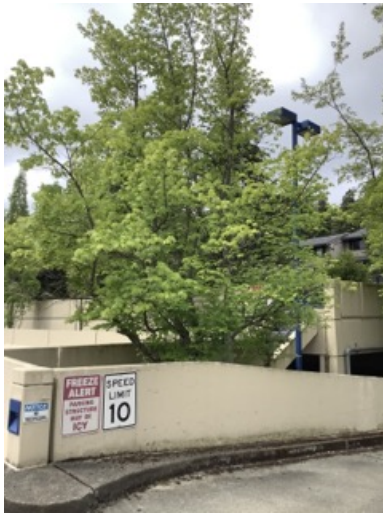
Tree	Species	DBH (in)	Drip Rad.	CRZ (ft)	Vigor	Structure	Risk	Pres Value	Recommendations
264	Armstrong maple <i>Acer x freemanii</i> 'Armstrong'	10.8	9.5	10.8	Good	Fair to Good	Low	Low	
Notes/ Defects	This is a healthy tree with a broad crown.
