**Title: 3003 77th Ave Project – Mercer South Park Project
Full Tree Inventory and Health Assessment
Level 2 Basic Tree Risk Assessment
3003 77th Ave SE
Mercer Island, Washington**

Date: July 15, 2020; updated July 24, 2020

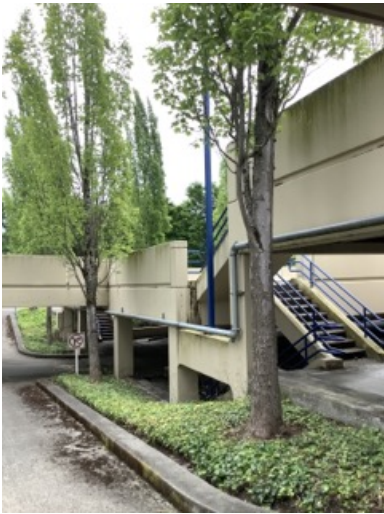
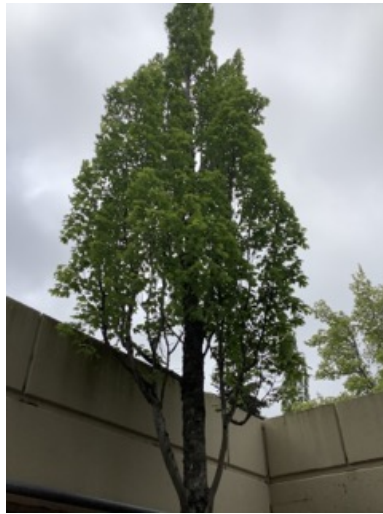
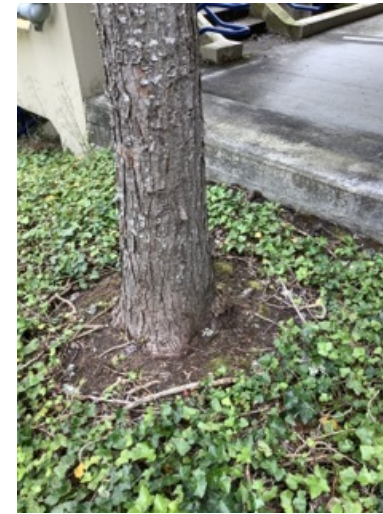
Tree	Species	DBH (in)	Drip Rad.	CRZ (ft)	Vigor	Structure	Risk	Pres Value	Recommendations
265	Armstrong maple <i>Acer x freemanii</i> 'Armstrong'	10.1	5.0	10.1	Good	Good	Low	Low	
Notes/ Defects	This is a healthy tree with a full crown.

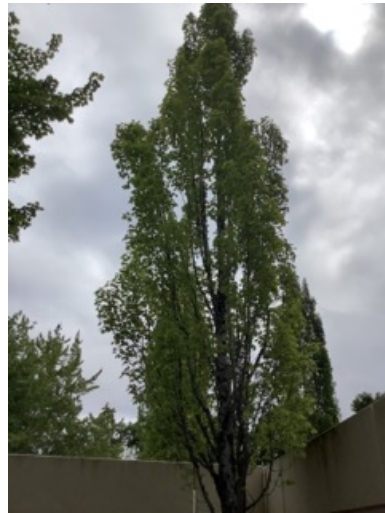
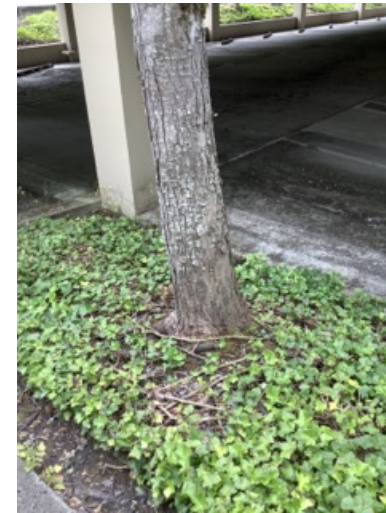
Tree	Species	DBH (in)	Drip Rad.	CRZ (ft)	Vigor	Structure	Risk	Pres Value	Recommendations
266	Armstrong maple <i>Acer x freemanii</i> 'Armstrong'	10.2	5.0	10.2	Fair to Good	Good	Low	Low	
Notes/ Defects	This is a healthy tree.

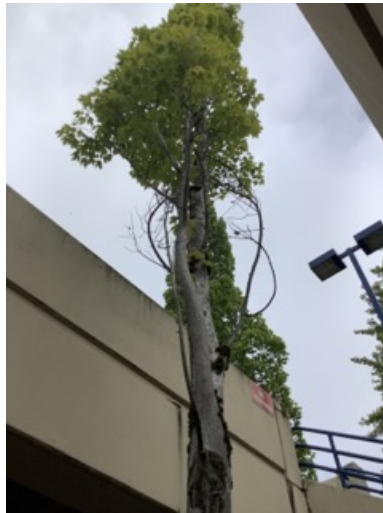
Tree	Species	DBH (in)	Drip Rad.	CRZ (ft)	Vigor	Structure	Risk	Pres Value	Recommendations
267	Armstrong maple <i>Acer x freemanii</i> 'Armstrong'	6.9	5.0	6.9	Fair to Good	Good	Low	Low	
Notes/ Defects	There is some minor dieback in the crown.

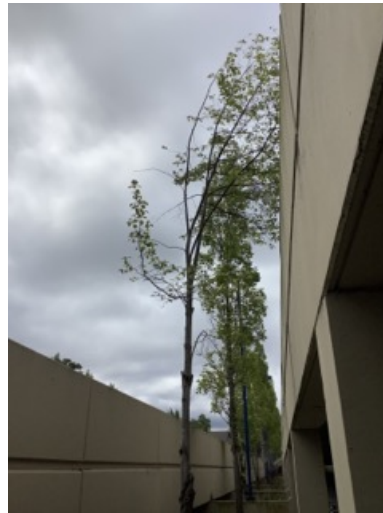
Tree	Species	DBH (in)	Drip Rad.	CRZ (ft)	Vigor	Structure	Risk	Pres Value	Recommendations
268	Armstrong maple <i>Acer x freemanii</i> 'Armstrong'	5.5	5.0	5.5	Poor	Poor	Low	Low	
Notes/ Defects	The crown has low branching density and major dieback.

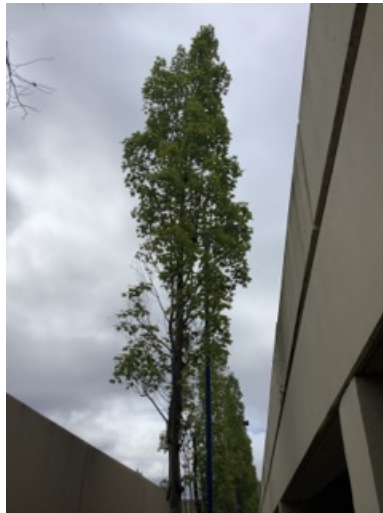
Tree	Species	DBH (in)	Drip Rad.	CRZ (ft)	Vigor	Structure	Risk	Pres Value	Recommendations
269	Armstrong maple <i>Acer x freemanii</i> 'Armstrong'	7.3	5.0	7.3	Fair	Fair to Good	Low	Low	
Notes/ Defects	There is minor dieback in the crown.

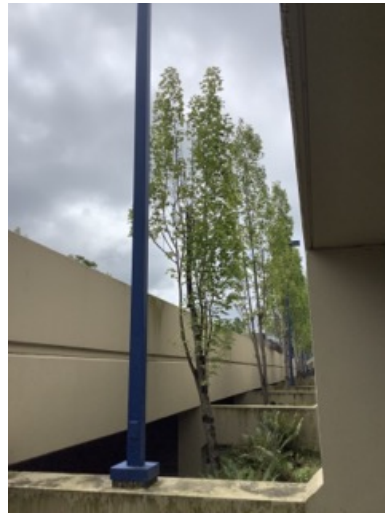
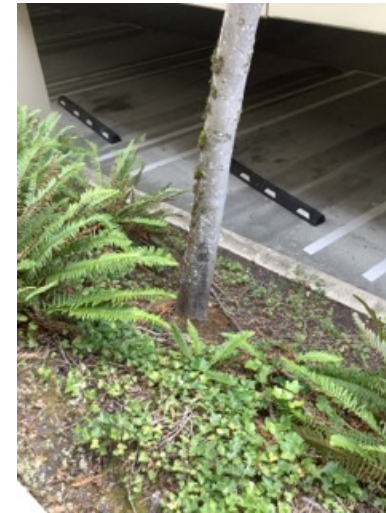
Tree	Species	DBH (in)	Drip Rad.	CRZ (ft)	Vigor	Structure	Risk	Pres Value	Recommendations
270	Armstrong maple <i>Acer x freemanii</i> 'Armstrong'	6.0	5.0	6.0	Fair	Fair to Good	Low	Low	
Notes/ Defects	There is minor dieback in the crown.

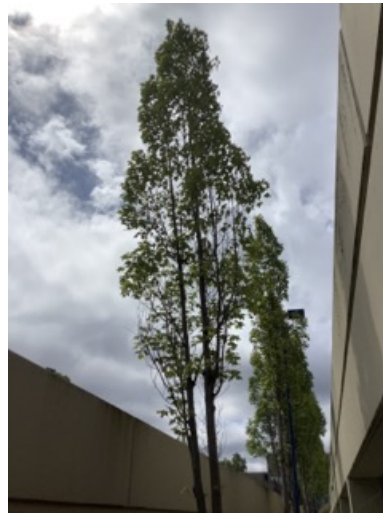
Tree	Species	DBH (in)	Drip Rad.	CRZ (ft)	Vigor	Structure	Risk	Pres Value	Recommendations
271	Armstrong maple <i>Acer x freemanii</i> 'Armstrong'	6.3	5.0	6.3	Fair	Fair to Good	Low	Low	
Notes/ Defects	There is minor dieback in the crown.

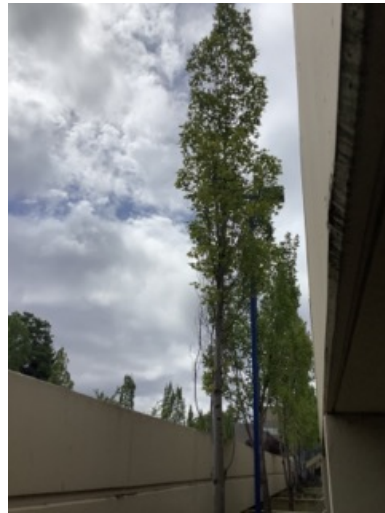
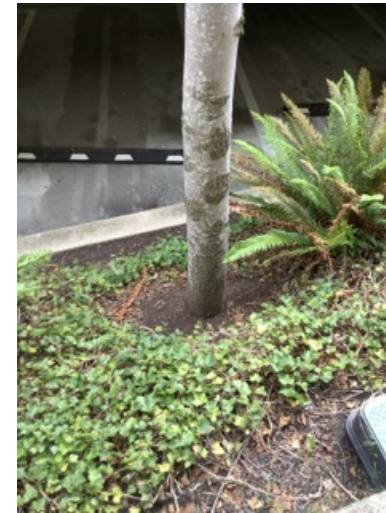
Tree	Species	DBH (in)	Drip Rad.	CRZ (ft)	Vigor	Structure	Risk	Pres Value	Recommendations
272	Armstrong maple <i>Acer x freemanii</i> 'Armstrong'	6.8	5.0	6.8	Fair	Fair to Good	Low	Low	
Notes/ Defects	There is minor dieback in the crown.

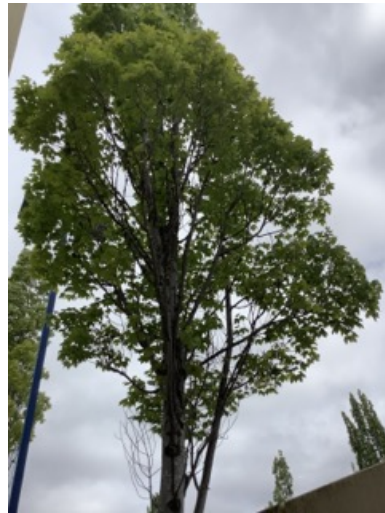
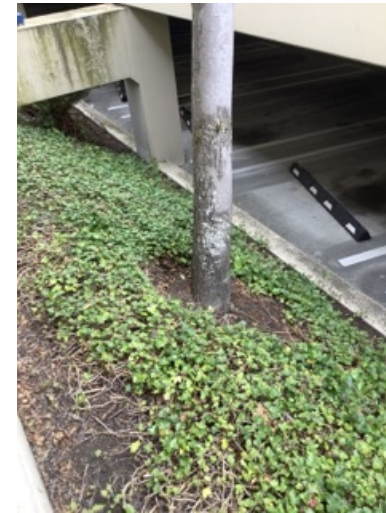
Tree	Species	DBH (in)	Drip Rad.	CRZ (ft)	Vigor	Structure	Risk	Pres Value	Recommendations
273	Armstrong maple <i>Acer x freemanii</i> 'Armstrong'	8.0	5.0	8.0	Fair to Good	Fair to Good	Low	Low	
Notes/ Defects	There is minor dieback in the crown.

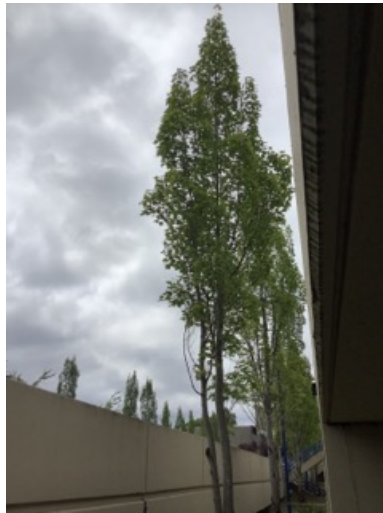
Tree	Species	DBH (in)	Drip Rad.	CRZ (ft)	Vigor	Structure	Risk	Pres Value	Recommendations
274	Armstrong maple <i>Acer x freemanii</i> 'Armstrong'	7.3	5.0	7.3	Fair to Good	Fair to Good	Low	Low	
Notes/ Defects	There is minor dieback in the crown.

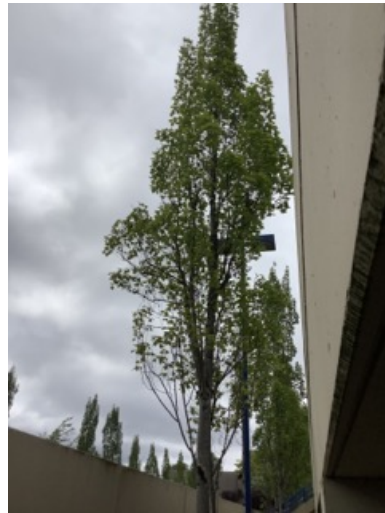
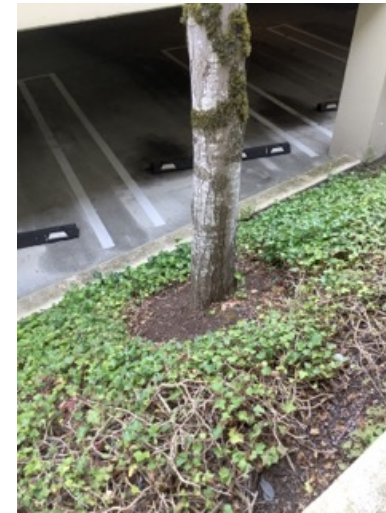
Tree	Species	DBH (in)	Drip Rad.	CRZ (ft)	Vigor	Structure	Risk	Pres Value	Recommendations
275	Armstrong maple <i>Acer x freemanii</i> 'Armstrong'	8.6	5.0	8.6	Fair to Good	Fair to Good	Low	Low	
Notes/ Defects	There is minor dieback in the crown.

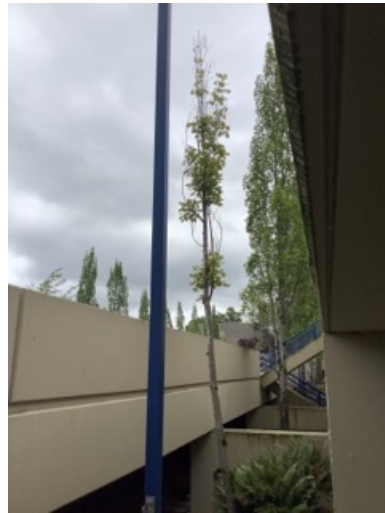
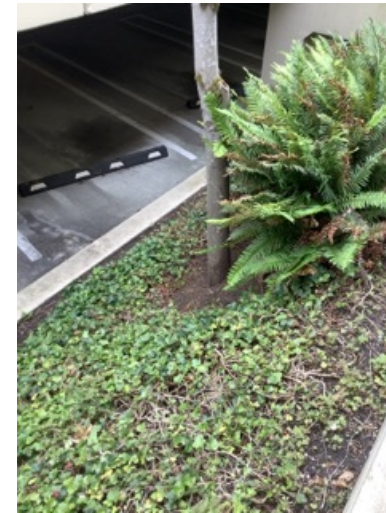
Tree	Species	DBH (in)	Drip Rad.	CRZ (ft)	Vigor	Structure	Risk	Pres Value	Recommendations
276	Armstrong maple <i>Acer x freemanii</i> 'Armstrong'	4.9	5.0	4.9	Poor	Poor	Low	Low	
Notes/ Defects	The crown has low branching density.

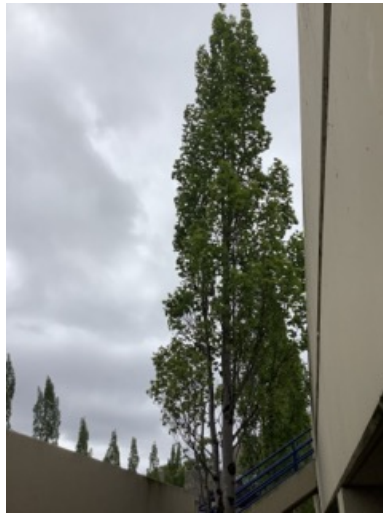
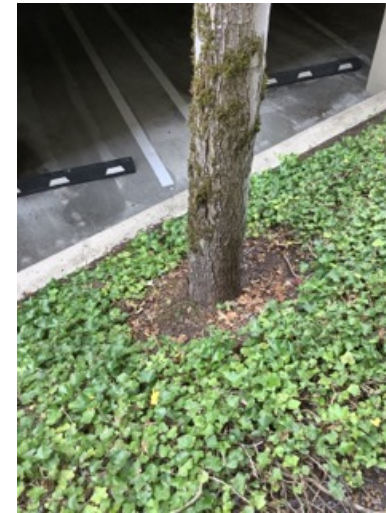
Tree	Species	DBH (in)	Drip Rad.	CRZ (ft)	Vigor	Structure	Risk	Pres Value	Recommendations
277	Armstrong maple <i>Acer x freemanii</i> 'Armstrong'	9.6	5.0	9.6	Good	Good	Low	Low	
Notes/ Defects	This is a large healthy tree.

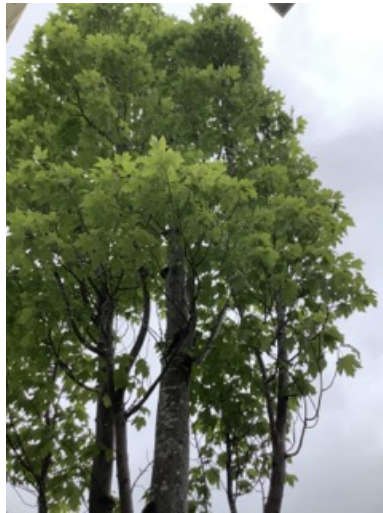
Tree	Species	DBH (in)	Drip Rad.	CRZ (ft)	Vigor	Structure	Risk	Pres Value	Recommendations
278	Armstrong maple <i>Acer x freemanii</i> 'Armstrong'	8.9	5.0	8.9	Good	Good	Low	Low	
Notes/ Defects	The form is broad and short instead of the typical columnar shape.

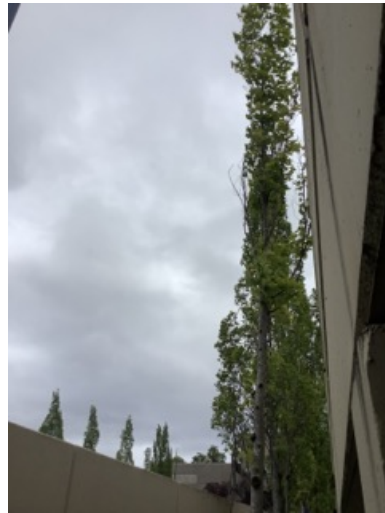
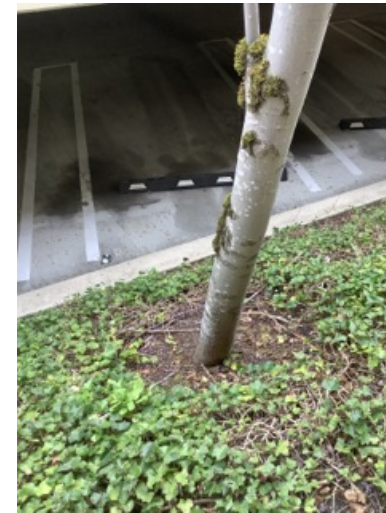
Tree	Species	DBH (in)	Drip Rad.	CRZ (ft)	Vigor	Structure	Risk	Pres Value	Recommendations
279	Armstrong maple <i>Acer x freemanii</i> 'Armstrong'	5.2	5.0	5.2	Poor	Poor	Low	Low	
Notes/ Defects	The tree has a weak crown and it is leaning slightly.

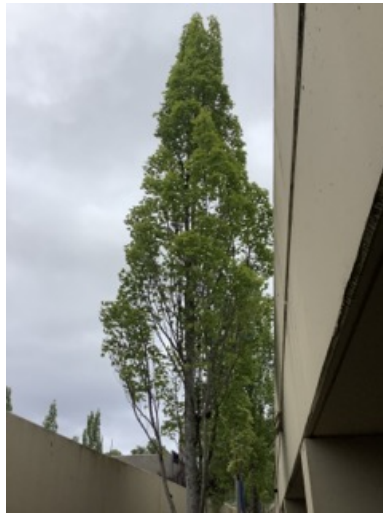
Tree	Species	DBH (in)	Drip Rad.	CRZ (ft)	Vigor	Structure	Risk	Pres Value	Recommendations
280	Armstrong maple <i>Acer x freemanii</i> 'Armstrong'	4.8	5.0	4.8	Fair to Good	Fair to Good	Low	Low	
Notes/ Defects	This is a shorter and broader crown the typical for the cultivar.

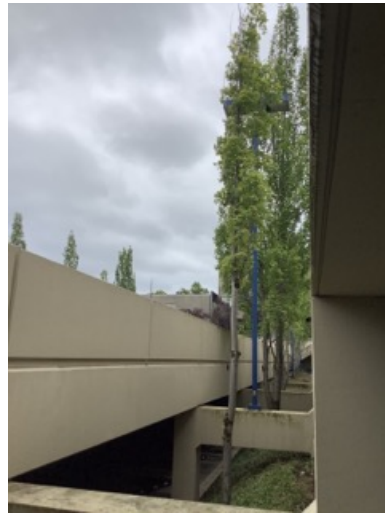
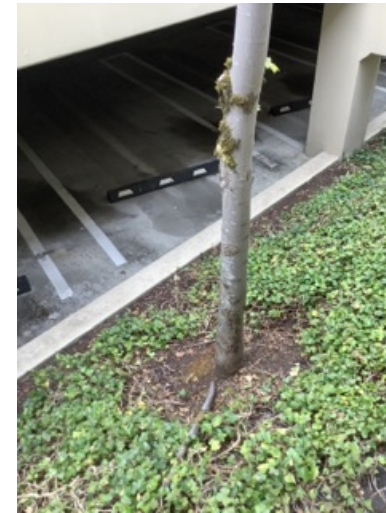
Tree	Species	DBH (in)	Drip Rad.	CRZ (ft)	Vigor	Structure	Risk	Pres Value	Recommendations
281	Armstrong maple <i>Acer x freemanii</i> 'Armstrong'	9.8	5.0	9.8	Poor to Fair	Fair to Good	Low	Low	
Notes/ Defects	This is a small tree with some minor dieback.

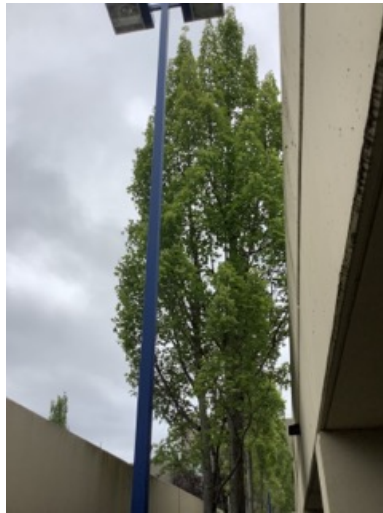
Tree	Species	DBH (in)	Drip Rad.	CRZ (ft)	Vigor	Structure	Risk	Pres Value	Recommendations
282	Armstrong maple <i>Acer x freemanii</i> 'Armstrong'		5.0	15.0	Good	Fair to Good	Low	Low	
Notes/ Defects	This tree has multiple codominant stems.

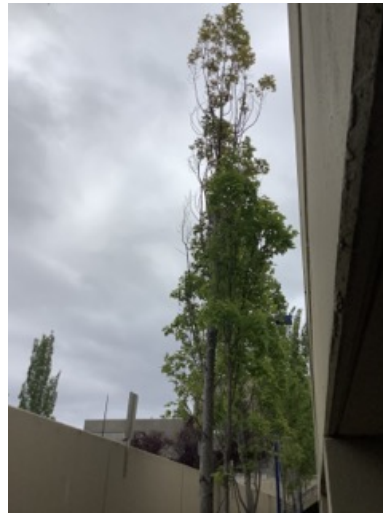
Tree	Species	DBH (in)	Drip Rad.	CRZ (ft)	Vigor	Structure	Risk	Pres Value	Recommendations
283	Armstrong maple <i>Acer x freemanii</i> 'Armstrong'	6.8	5.0	6.8	Poor	Fair	Low	Low	
Notes/ Defects	The crown is weak with some dieback.

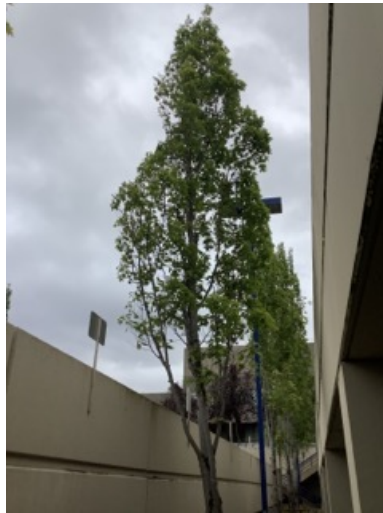
Tree	Species	DBH (in)	Drip Rad.	CRZ (ft)	Vigor	Structure	Risk	Pres Value	Recommendations
284	Armstrong maple <i>Acer x freemanii</i> 'Armstrong'	8.5	5.0	8.5	Fair to Good	Fair to Good	Low	Low	
Notes/ Defects	The crown is broad instead of columnar.

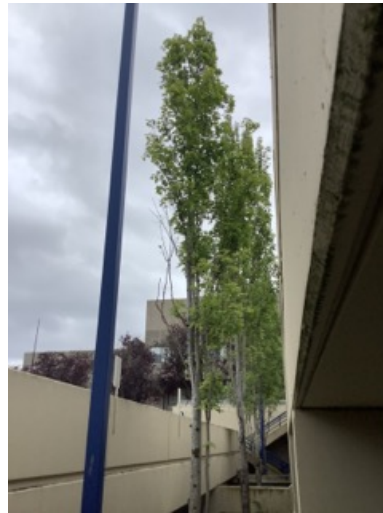
Tree	Species	DBH (in)	Drip Rad.	CRZ (ft)	Vigor	Structure	Risk	Pres Value	Recommendations
285	Armstrong maple <i>Acer x freemanii</i> 'Armstrong'	7.4	5.0	7.4	Fair	Fair to Good	Low	Low	
Notes/ Defects	There is some branch dieback in the crown.

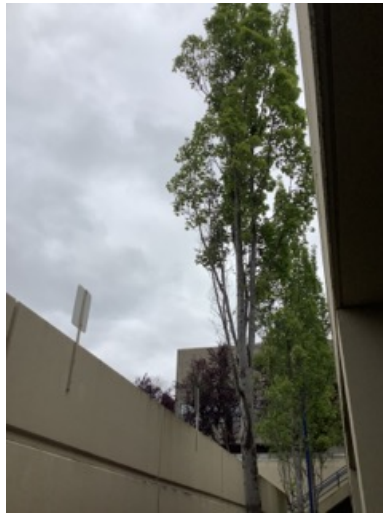
Tree	Species	DBH (in)	Drip Rad.	CRZ (ft)	Vigor	Structure	Risk	Pres Value	Recommendations
286	Armstrong maple <i>Acer x freemanii</i> 'Armstrong'	9.0	5.0	9.0	Fair	Fair to Good	Low	Low	
Notes/ Defects	The crown has minor branch dieback.

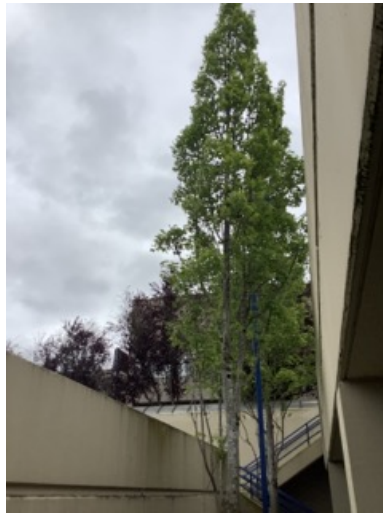
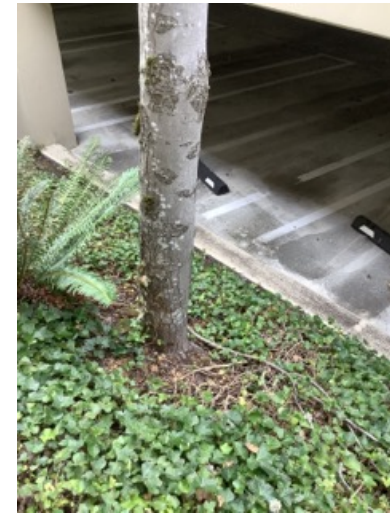
Tree	Species	DBH (in)	Drip Rad.	CRZ (ft)	Vigor	Structure	Risk	Pres Value	Recommendations
287	Armstrong maple <i>Acer x freemanii</i> 'Armstrong'	8.0	5.0	8.0	Fair	Fair to Good	Low	Low	
Notes/ Defects	There is minor dieback in the crown.

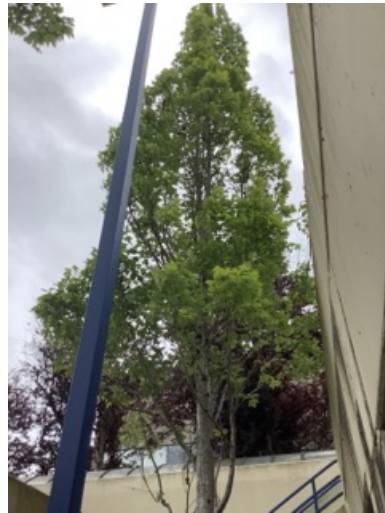
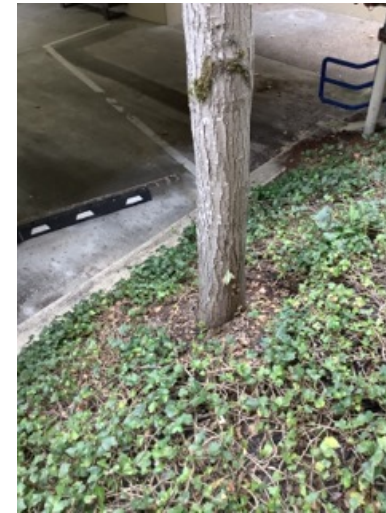
Tree	Species	DBH (in)	Drip Rad.	CRZ (ft)	Vigor	Structure	Risk	Pres Value	Recommendations
288	Armstrong maple <i>Acer x freemanii</i> 'Armstrong'	8.5	5.0	8.5	Good	Fair to Good	Low	Low	
Notes/ Defects	This is a tall healthy tree.

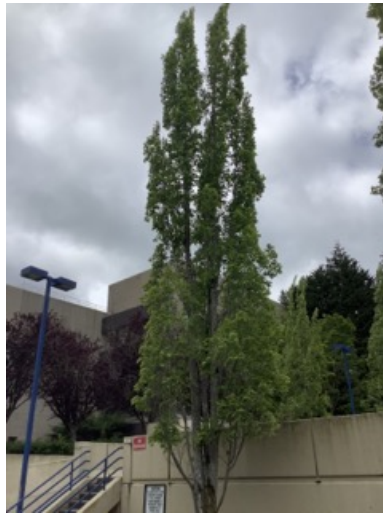
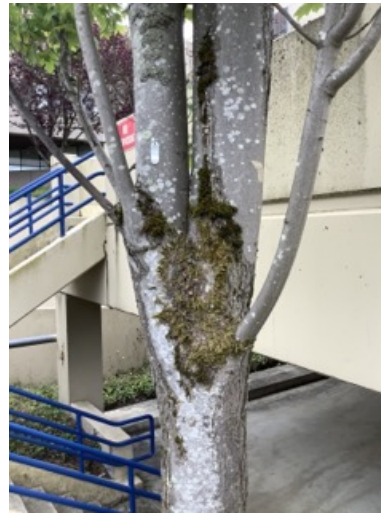
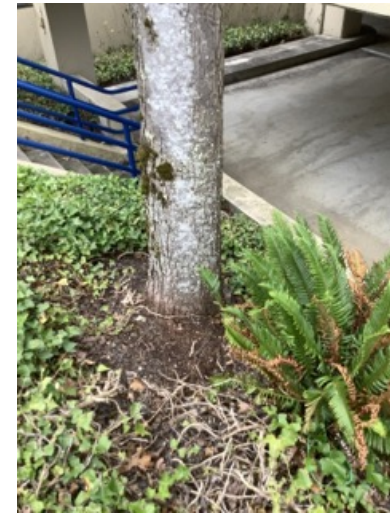
Tree	Species	DBH (in)	Drip Rad.	CRZ (ft)	Vigor	Structure	Risk	Pres Value	Recommendations
289	Armstrong maple <i>Acer x freemanii</i> 'Armstrong'	11.2	5.0	11.2	Good	Fair to Good	Low	Low	
Notes/ Defects	The crown if healthy and there is included bark between two codominant stems.

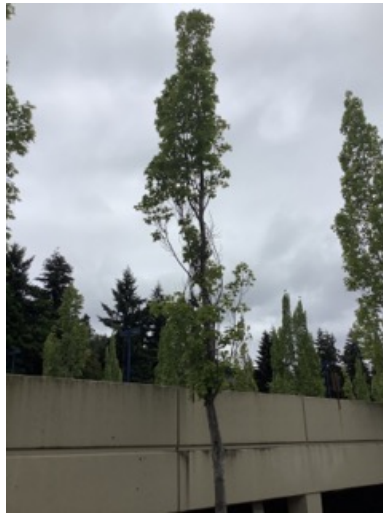
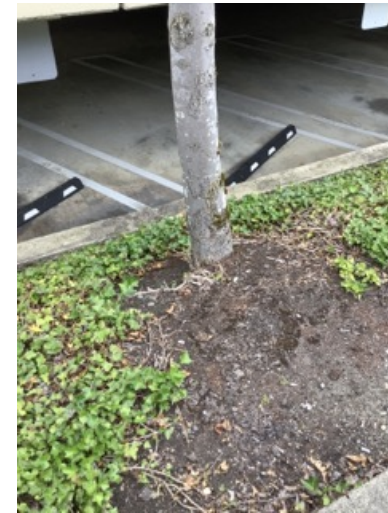
Tree	Species	DBH (in)	Drip Rad.	CRZ (ft)	Vigor	Structure	Risk	Pres Value	Recommendations
290	Armstrong maple <i>Acer x freemanii</i> 'Armstrong'	6.5	5.0	6.5	Poor to Fair	Fair	Low	Low	
Notes/ Defects	There is minor dieback in the crown.

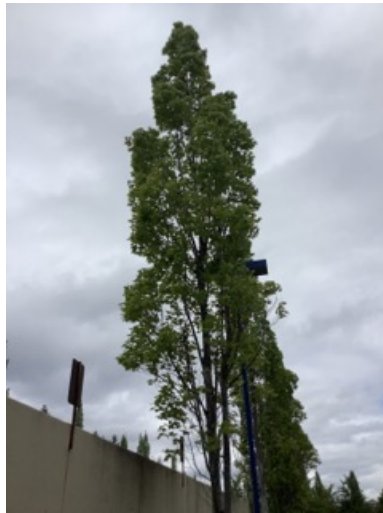
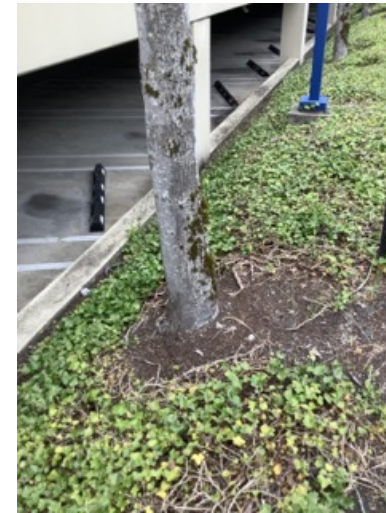
Tree	Species	DBH (in)	Drip Rad.	CRZ (ft)	Vigor	Structure	Risk	Pres Value	Recommendations
291	Armstrong maple <i>Acer x freemanii</i> 'Armstrong'	8.0	5.0	8.0	Fair to Good	Fair to Good	Low	Low	
Notes/ Defects	This is a shorter tree.

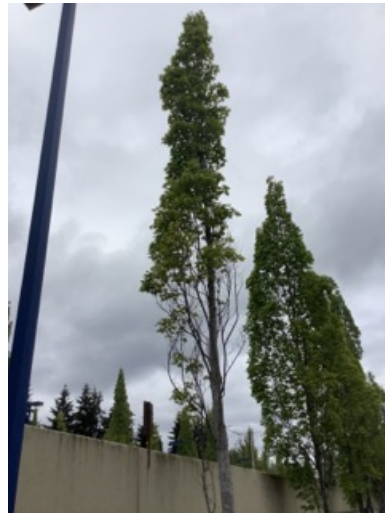
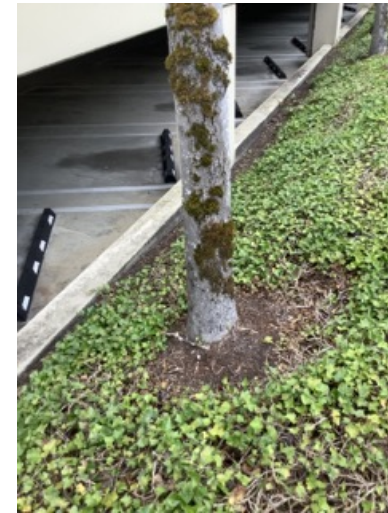
Tree	Species	DBH (in)	Drip Rad.	CRZ (ft)	Vigor	Structure	Risk	Pres Value	Recommendations
292	Armstrong maple <i>Acer x freemanii</i> 'Armstrong'	8.0	5.0	8.0	Fair to Good	Fair to Good	Low	Low	
Notes/ Defects	The tree has minor dieback in the crown.

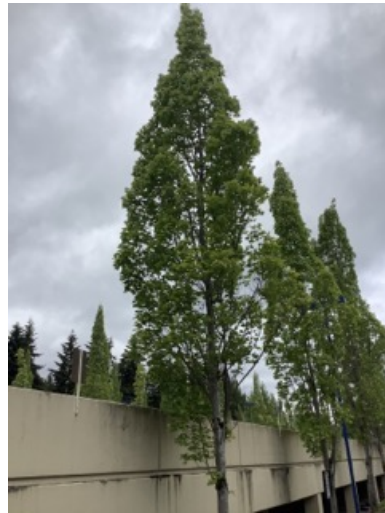
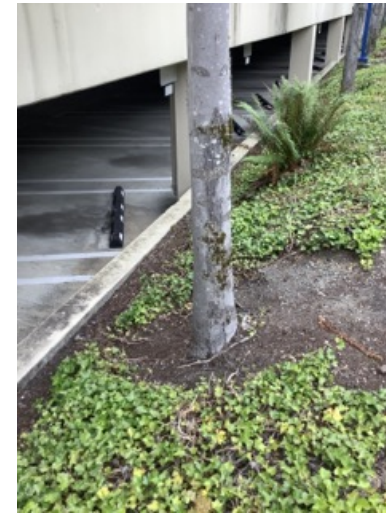
Tree	Species	DBH (in)	Drip Rad.	CRZ (ft)	Vigor	Structure	Risk	Pres Value	Recommendations
293	Armstrong maple <i>Acer x freemanii</i> 'Armstrong'	8.5	5.0	8.5	Fair to Good	Fair to Good	Low	Low	
Notes/ Defects	This is a healthy tree in good condition.

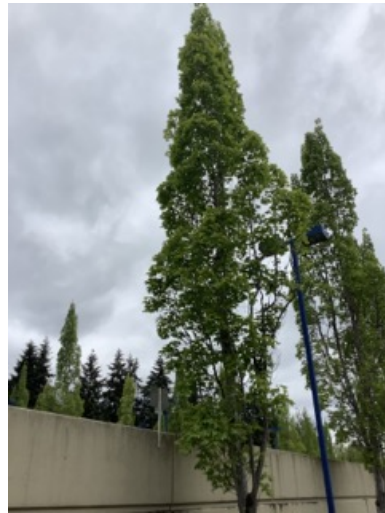
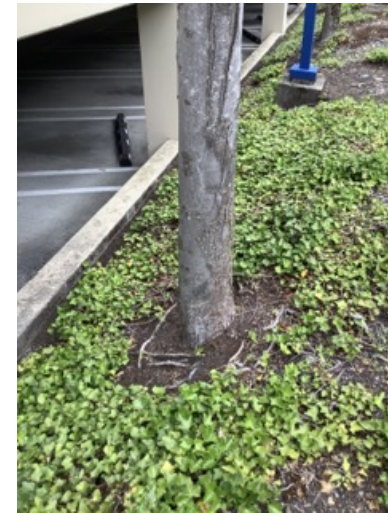
Tree	Species	DBH (in)	Drip Rad.	CRZ (ft)	Vigor	Structure	Risk	Pres Value	Recommendations
294	Armstrong maple <i>Acer x freemanii</i> 'Armstrong'	8.9	5.0	8.9	Fair to Good	Fair to Good	Low	Low	
Notes/ Defects	This is a healthy tree in good condition.

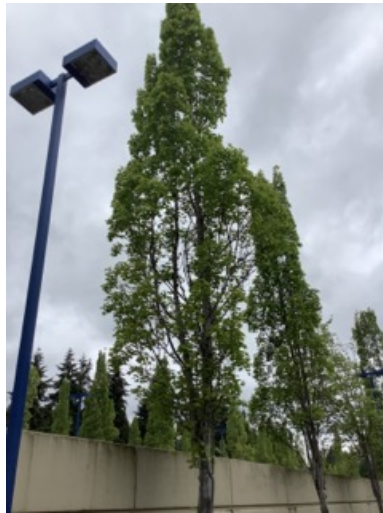
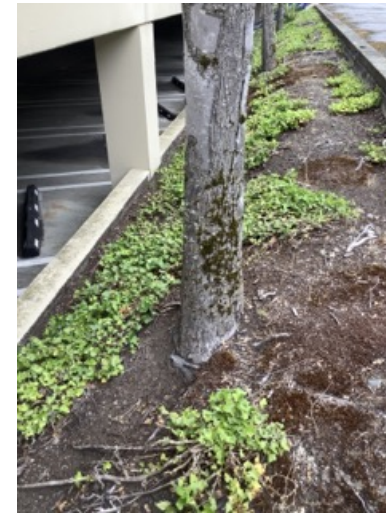
Tree	Species	DBH (in)	Drip Rad.	CRZ (ft)	Vigor	Structure	Risk	Pres Value	Recommendations
295	Armstrong maple <i>Acer x freemanii</i> 'Armstrong'	10.7	5.0	10.7	Fair to Good	Fair to Good	Low	Low	
Notes/ Defects	The tree is healthy. There is one circling root around the root flare.

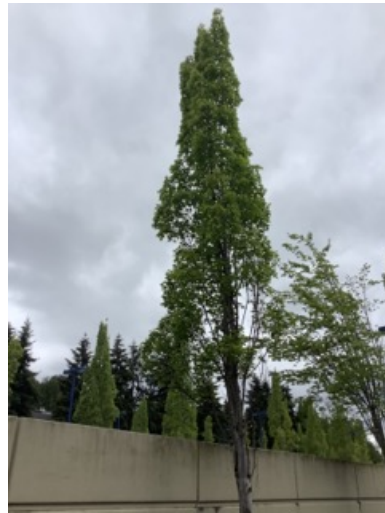
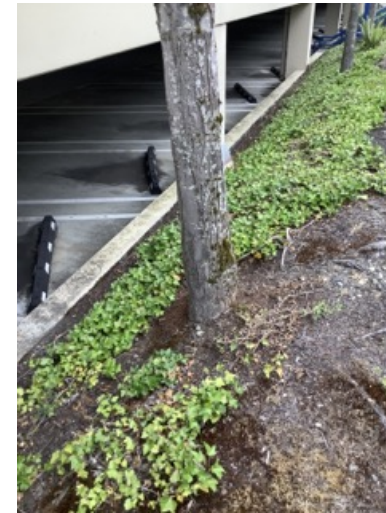
Tree	Species	DBH (in)	Drip Rad.	CRZ (ft)	Vigor	Structure	Risk	Pres Value	Recommendations
296	Armstrong maple <i>Acer x freemanii</i> 'Armstrong'	8.9	5.0	8.9	Fair to Good	Fair to Good	Low	Low	
Notes/ Defects	There is minor dieback in the crown.

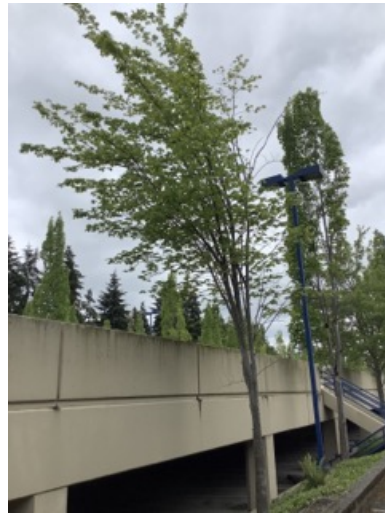
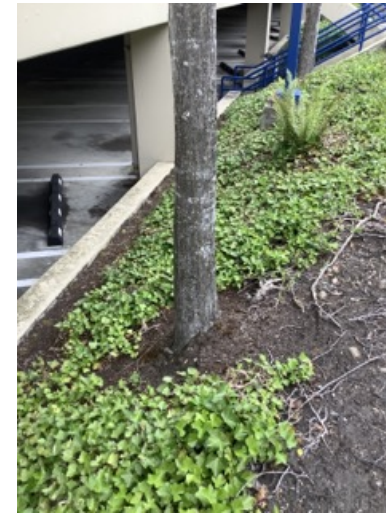
Tree	Species	DBH (in)	Drip Rad.	CRZ (ft)	Vigor	Structure	Risk	Pres Value	Recommendations
297	Armstrong maple <i>Acer x freemanii</i> 'Armstrong'	6.3	5.0	6.3	Fair	Fair	Low	Low	
Notes/ Defects	The spreading crown is slightly asymmetrical.

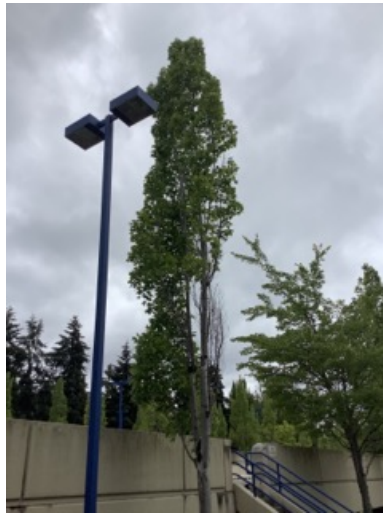
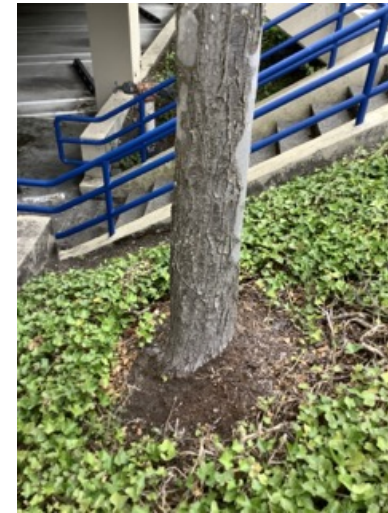
Tree	Species	DBH (in)	Drip Rad.	CRZ (ft)	Vigor	Structure	Risk	Pres Value	Recommendations
298	Armstrong maple <i>Acer x freemanii</i> 'Armstrong'	7.8	5.0	7.8	Fair	Fair	Low	Low	
Notes/ Defects	There is minor dieback in the crown.

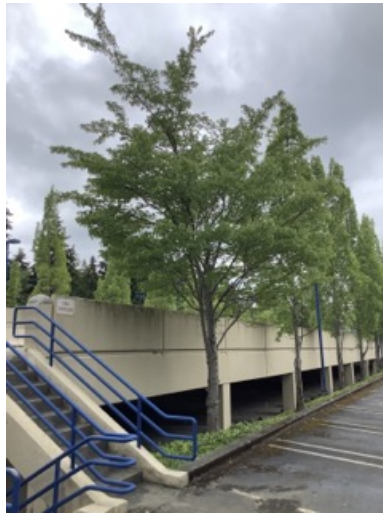
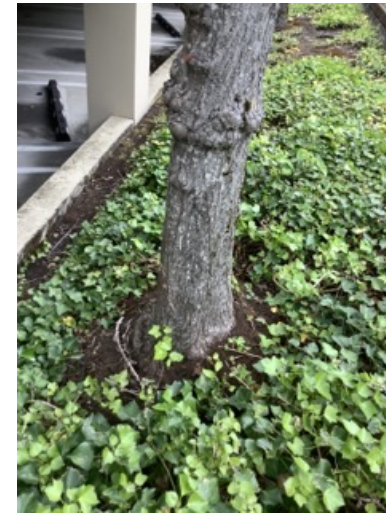
Tree	Species	DBH (in)	Drip Rad.	CRZ (ft)	Vigor	Structure	Risk	Pres Value	Recommendations
299	Armstrong maple <i>Acer x freemanii</i> 'Armstrong'	9.7	5.0	9.7	Fair	Fair	Low	Low	
Notes/ Defects	The tree has a spreading crown.

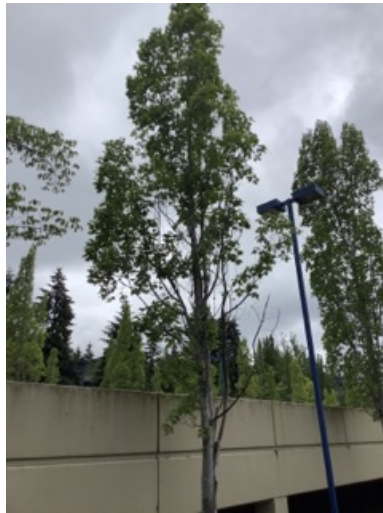
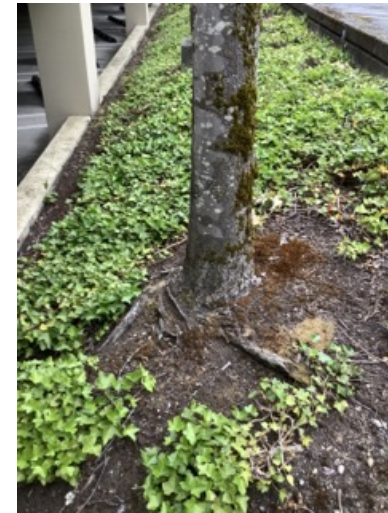
Tree	Species	DBH (in)	Drip Rad.	CRZ (ft)	Vigor	Structure	Risk	Pres Value	Recommendations
300	Armstrong maple <i>Acer x freemanii</i> 'Armstrong'	8.9	5.0	8.9	Fair	Fair	Low	Low	
Notes/ Defects	The tree has codominant stems and some dieback in the crown.

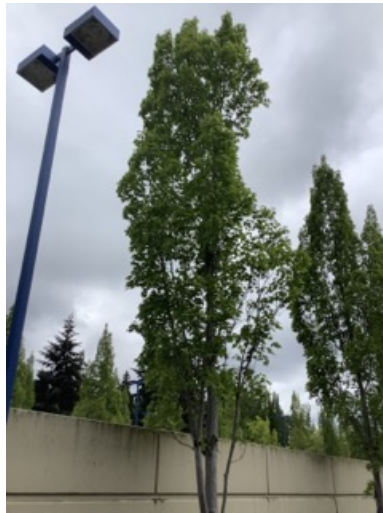
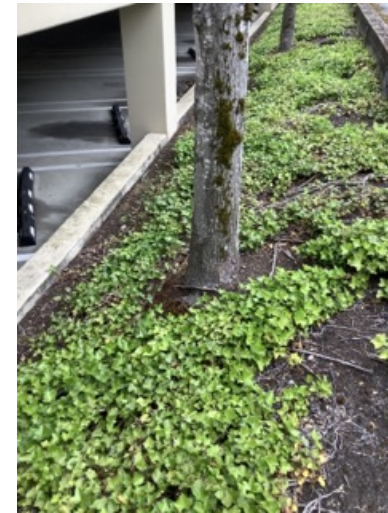
Tree	Species	DBH (in)	Drip Rad.	CRZ (ft)	Vigor	Structure	Risk	Pres Value	Recommendations
301	Armstrong maple <i>Acer x freemanii</i> 'Armstrong'	10.0	5.0	10.0	Good	Fair to Good	Low	Low	
Notes/ Defects	This is a healthy tree in good condition.

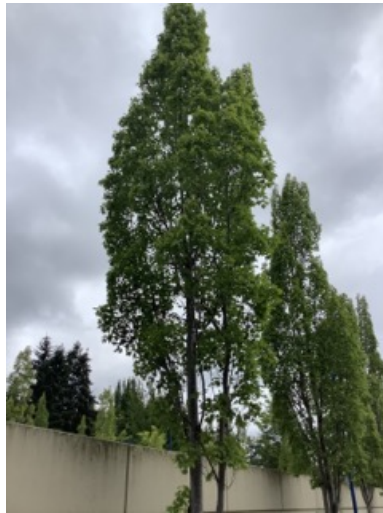
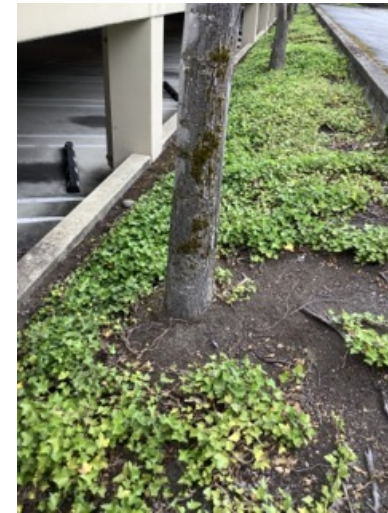
Tree	Species	DBH (in)	Drip Rad.	CRZ (ft)	Vigor	Structure	Risk	Pres Value	Recommendations
302	Armstrong maple <i>Acer x freemanii</i> 'Armstrong'	8.8	5.0	8.8	Good	Good	Low	Low	
Notes/ Defects	This is a healthy tree in good condition.

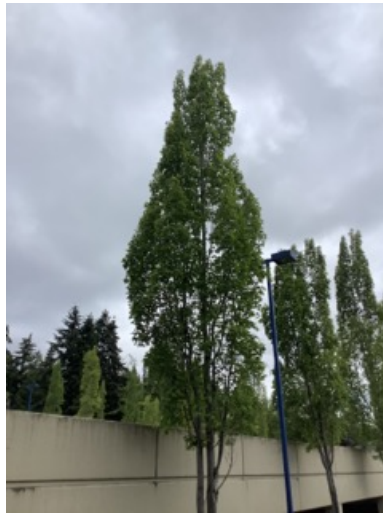
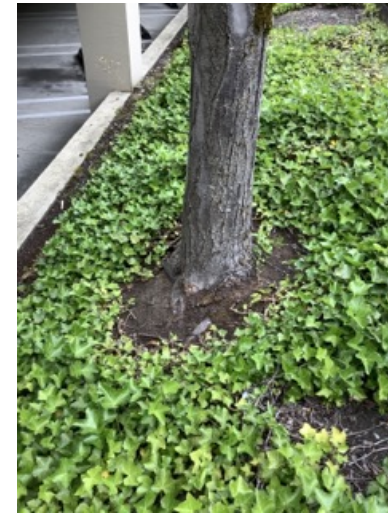
Tree	Species	DBH (in)	Drip Rad.	CRZ (ft)	Vigor	Structure	Risk	Pres Value	Recommendations
303	Armstrong maple <i>Acer x freemanii</i> 'Armstrong'		5.0	9.8	Fair to Good	Good	Low	Low	
Notes/ Defects	This is a healthy tree in good condition.

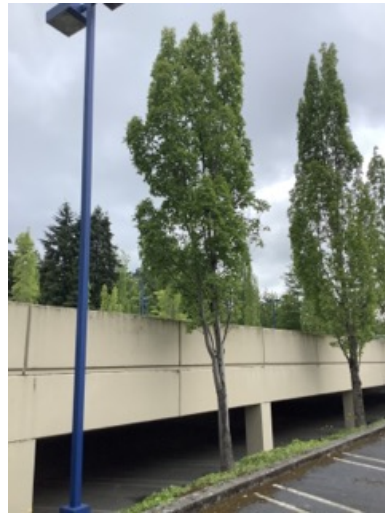
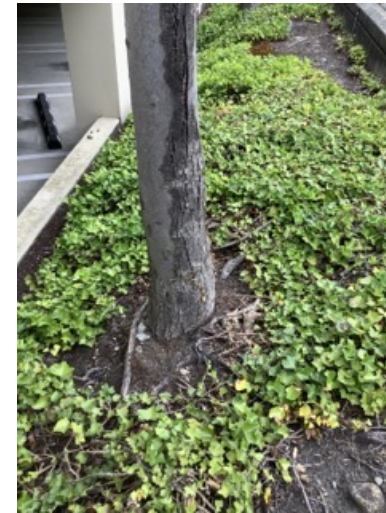
Tree	Species	DBH (in)	Drip Rad.	CRZ (ft)	Vigor	Structure	Risk	Pres Value	Recommendations
304	Armstrong maple <i>Acer x freemanii</i> 'Armstrong'	7.8	5.0	7.8	Good	Fair	Low	Low	
Notes/ Defects	This is a smaller tree in good condition.

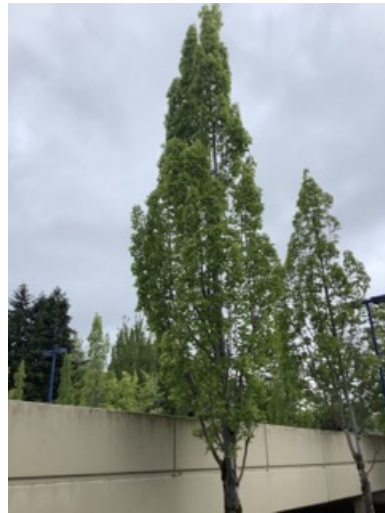
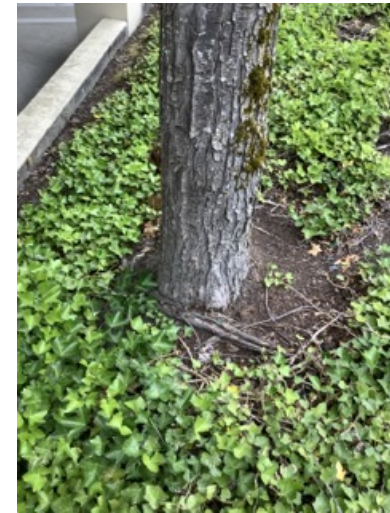
Tree	Species	DBH (in)	Drip Rad.	CRZ (ft)	Vigor	Structure	Risk	Pres Value	Recommendations
305	Armstrong maple <i>Acer x freemanii</i> 'Armstrong'	10.8	5.0	10.8	Good	Good	Low	Low	
Notes/ Defects	This is a healthy tree with a full crown.

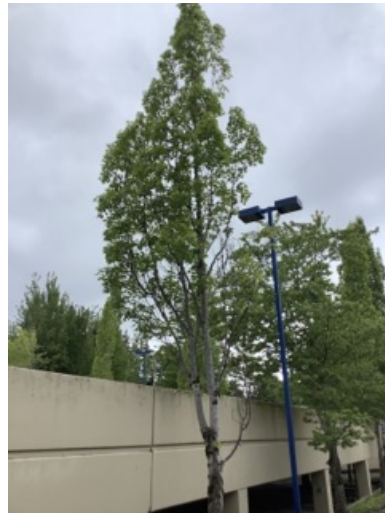
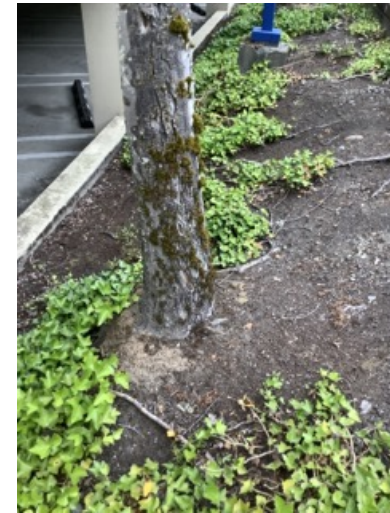
Tree	Species	DBH (in)	Drip Rad.	CRZ (ft)	Vigor	Structure	Risk	Pres Value	Recommendations
306	Armstrong maple <i>Acer x freemanii</i> 'Armstrong'	9.3	5.0	9.3	Fair	Fair to Good	Low	Low	
Notes/ Defects	Some dieback, old wounds at base of trunk

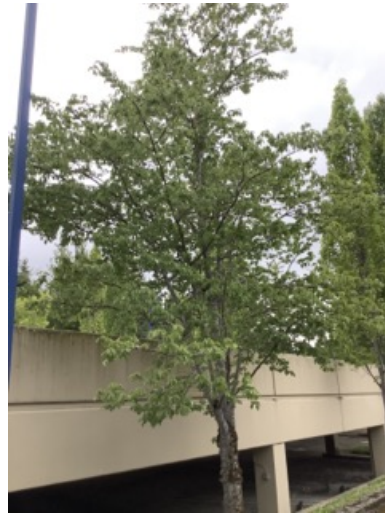
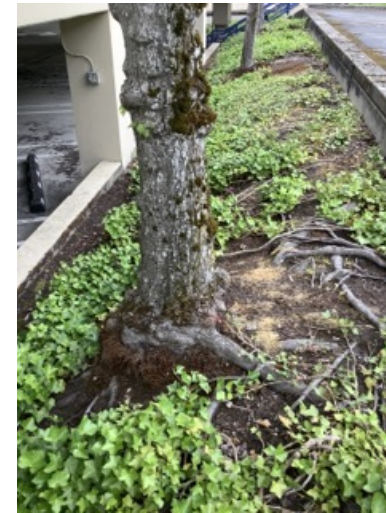
Tree	Species	DBH (in)	Drip Rad.	CRZ (ft)	Vigor	Structure	Risk	Pres Value	Recommendations
307	Armstrong maple <i>Acer x freemanii</i> 'Armstrong'	10.1	5.0	10.1	Good	Fair	Low	Low	
Notes/ Defects	This tree has a spreading crown form.

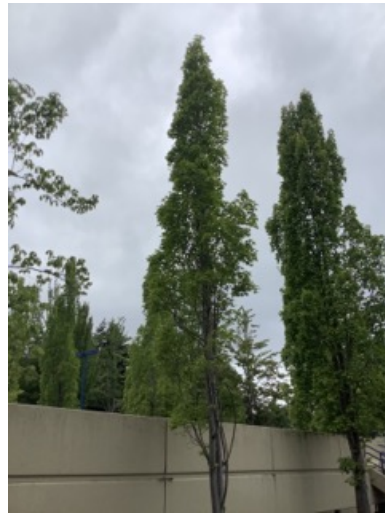
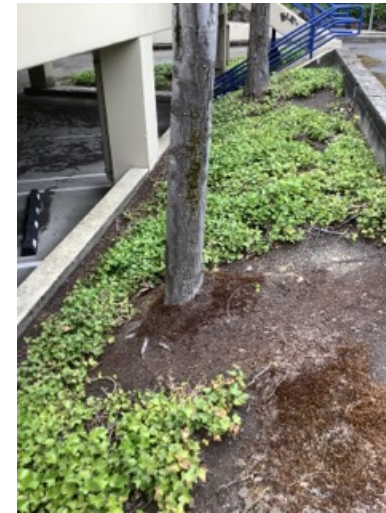
Tree	Species	DBH (in)	Drip Rad.	CRZ (ft)	Vigor	Structure	Risk	Pres Value	Recommendations
308	Armstrong maple <i>Acer x freemanii</i> 'Armstrong'	8.0	5.0	8.0	Fair	Fair	Low	Low	
Notes/ Defects	There is minor dieback in the crown.

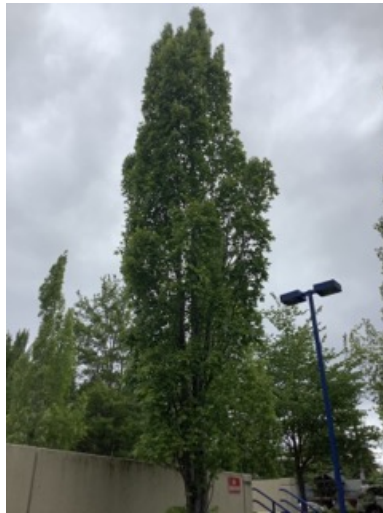
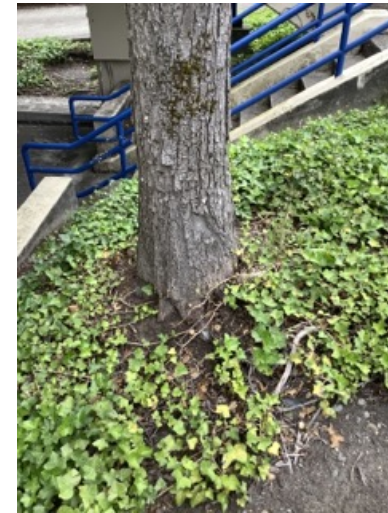
Tree	Species	DBH (in)	Drip Rad.	CRZ (ft)	Vigor	Structure	Risk	Pres Value	Recommendations
309	Armstrong maple <i>Acer x freemanii</i> 'Armstrong'	12.8	5.0	12.8	Good	Fair to Good	Low	Low	
Notes/ Defects	The crown is full length and healthy.

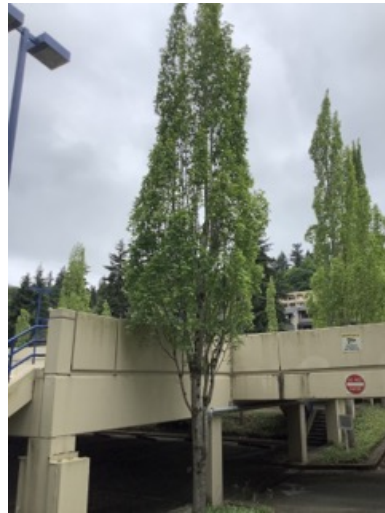
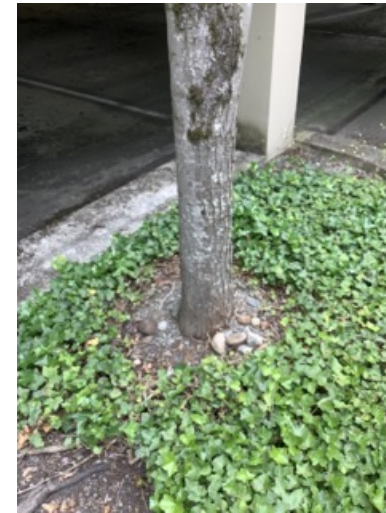
Tree	Species	DBH (in)	Drip Rad.	CRZ (ft)	Vigor	Structure	Risk	Pres Value	Recommendations
310	Armstrong maple <i>Acer x freemanii</i> 'Armstrong'	9.4	5.0	9.4	Good	Fair to Good	Low	Low	
Notes/ Defects	The tree is in good condition.

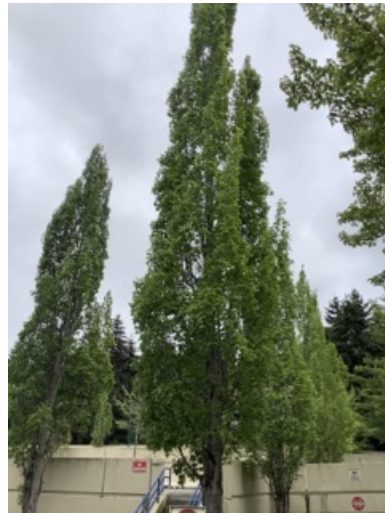
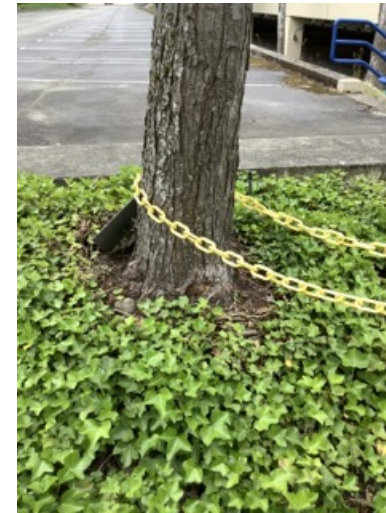
Tree	Species	DBH (in)	Drip Rad.	CRZ (ft)	Vigor	Structure	Risk	Pres Value	Recommendations
311	Armstrong maple <i>Acer x freemanii</i> 'Armstrong'	12.1	5.0	12.1	Good	Fair to Good	Low	Low	
Notes/ Defects	The tree is in good condition. It has multiple codominant stems.

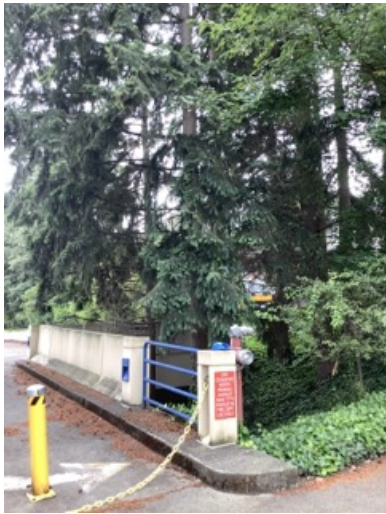
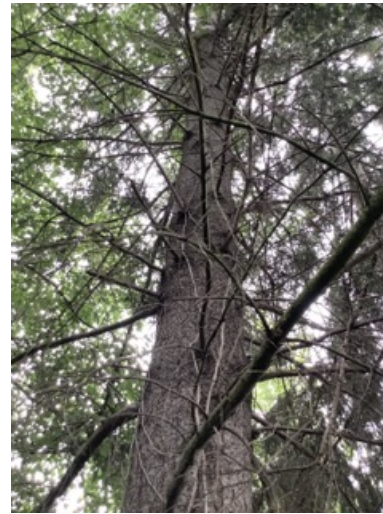
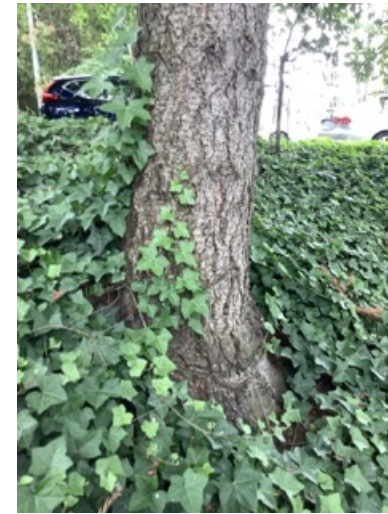
Tree	Species	DBH (in)	Drip Rad.	CRZ (ft)	Vigor	Structure	Risk	Pres Value	Recommendations
312	Douglas fir <i>Pseudotsuga menziesii</i>	17.2	12.0	17.2	Fair	Fair to Good	Low	Medium	
Notes/ Defects	This tree is in a grove of 11 trees, 4 of which are on the subject property. They are on a slight slope. Ivy is the dominant ground cover and starting up the trees.

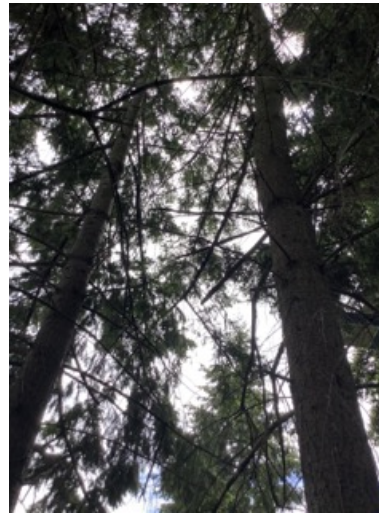
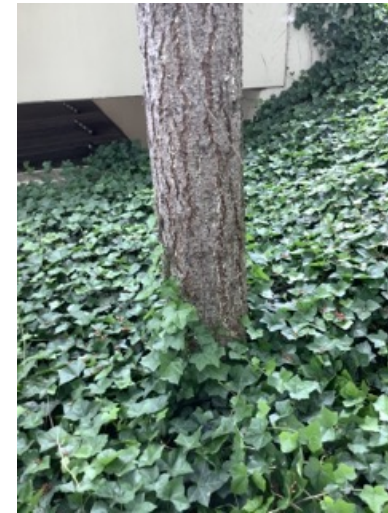
Tree	Species	DBH (in)	Drip Rad.	CRZ (ft)	Vigor	Structure	Risk	Pres Value	Recommendations
313	Douglas fir <i>Pseudotsuga menziesii</i>	11.5	6.8	11.5	Fair	Fair	Low	Low	
Notes/ Defects	The tree has a slight asymmetrical crown.

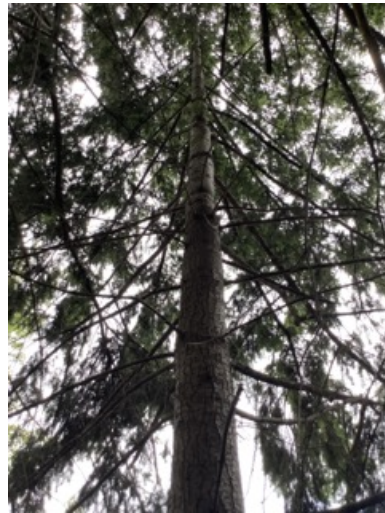
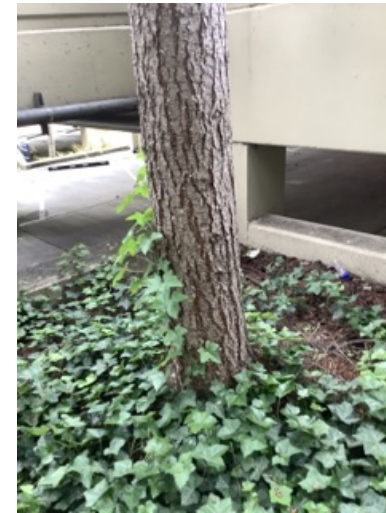
Tree	Species	DBH (in)	Drip Rad.	CRZ (ft)	Vigor	Structure	Risk	Pres Value	Recommendations
314	Douglas fir <i>Pseudotsuga menziesii</i>	11.2	8.8	11.2	Fair to Good	Fair	Low	Low	
Notes/ Defects	The crown is asymmetrical over the parking area.

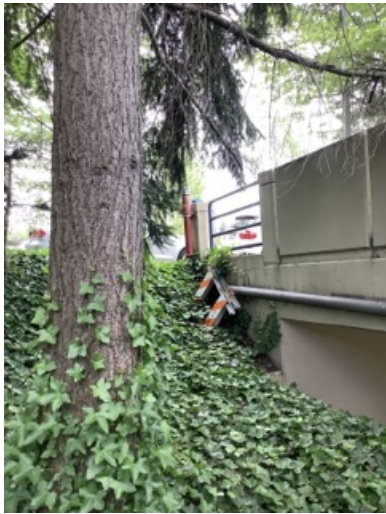
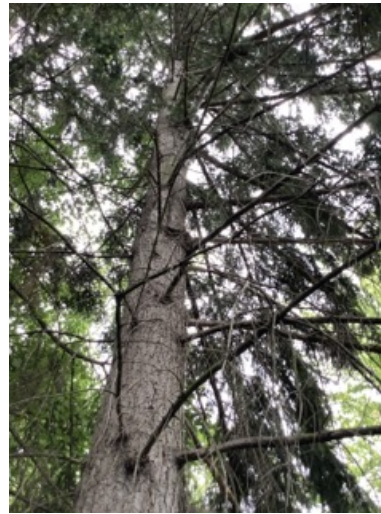
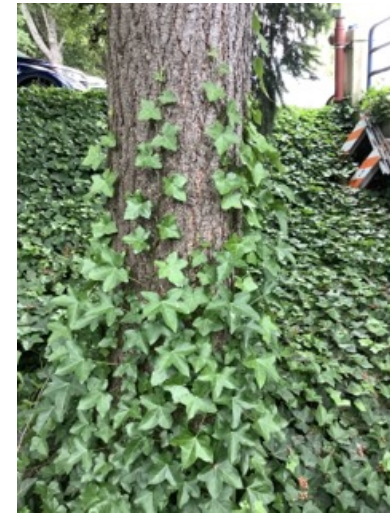
Tree	Species	DBH (in)	Drip Rad.	CRZ (ft)	Vigor	Structure	Risk	Pres Value	Recommendations
315	Douglas fir <i>Pseudotsuga menziesii</i>	16.8	9.8	16.8	Fair to Good	Fair to Good	Low	Medium	
Notes/ Defects	Ivy is starting to encroach on the lower crown.

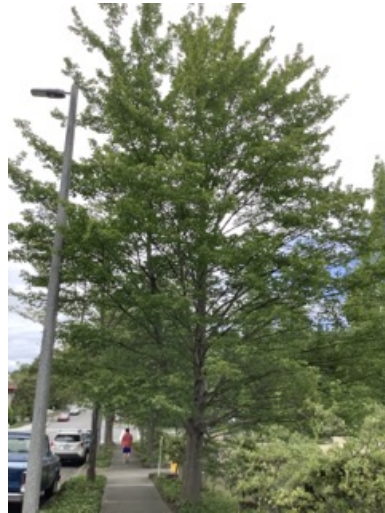
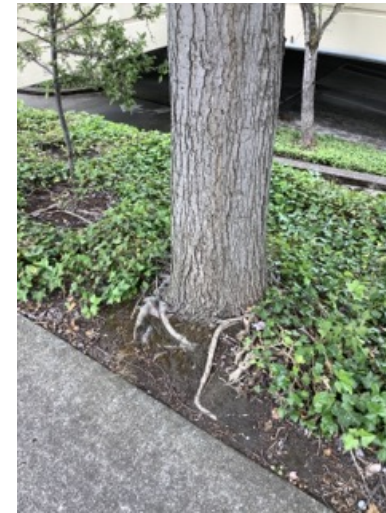
Tree	Species	DBH (in)	Drip Rad.	CRZ (ft)	Vigor	Structure	Risk	Pres Value	Recommendations
316	Red maple <i>Acer rubrum</i>	14.5	13.0	14.5	Good	Fair to Good	Low	Medium	
Notes/ Defects	The tree has a nice shape and it is in good condition. The lower branches could be elevated over the sidewalk. There is an encircling root and some sidewalk upheaval next to the tree.
