**Title: 3003 77th Ave Project – Mercer South Park Project
Full Tree Inventory and Health Assessment
Level 2 Basic Tree Risk Assessment
3003 77th Ave SE
Mercer Island, Washington**

Date: July 15, 2020; updated July 24, 2020

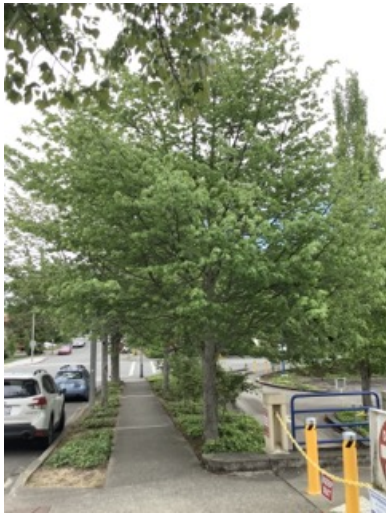
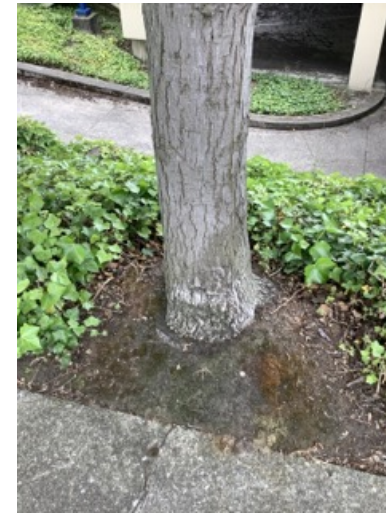
Tree	Species	DBH (in)	Drip Rad.	CRZ (ft)	Vigor	Structure	Risk	Pres Value	Recommendations
317	Red maple <i>Acer rubrum</i>	9.8	11.0	9.8	Good	Good	Low	Low	
Notes/ Defects	This is a healthy tree in good condition. The lower branches over the sidewalk could be pruned.

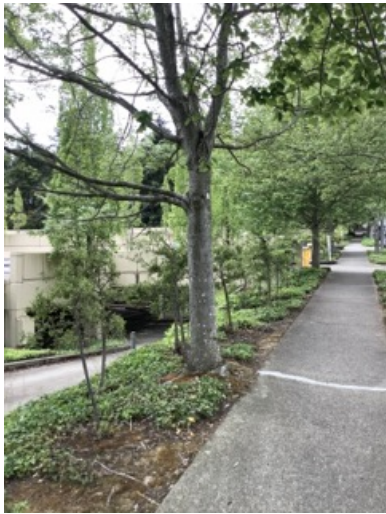
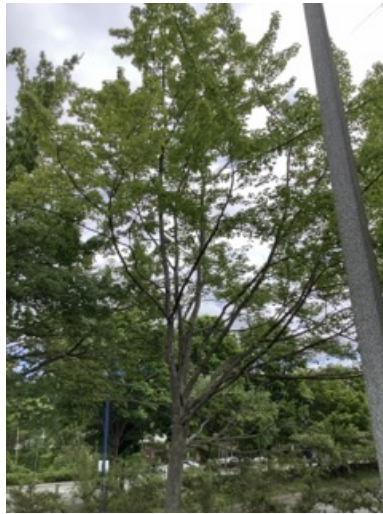
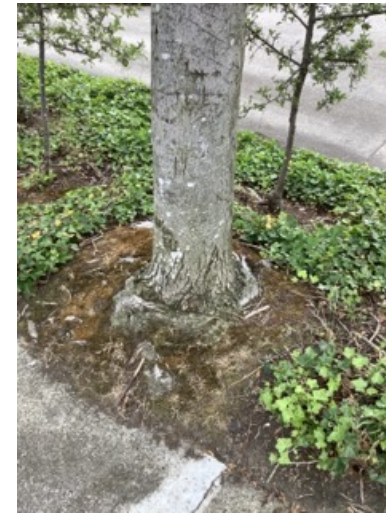
Tree	Species	DBH (in)	Drip Rad.	CRZ (ft)	Vigor	Structure	Risk	Pres Value	Recommendations
318	Red maple <i>Acer rubrum</i>	10.3	14.0	10.3	Fair	Fair to Good	Low	Low	
Notes/ Defects	The crown is thinning and there is one encircling root.

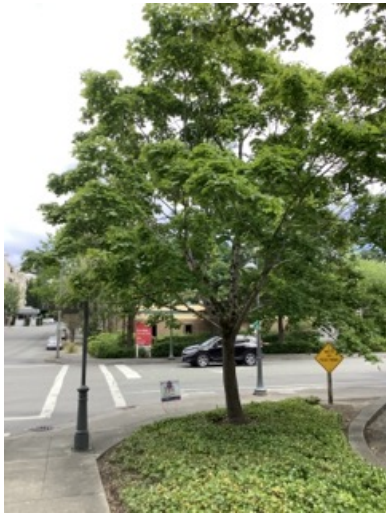
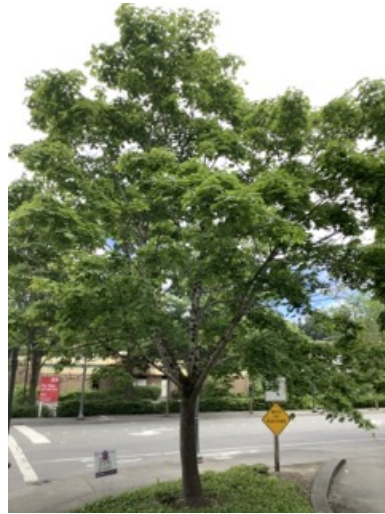
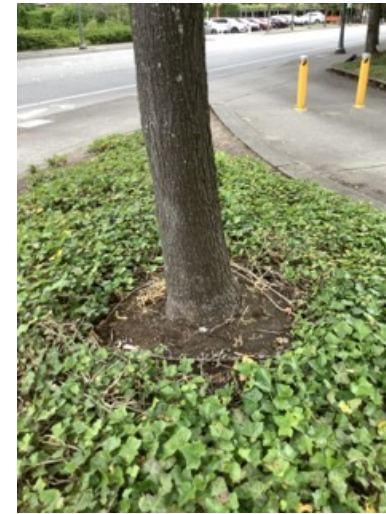
Tree	Species	DBH (in)	Drip Rad.	CRZ (ft)	Vigor	Structure	Risk	Pres Value	Recommendations
319	Norway maple <i>Acer platanoides</i>	9.8	14.0	9.8	Good	Good	Low	Low	
Notes/ Defects	This tree is in good condition at the corner of the property.

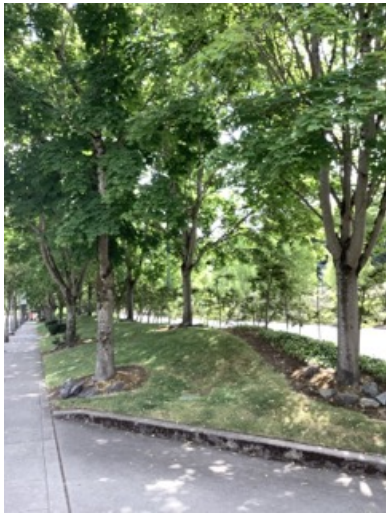
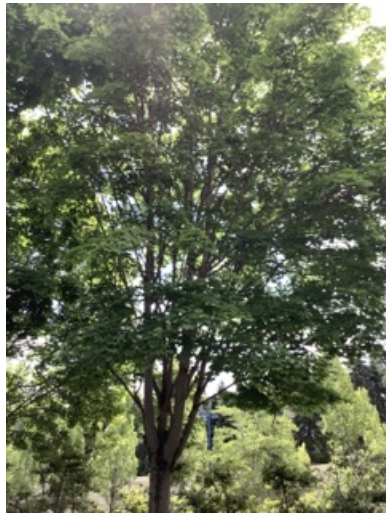
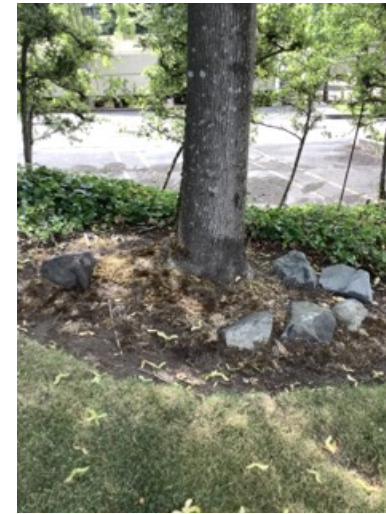
Tree	Species	DBH (in)	Drip Rad.	CRZ (ft)	Vigor	Structure	Risk	Pres Value	Recommendations
320	Norway maple <i>Acer platanoides</i>	11.2	10.0	11.2	Good	Good	Low	Medium	
Notes/ Defects	This is a healthy tree in good condition.

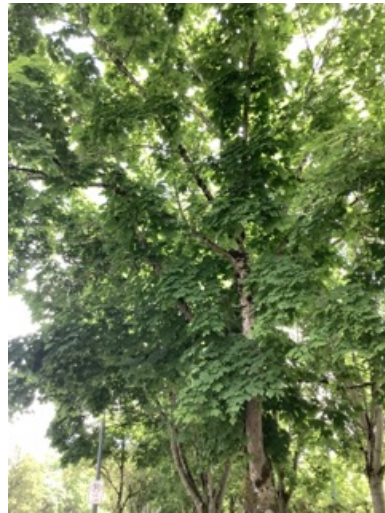
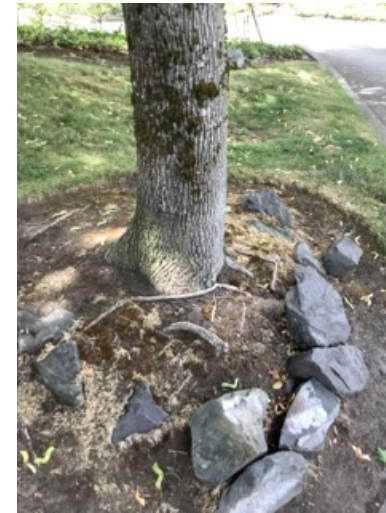
Tree	Species	DBH (in)	Drip Rad.	CRZ (ft)	Vigor	Structure	Risk	Pres Value	Recommendations
321	Norway maple <i>Acer platanoides</i>	12.4	10.0	12.4	Good	Good	Low	Medium	
Notes/ Defects	This is a healthy tree with a very dense crown.

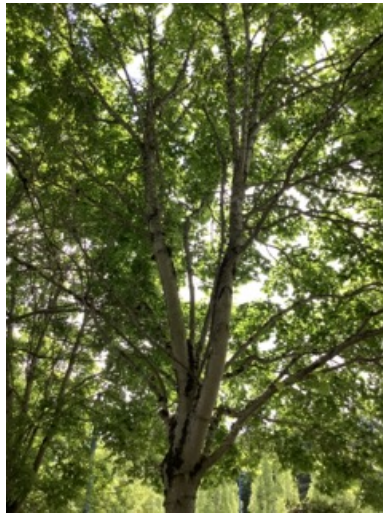
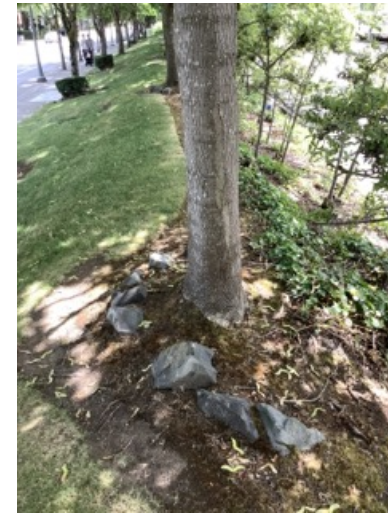
Tree	Species	DBH (in)	Drip Rad.	CRZ (ft)	Vigor	Structure	Risk	Pres Value	Recommendations
322	Norway maple <i>Acer platanoides</i>	10.3	10.0	10.3	Fair to Good	Fair to Good	Low	Medium	
Notes/ Defects	There is some minor dieback in the crown.

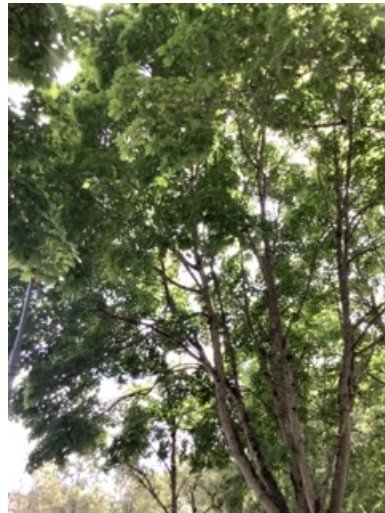
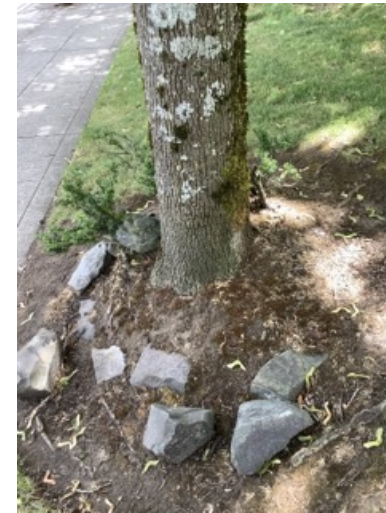
Tree	Species	DBH (in)	Drip Rad.	CRZ (ft)	Vigor	Structure	Risk	Pres Value	Recommendations
323	Norway maple <i>Acer platanoides</i>	13.1	10.0	13.1	Good	Fair to Good	Low	Medium	
Notes/ Defects	The tree has some dead twigs but the crown is dense and the foliage is healthy.

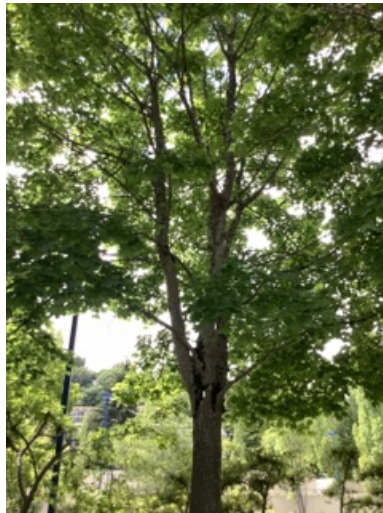
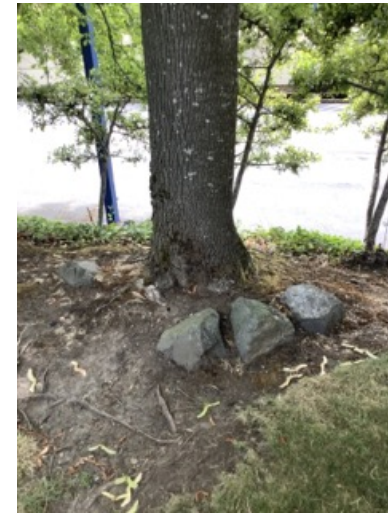
Tree	Species	DBH (in)	Drip Rad.	CRZ (ft)	Vigor	Structure	Risk	Pres Value	Recommendations
324	Norway maple <i>Acer platanoides</i>	12.6	10.0	12.6	Good	Fair to Good	Low	Medium	
Notes/ Defects	The crown is dense and the foliage is healthy.

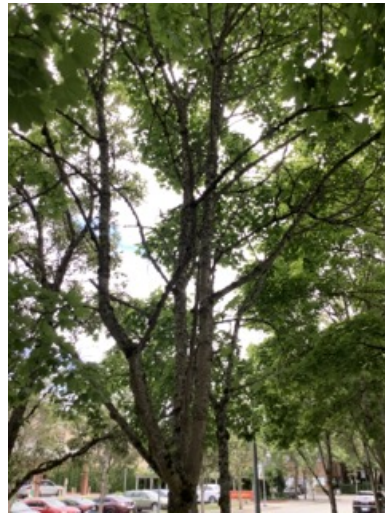
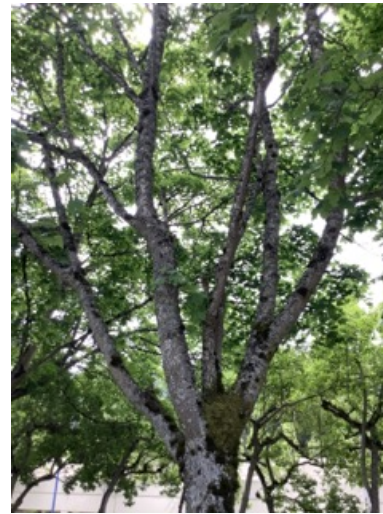
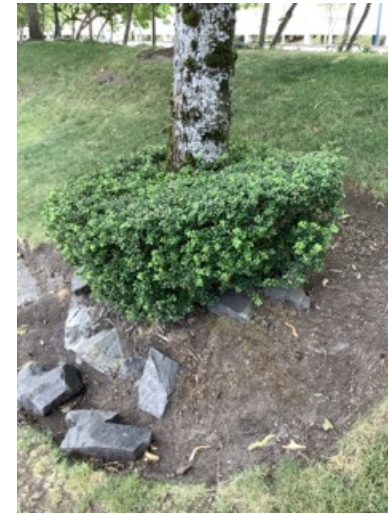
Tree	Species	DBH (in)	Drip Rad.	CRZ (ft)	Vigor	Structure	Risk	Pres Value	Recommendations
325	Norway maple <i>Acer platanoides</i>	9.2	10.0	9.2	Good	Fair to Good	Low	Medium	
Notes/ Defects	There is some dieback in the crown but the foliage is healthy.

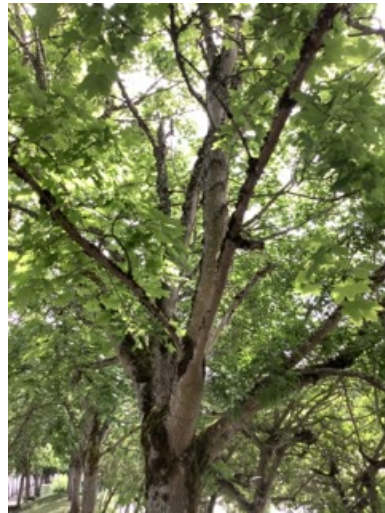
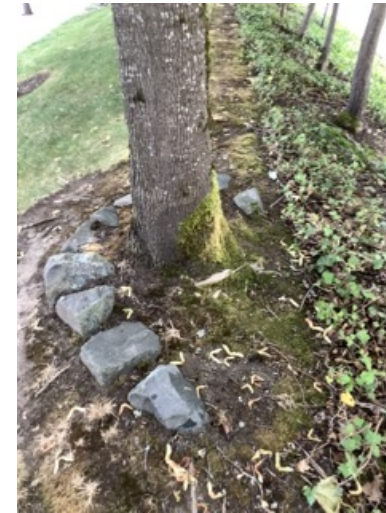
Tree	Species	DBH (in)	Drip Rad.	CRZ (ft)	Vigor	Structure	Risk	Pres Value	Recommendations
326	Norway maple <i>Acer platanoides</i>	10.9	10.0	10.9	Good	Fair to Good	Low	Medium	
Notes/ Defects	There is some dieback in the crown but the foliage is lush and healthy.

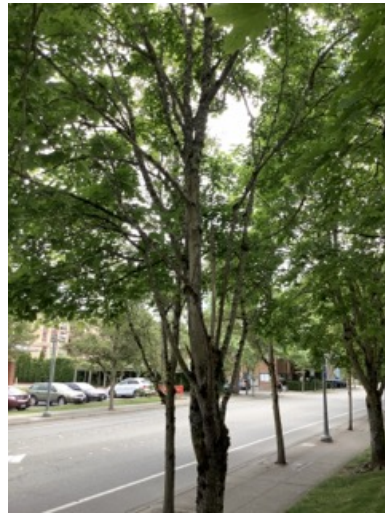
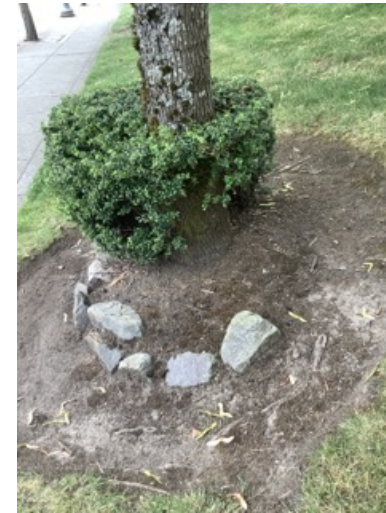
Tree	Species	DBH (in)	Drip Rad.	CRZ (ft)	Vigor	Structure	Risk	Pres Value	Recommendations
327	Norway maple <i>Acer platanoides</i>	10.9	10.0	10.9	Good	Fair to Good	Low	Medium	
Notes/ Defects	The lower crown has some dieback and the upper crown is dense.

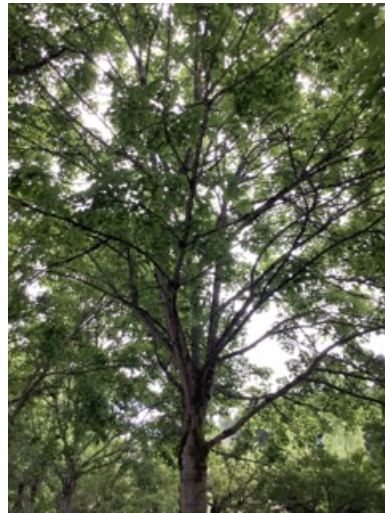
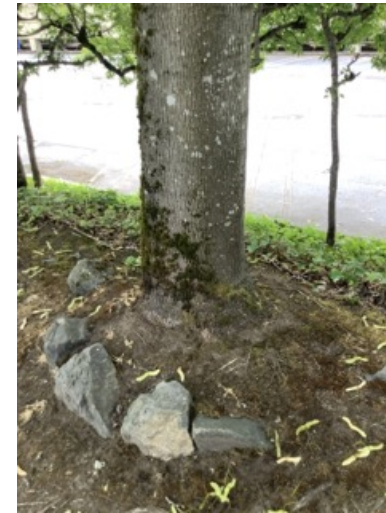
Tree	Species	DBH (in)	Drip Rad.	CRZ (ft)	Vigor	Structure	Risk	Pres Value	Recommendations
328	Norway maple <i>Acer platanoides</i>	12.2	10.0	12.2	Good	Fair to Good	Low	Medium	
Notes/ Defects	The upper crown is dense.

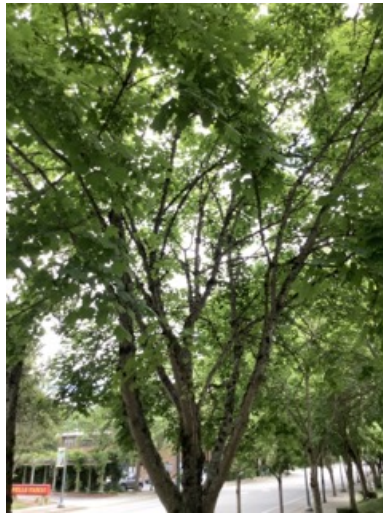
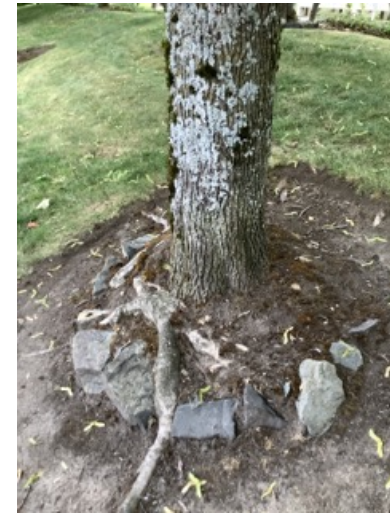
Tree	Species	DBH (in)	Drip Rad.	CRZ (ft)	Vigor	Structure	Risk	Pres Value	Recommendations
329	Norway maple <i>Acer platanoides</i>	13.8	10.0	13.8	Good	Fair to Good	Low	Medium	
Notes/ Defects	There is some dieback in the crown but the foliage is healthy.

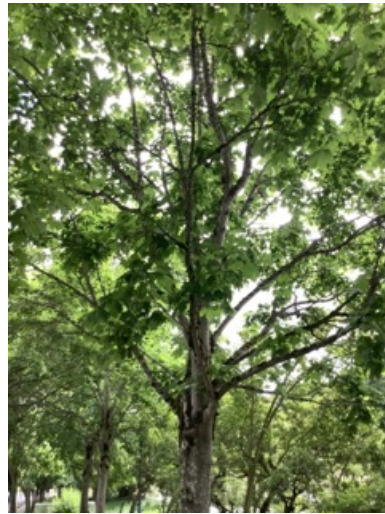
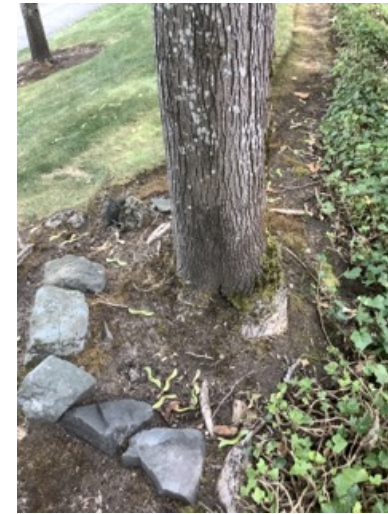
Tree	Species	DBH (in)	Drip Rad.	CRZ (ft)	Vigor	Structure	Risk	Pres Value	Recommendations
330	Norway maple <i>Acer platanoides</i>	11.8	10.0	11.8	Good	Fair to Good	Low	Medium	
Notes/ Defects	There is some dieback in the crown but the foliage is healthy.

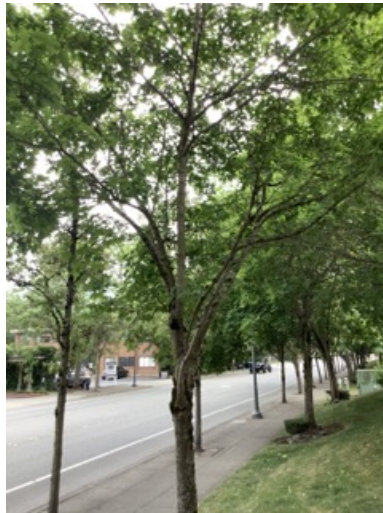
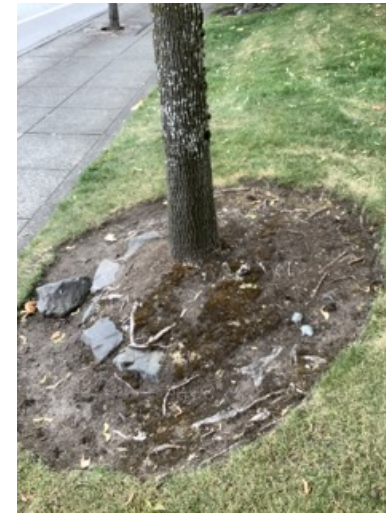
Tree	Species	DBH (in)	Drip Rad.	CRZ (ft)	Vigor	Structure	Risk	Pres Value	Recommendations
331	Norway maple <i>Acer platanoides</i>	7.8	10.0	7.8	Fair	Fair to Good	Low	Medium	
Notes/ Defects	The crown has some dieback.

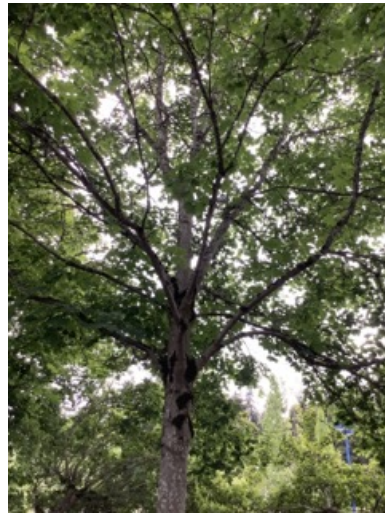
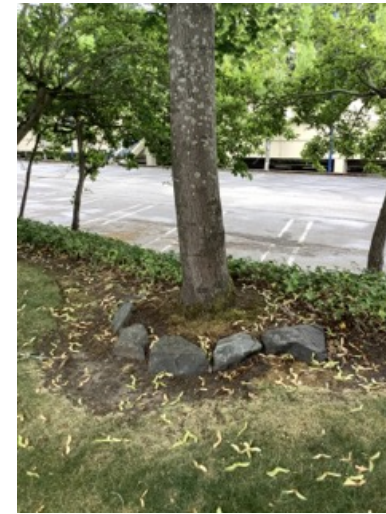
Tree	Species	DBH (in)	Drip Rad.	CRZ (ft)	Vigor	Structure	Risk	Pres Value	Recommendations
332	Norway maple <i>Acer platanoides</i>	9.1	10.0	9.1	Good	Fair to Good	Low	Medium	
Notes/ Defects	The crown is very dense.

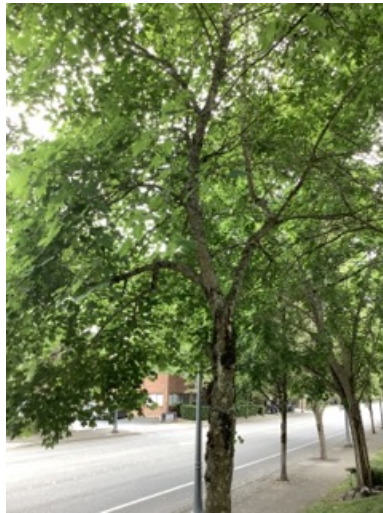
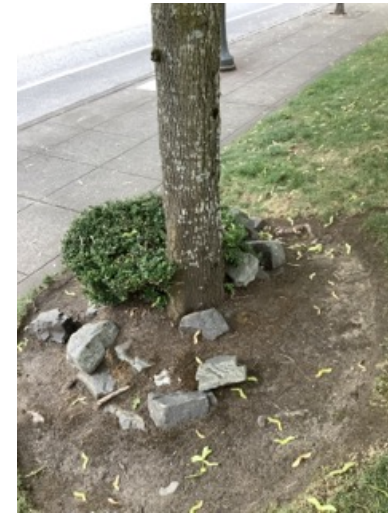
Tree	Species	DBH (in)	Drip Rad.	CRZ (ft)	Vigor	Structure	Risk	Pres Value	Recommendations
333	Norway maple <i>Acer platanoides</i>	8.7	10.0	8.7	Fair	Fair to Good	Low	Medium	
Notes/ Defects	There is some dieback in the crown but the foliage is healthy.

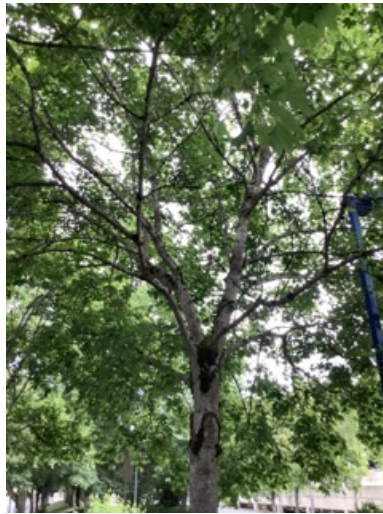
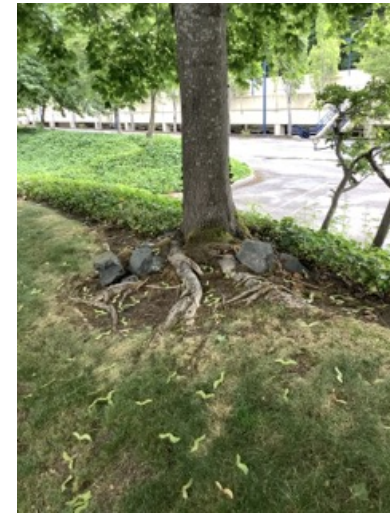
Tree	Species	DBH (in)	Drip Rad.	CRZ (ft)	Vigor	Structure	Risk	Pres Value	Recommendations
334	Norway maple <i>Acer platanoides</i>	12.1	10.0	12.1	Fair	Fair to Good	Low	Medium	
Notes/ Defects	There is some dieback in the crown but the foliage is healthy.

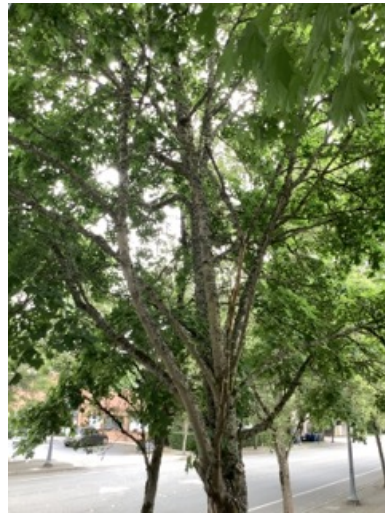
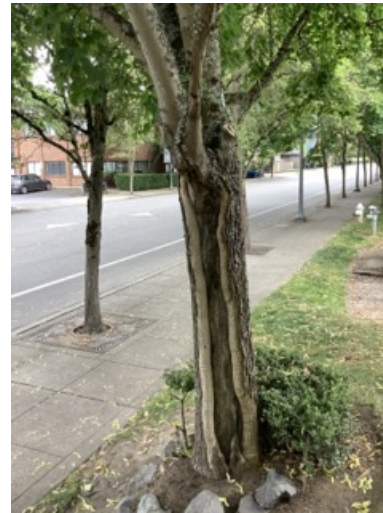
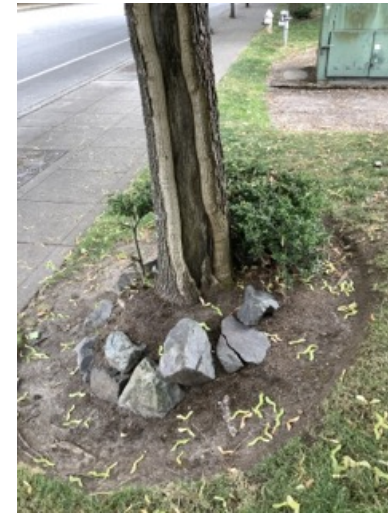
Tree	Species	DBH (in)	Drip Rad.	CRZ (ft)	Vigor	Structure	Risk	Pres Value	Recommendations
335	Norway maple <i>Acer platanoides</i>	13.3	10.0	13.3	Fair to Good	Fair to Good	Low	Medium	
Notes/ Defects	The crown is dense and healthy. A large wound on the lower trunk is compartmentalized.

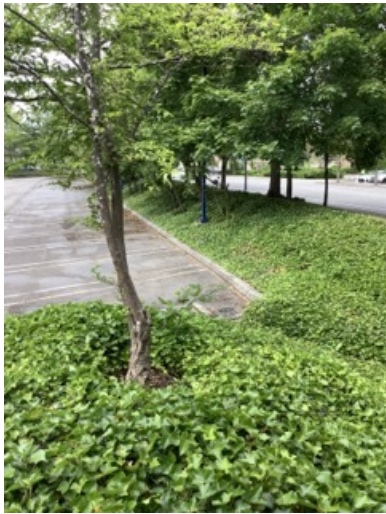
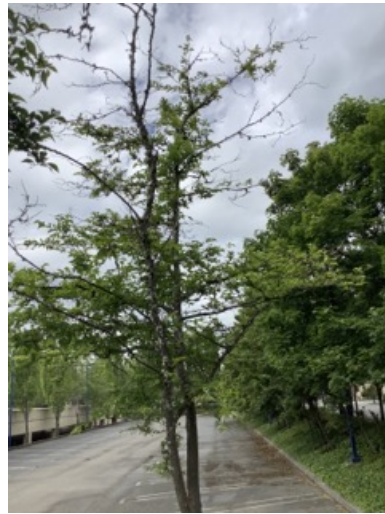
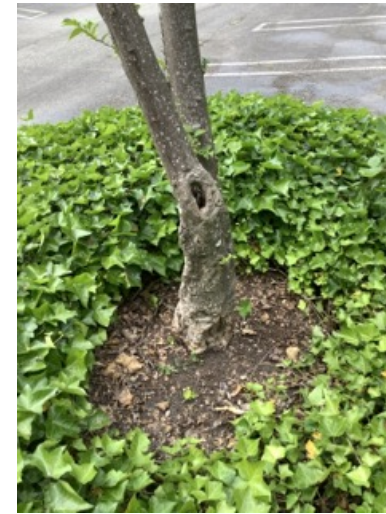
Tree	Species	DBH (in)	Drip Rad.	CRZ (ft)	Vigor	Structure	Risk	Pres Value	Recommendations
336	Japanese snowbell <i>Styrax japonicus</i>		4.0	4.2	Poor	Poor to Fair	Low	Low	
Notes/ Defects	One of the codominant stems is mostly dead.

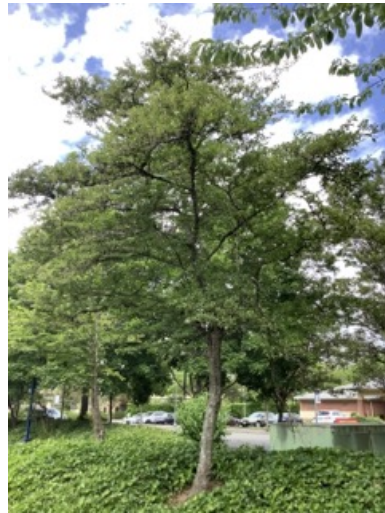
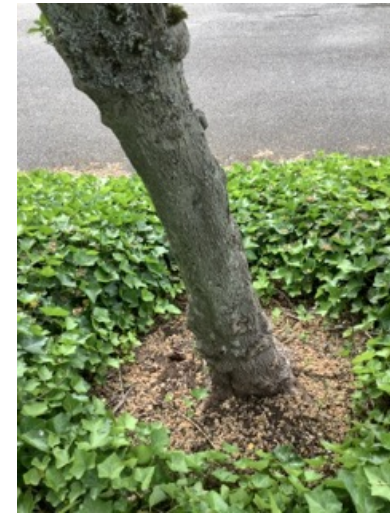
Tree	Species	DBH (in)	Drip Rad.	CRZ (ft)	Vigor	Structure	Risk	Pres Value	Recommendations
337	Japanese snowbell <i>Styrax japonicus</i>	5.8	6.0	5.8	Fair to Good	Fair to Good	Low	Low	
Notes/ Defects	There is some minor dieback in the crown. The tree has a good shape.

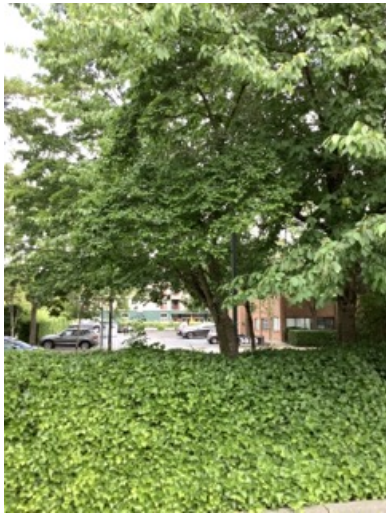
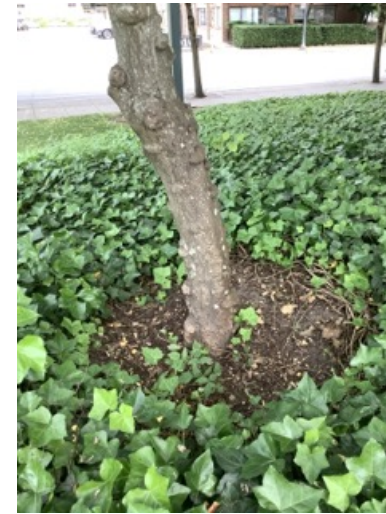
Tree	Species	DBH (in)	Drip Rad.	CRZ (ft)	Vigor	Structure	Risk	Pres Value	Recommendations
338	Japanese snowbell <i>Styrax japonicus</i>	4.0	6.0	4.0	Fair to Good	Fair to Good	Low	Low	
Notes/ Defects	This is a short tree growing under a larger cherry.

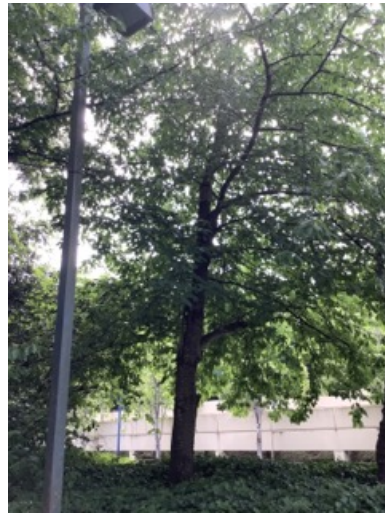
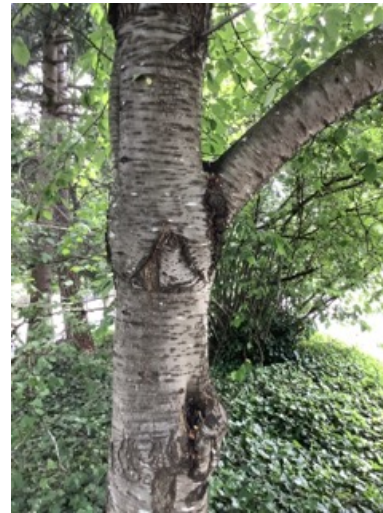
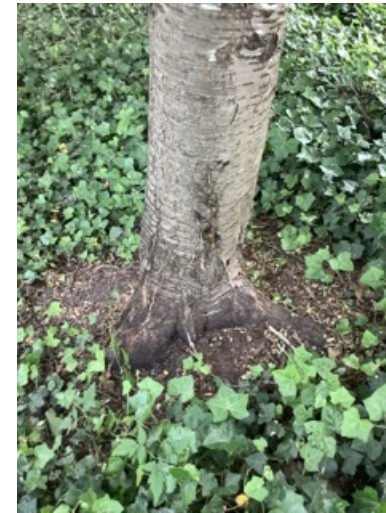
Tree	Species	DBH (in)	Drip Rad.	CRZ (ft)	Vigor	Structure	Risk	Pres Value	Recommendations
339	Bitter cherry <i>Prunus emarginata</i>	11.8	15.0	11.8	Good	Fair	Low	Low	
Notes/ Defects	The tree has a slight lean towards the parking area.

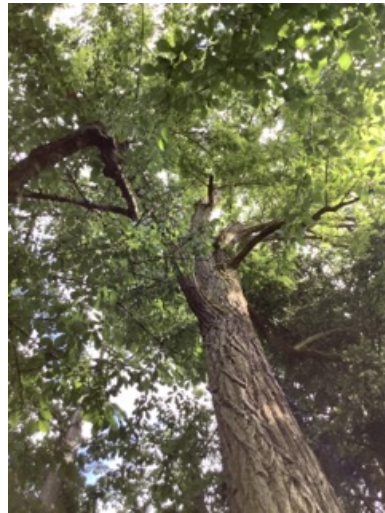
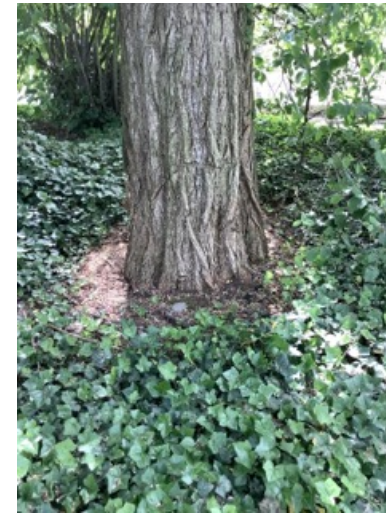
Tree	Species	DBH (in)	Drip Rad.	CRZ (ft)	Vigor	Structure	Risk	Pres Value	Recommendations
340	Honey locust <i>Gleditsia triacanthos</i>	25.3	14.0	25.3	Fair to Good	Good	Low	Medium	
Notes/ Defects	The trunk is mostly growing straight. The lowest branches start at approximately 20 feet high.

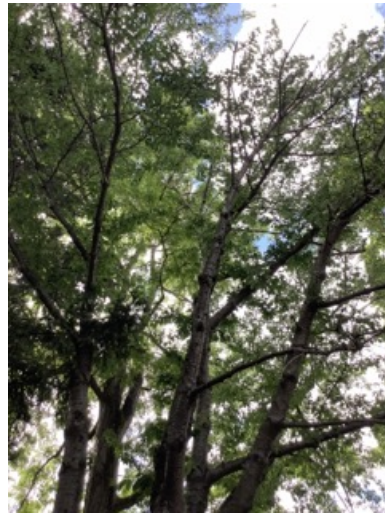
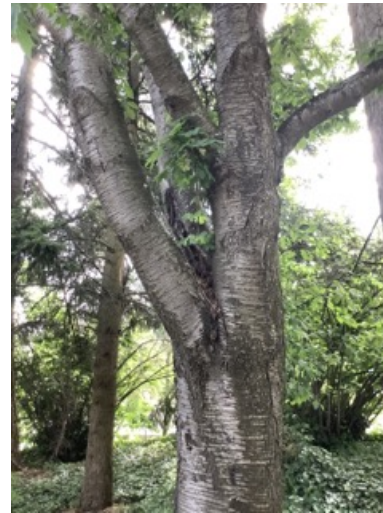
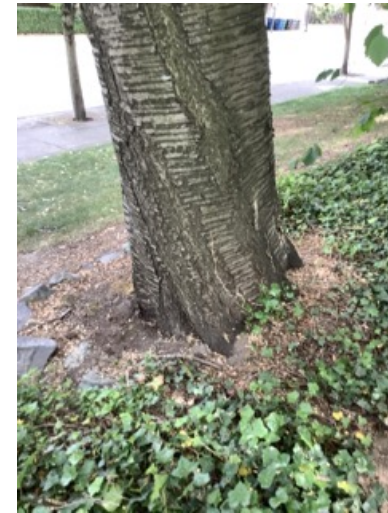
Tree	Species	DBH (in)	Drip Rad.	CRZ (ft)	Vigor	Structure	Risk	Pres Value	Recommendations
341	Bitter cherry <i>Prunus emarginata</i>	28.6	20.0	28.6	Fair	Fair	Low	Medium	
Notes/ Defects	There are three main codominant stems. One stem has a cavity and it could fail, but there is no target within striking distance.

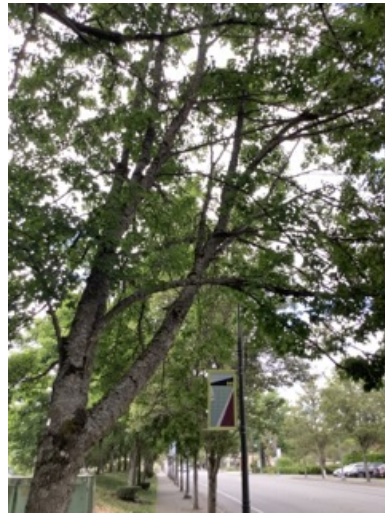
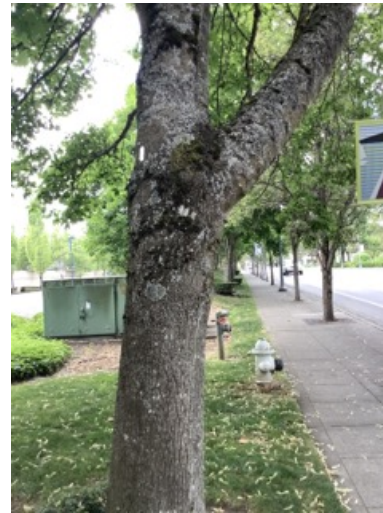
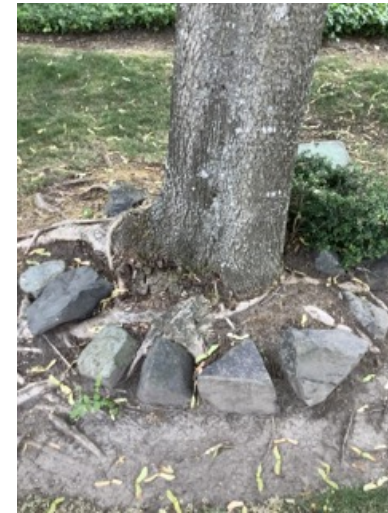
Tree	Species	DBH (in)	Drip Rad.	CRZ (ft)	Vigor	Structure	Risk	Pres Value	Recommendations
342	Norway maple <i>Acer platanoides</i>	14.2	15.8	14.2	Fair	Fair	Low	Low	
Notes/ Defects	The asymmetrical crown is growing towards the street.

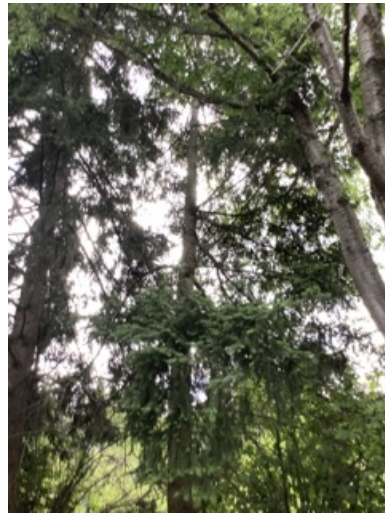
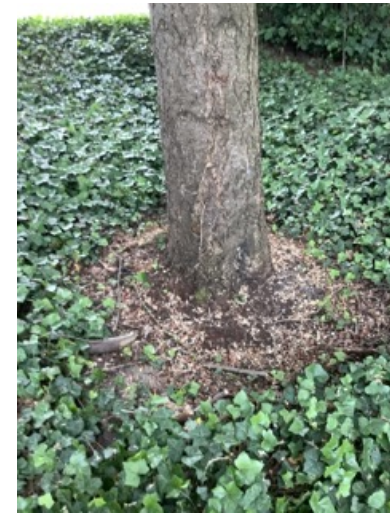
Tree	Species	DBH (in)	Drip Rad.	CRZ (ft)	Vigor	Structure	Risk	Pres Value	Recommendations
343	Douglas fir <i>Pseudotsuga menziesii</i>	14.2	11.5	14.2	Fair to Good	Fair to Good	Low	Low	
Notes/ Defects	The asymmetrical crown is growing towards the parking area.

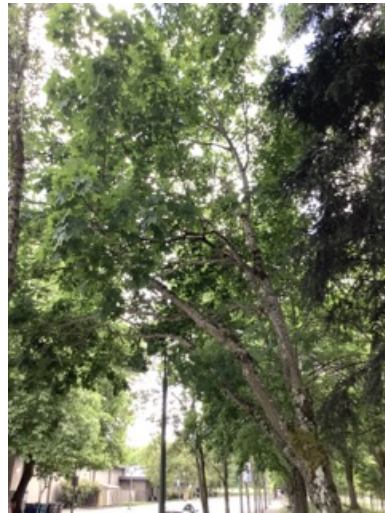
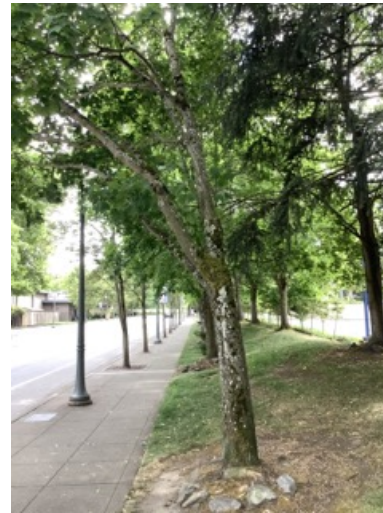
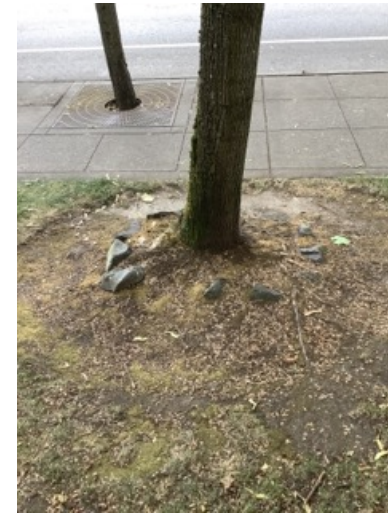
Tree	Species	DBH (in)	Drip Rad.	CRZ (ft)	Vigor	Structure	Risk	Pres Value	Recommendations
344	Norway maple <i>Acer platanoides</i>	10.3	10.0	10.3	Fair to Good	Fair	Low	Low	
Notes/ Defects	The crown has dense healthy foliage.

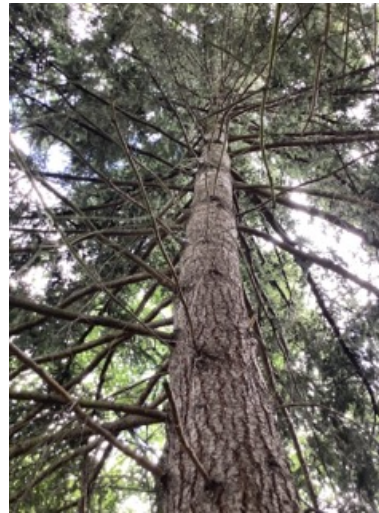
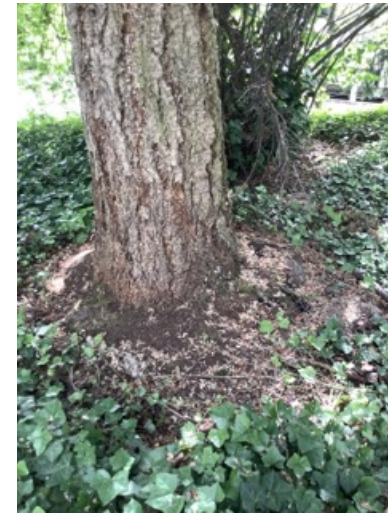
Tree	Species	DBH (in)	Drip Rad.	CRZ (ft)	Vigor	Structure	Risk	Pres Value	Recommendations
345	Douglas fir <i>Pseudotsuga menziesii</i>	20.5	14.0	20.5	Good	Good	Low	Medium	
Notes/ Defects	This is the largest tree in the group.

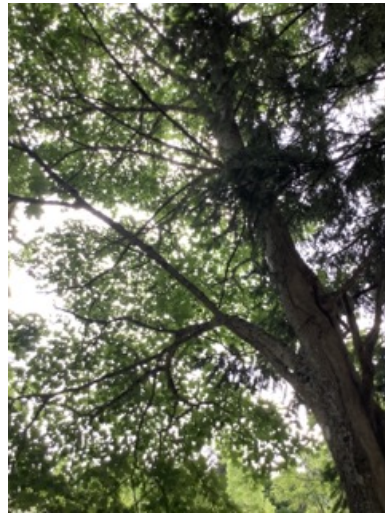
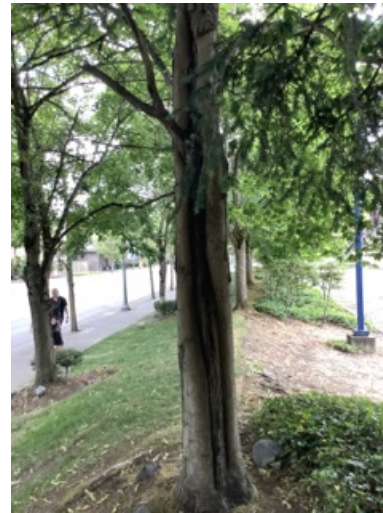
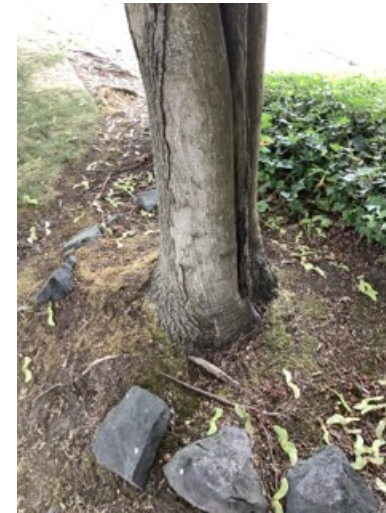
Tree	Species	DBH (in)	Drip Rad.	CRZ (ft)	Vigor	Structure	Risk	Pres Value	Recommendations
346	Norway maple <i>Acer platanoides</i>	11.0	14.0	11.0	Good	Poor to Fair	Low	Low	
Notes/ Defects	There is a large wound and dead wood in the trunk. The crown is asymmetrical towards the south.

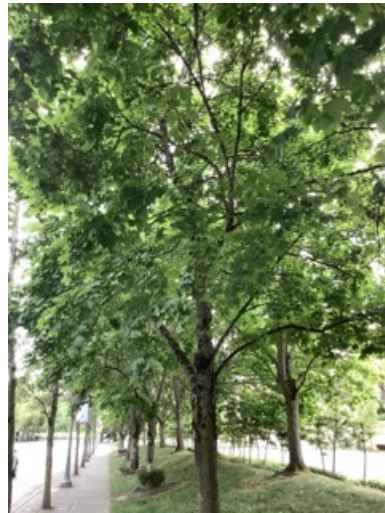
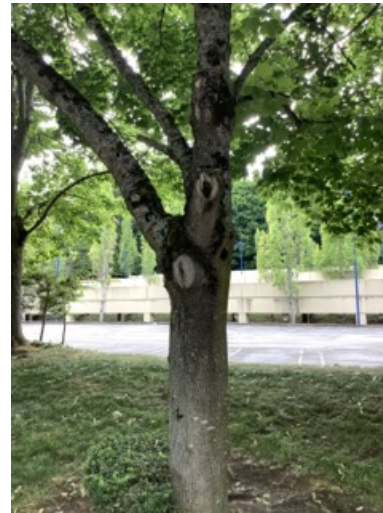
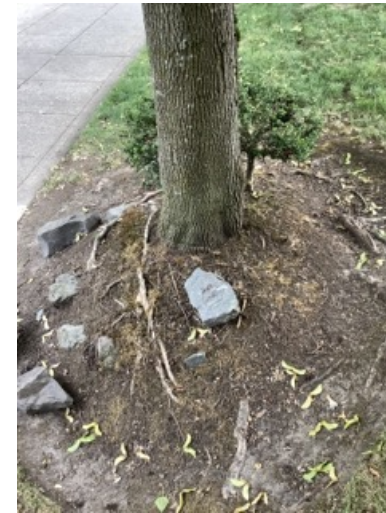
Tree	Species	DBH (in)	Drip Rad.	CRZ (ft)	Vigor	Structure	Risk	Pres Value	Recommendations
347	Norway maple <i>Acer platanoides</i>	12.0	12.0	12.0	Good	Good	Low	Low	
Notes/ Defects	There is some dieback in the crown but the foliage is healthy.

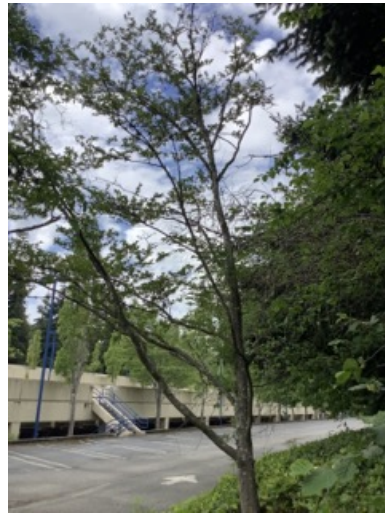
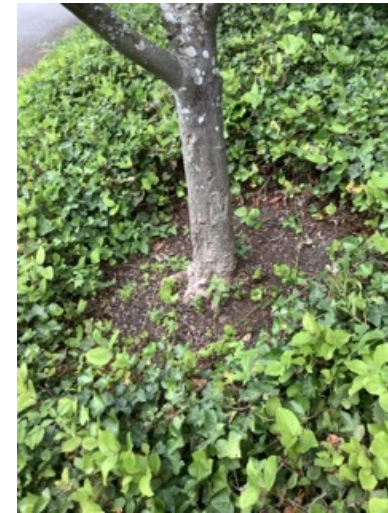
Tree	Species	DBH (in)	Drip Rad.	CRZ (ft)	Vigor	Structure	Risk	Pres Value	Recommendations
348	Japanese snowbell <i>Styrax japonicus</i>	4.3	8.0	4.3	Poor to Fair	Fair	Low	Low	
Notes/ Defects	There is dead wood in the main stem. The tree is in decline.

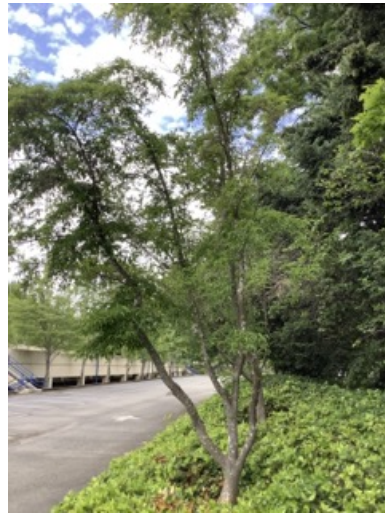
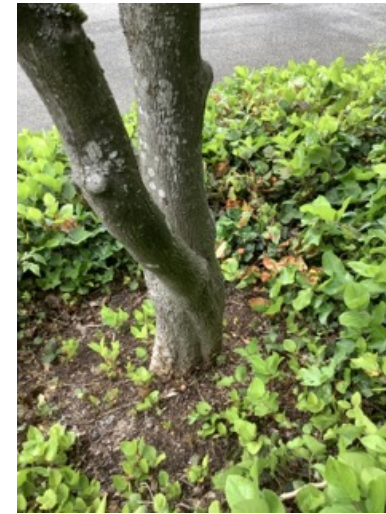
Tree	Species	DBH (in)	Drip Rad.	CRZ (ft)	Vigor	Structure	Risk	Pres Value	Recommendations
349	Japanese snowbell <i>Styrax japonicus</i>		4.0	6.5	Fair to Good	Fair to Good	Low	Low	
Notes/ Defects	The crown is thinning but the tree is still viable.

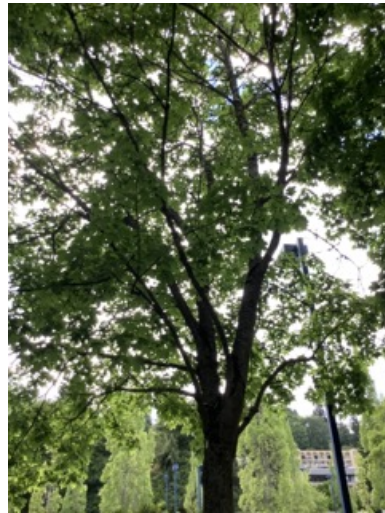
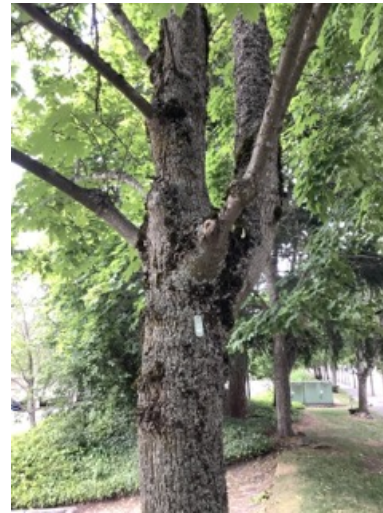
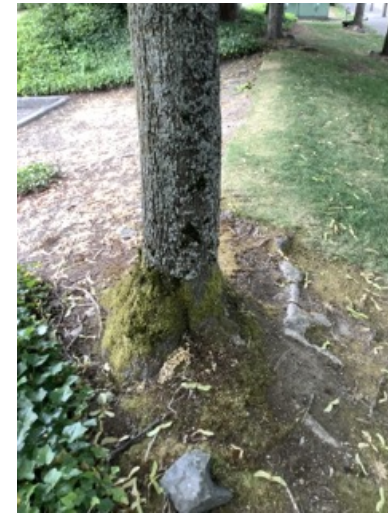
Tree	Species	DBH (in)	Drip Rad.	CRZ (ft)	Vigor	Structure	Risk	Pres Value	Recommendations
350	Norway maple <i>Acer platanoides</i>	10.9	10.0	10.9	Good	Good	Low	Low	
Notes/ Defects	The tree has a dense crown.

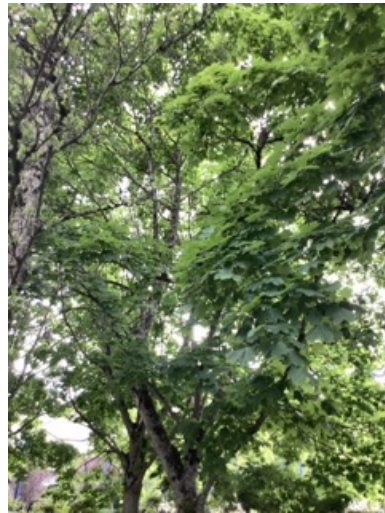
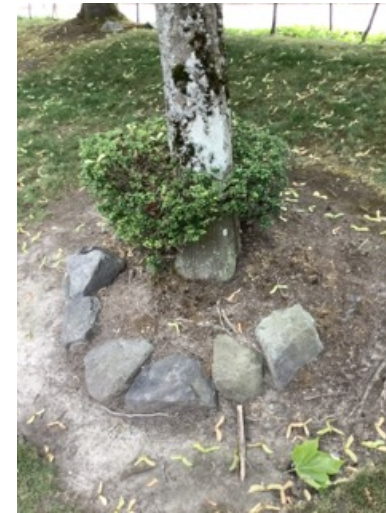
Tree	Species	DBH (in)	Drip Rad.	CRZ (ft)	Vigor	Structure	Risk	Pres Value	Recommendations
351	Norway maple <i>Acer platanoides</i>	9.1	10.0	9.1	Good	Good	Low	Low	
Notes/ Defects	The tree has a dense crown.

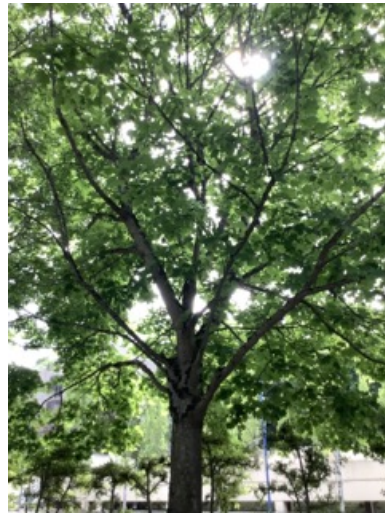
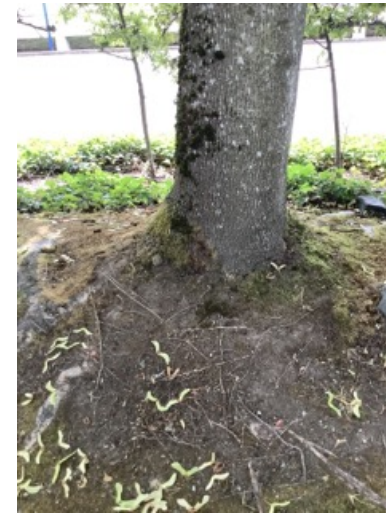
Tree	Species	DBH (in)	Drip Rad.	CRZ (ft)	Vigor	Structure	Risk	Pres Value	Recommendations
352	Norway maple <i>Acer platanoides</i>	13.2	10.0	13.2	Good	Good	Low	Medium	
Notes/ Defects	This is a healthy tree with a nice form.

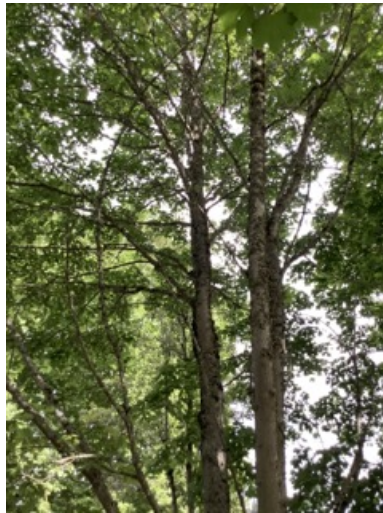
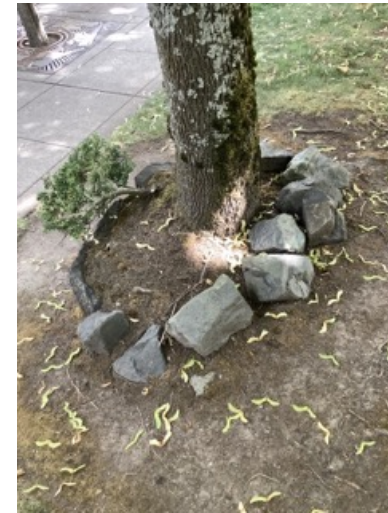
Tree	Species	DBH (in)	Drip Rad.	CRZ (ft)	Vigor	Structure	Risk	Pres Value	Recommendations
353	Norway maple <i>Acer platanoides</i>	12.6	10.0	12.6	Fair to Good	Good	Low	Medium	
Notes/ Defects	There is some minor dieback in the crown.

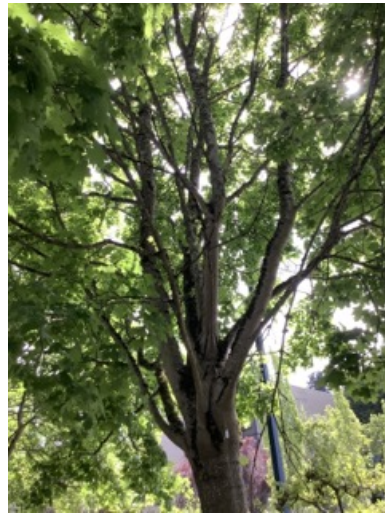
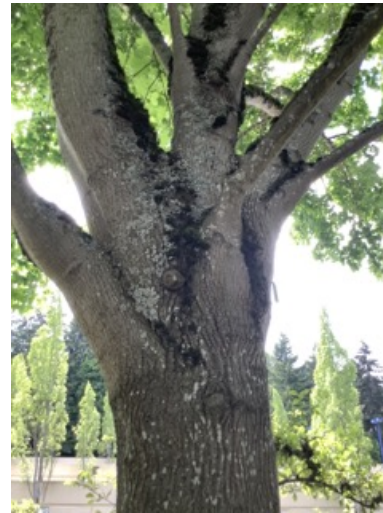
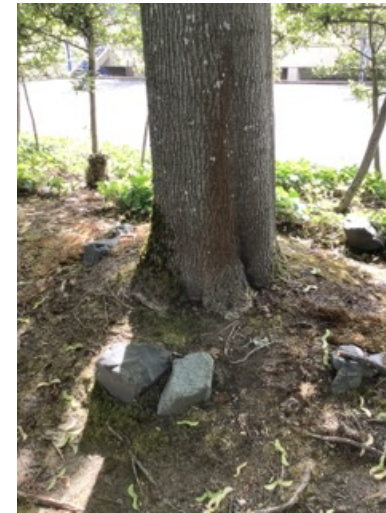
Tree	Species	DBH (in)	Drip Rad.	CRZ (ft)	Vigor	Structure	Risk	Pres Value	Recommendations
354	Norway maple <i>Acer platanoides</i>	15.5	10.0	15.5	Good	Good	Low	Medium	
Notes/ Defects	The tree has a large, healthy crown.

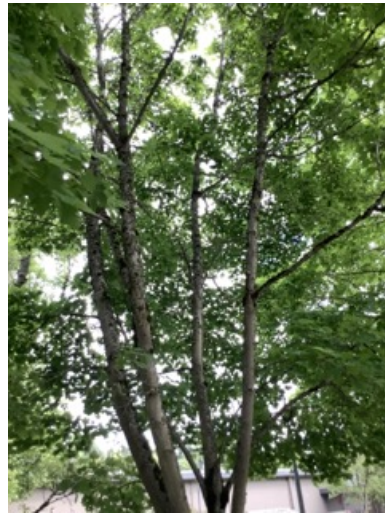
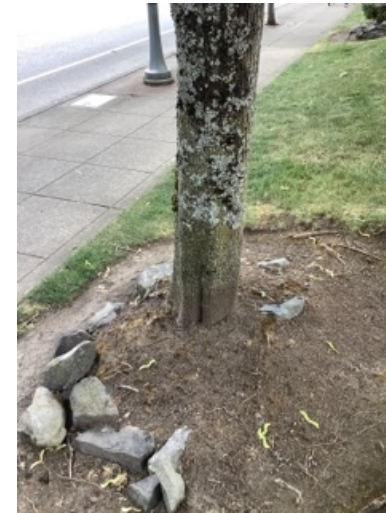
Tree	Species	DBH (in)	Drip Rad.	CRZ (ft)	Vigor	Structure	Risk	Pres Value	Recommendations
355	Norway maple <i>Acer platanoides</i>	10.2	10.0	10.2	Good	Good	Low	Medium	
Notes/ Defects	The crown is dense and healthy.

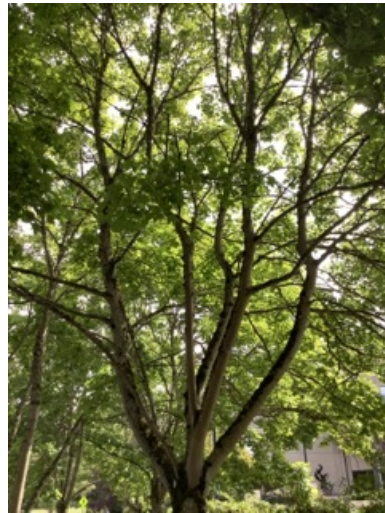
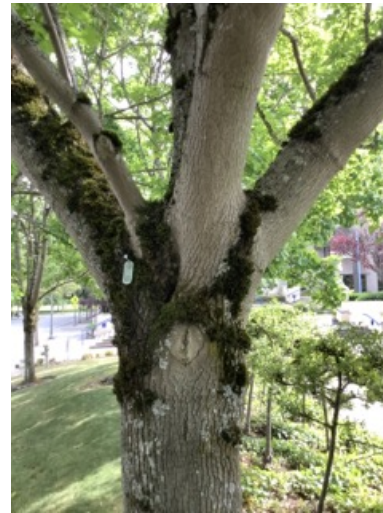
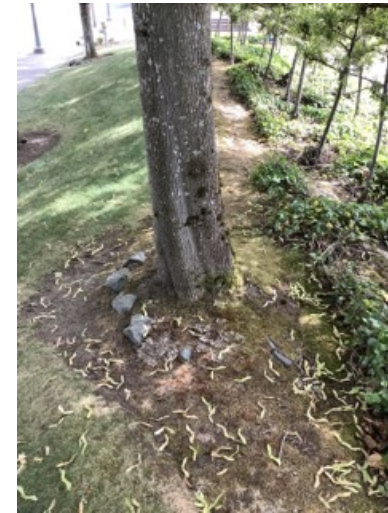
Tree	Species	DBH (in)	Drip Rad.	CRZ (ft)	Vigor	Structure	Risk	Pres Value	Recommendations
356	Norway maple <i>Acer platanoides</i>	13.1	10.0	13.1	Fair to Good	Good	Low	Low	
Notes/ Defects	There is some dieback in the crown.

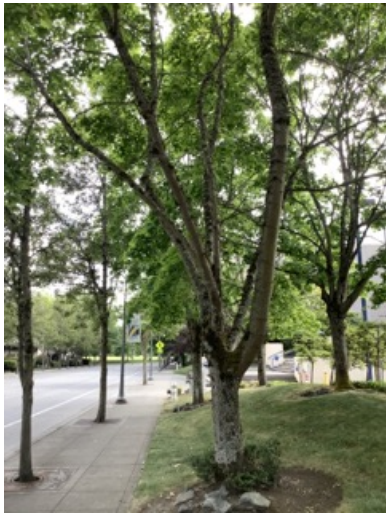
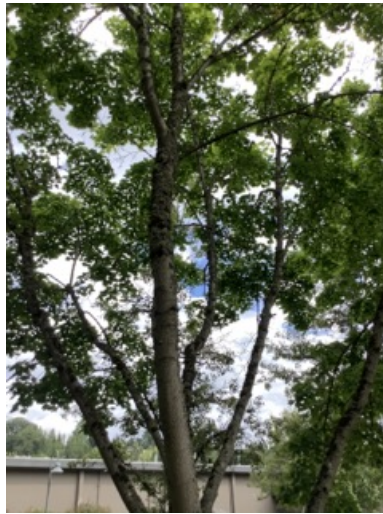
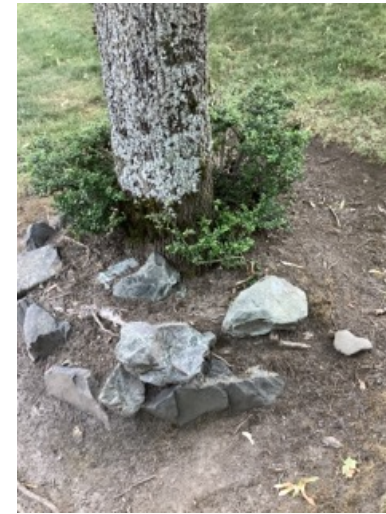
Tree	Species	DBH (in)	Drip Rad.	CRZ (ft)	Vigor	Structure	Risk	Pres Value	Recommendations
357	Norway maple <i>Acer platanoides</i>	13.1	10.0	13.1	Fair to Good	Good	Low	Low	
Notes/ Defects	There is some dieback in the crown.

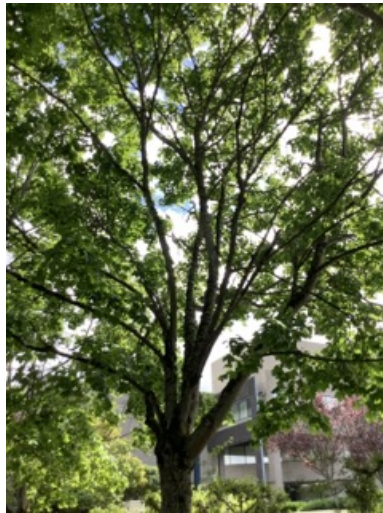
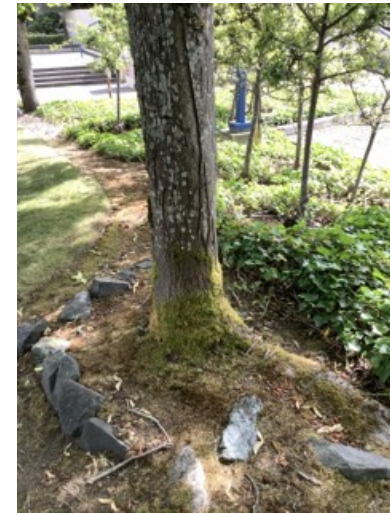
Tree	Species	DBH (in)	Drip Rad.	CRZ (ft)	Vigor	Structure	Risk	Pres Value	Recommendations
358	Norway maple <i>Acer platanoides</i>	11.6	10.0	11.6	Fair to Good	Good	Low	Low	
Notes/ Defects	There is some dieback in the crown.
