**Title: 3003 77th Ave Project – Mercer South Park Project
Full Tree Inventory and Health Assessment
Level 2 Basic Tree Risk Assessment
3003 77th Ave SE
Mercer Island, Washington**

Date: July 15, 2020; updated July 24, 2020

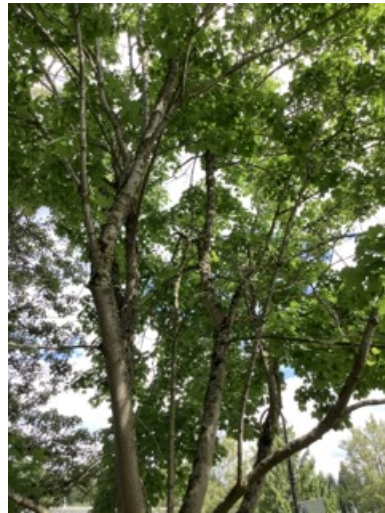
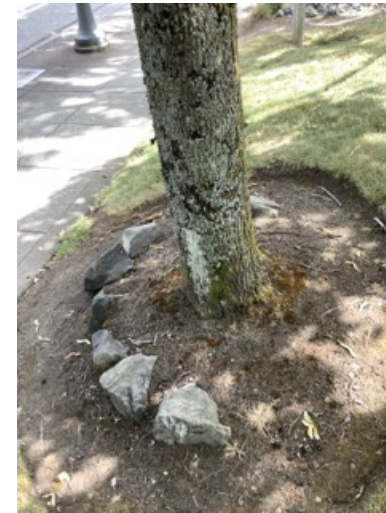
Tree	Species	DBH (in)	Drip Rad.	CRZ (ft)	Vigor	Structure	Risk	Pres Value	Recommendations
359	Norway maple <i>Acer platanoides</i>	12.0	10.0	12.0	Fair to Good	Good	Low	Low	
Notes/ Defects	There is some dieback in the crown.

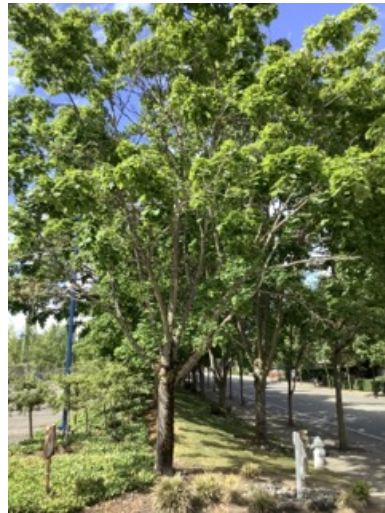
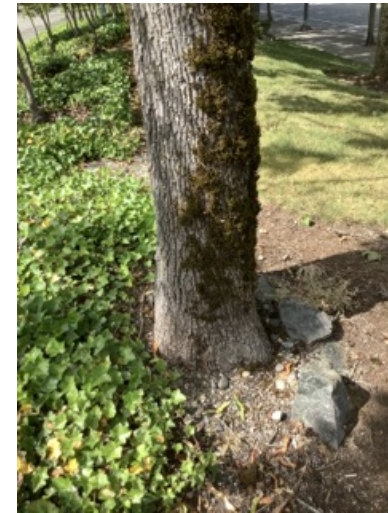
Tree	Species	DBH (in)	Drip Rad.	CRZ (ft)	Vigor	Structure	Risk	Pres Value	Recommendations
360	Norway maple <i>Acer platanoides</i>	12.2	10.0	12.2	Fair	Good	Low	Low	
Notes/ Defects	The crown has lots of dieback and the foliage is thinning overall.
