ARBORIST NOTES

SUBJECT: Capital Improvement Project
PS 25 Tree Evaluation
4266 E. Mercer Way

DATE: March 13, 2024

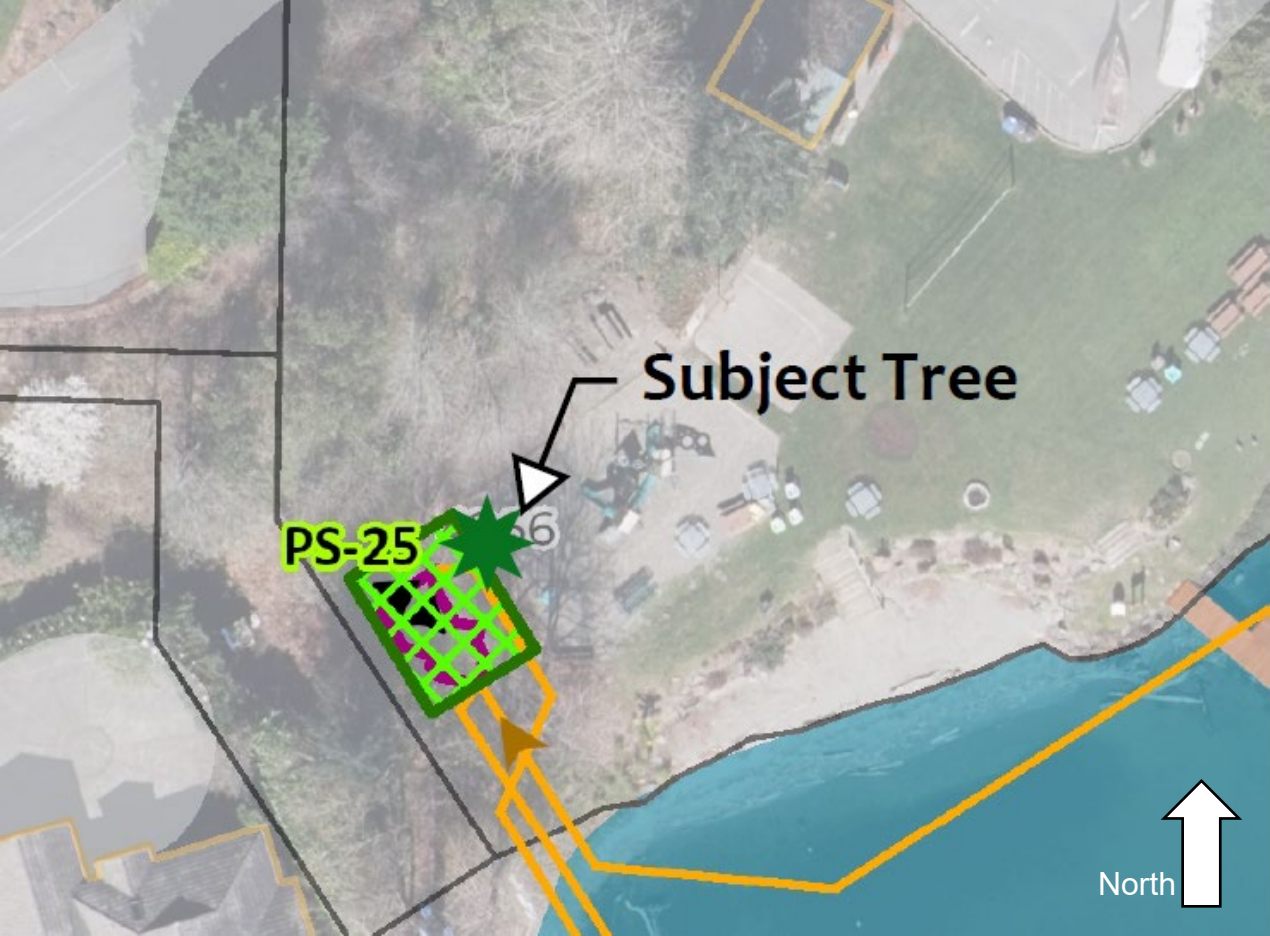
The tree was growing 2.5 feet northeast of the edge of the concrete lid (Photo 2). I saw at least one root about 3 inches in diameter over the top of the lid. The southern half of the tree's crown was overhanging the lid (Photo 1).

I do not expect tree #171 to survive the root and crown pruning required for the improvements. Even if it did survive, the crown would be weighted to the northeast and there would be fewer structural roots supporting the side opposite the asymmetrical crown. There was a parking area northeast of the tree and a children's play area on east of the tree that was within striking range if the tree failed.

Photo 1. The red maple next to PS 25 has about half its crown overhanging the concrete lid (yellow outline) that will be lifted by an overhead crown. The viewer is looking northwest.

Given the lower survival and increased likelihood of failure after construction, I recommend removing the red maple.
