**Project:** Pre-construction assessment for lot re-development at 4001 W Mercer Way, Mercer Island, WA. Parcel number 3623500365.

**Objectives:** Evaluate health of existing trees and establish criteria for the preservation of those to be retained.

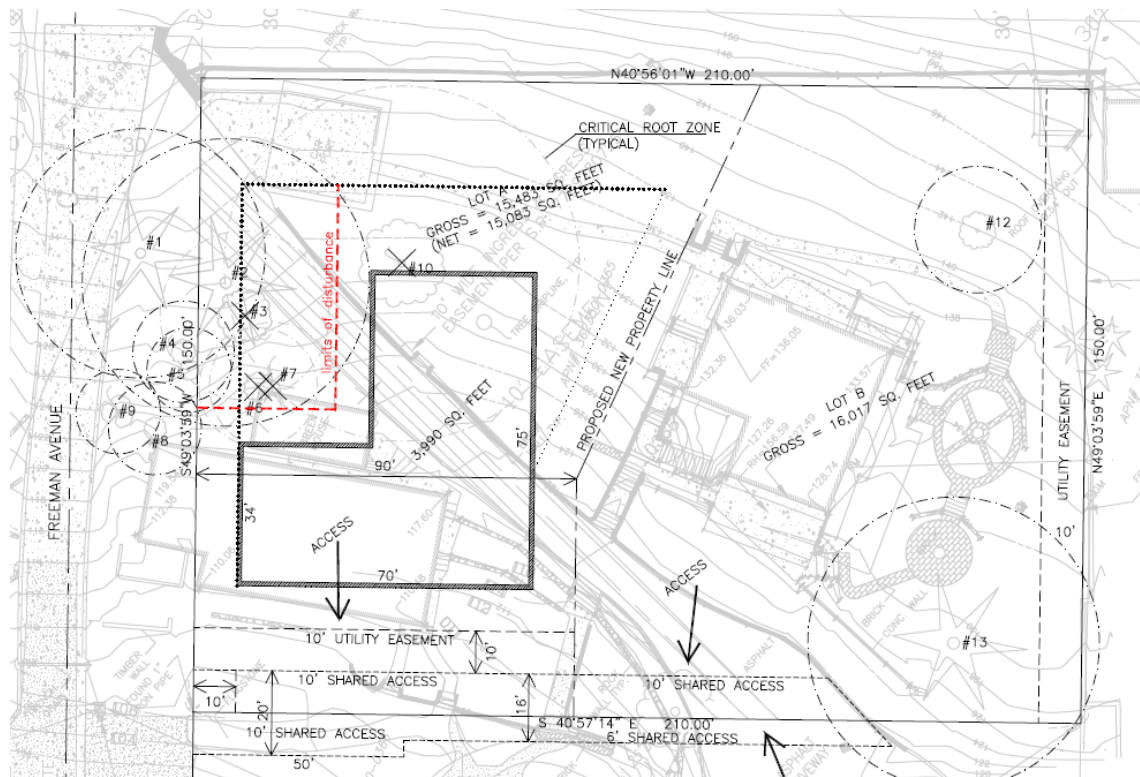
Figure 20. Excerpt from the proposed plan set showing the new property layout.

**Construction Impact Analysis:** The owners have generated a short plat which retains the existing house on Lot B and crafts a space for a new home on Lot A (Figure 20). In this scenario the existing driveway and carport will be removed along with the garden shed. A fairly deep excavation will have to be made to create a building pad. The new house will likely be built into the existing slope with tall concrete walls formed out for the lower story. A full 10' of space around the perimeter of the house location will have to be accounted for to allow safe building space for forms and retention walls.
