From: Frank Close <fclose@guardiansecurity.com>
Sent: Tuesday, June 1, 2021 10:10 AM
To: Lauren Anderson
Subject: Freeman subdivision parking & Right of way Issues:
Attachments: Freeman Subdivision Parking 6-1-2021.pdf

From: Frank Close <fclose@guardiansecurity.com>
Sent: Tuesday, June 1, 2021 10:08 AM
To: Lauren Anderson
Subject: Freeman subdivision 4001 West Mercer way
Attachments: Freeman Subdivision drainage 6-1-2021-2021.pdf; Freeman subdivisioin arborist report iTree Letter (Mercer Island) (2).pdf

Environmental Degradation and Water Damage Pose Severe Slide Risk

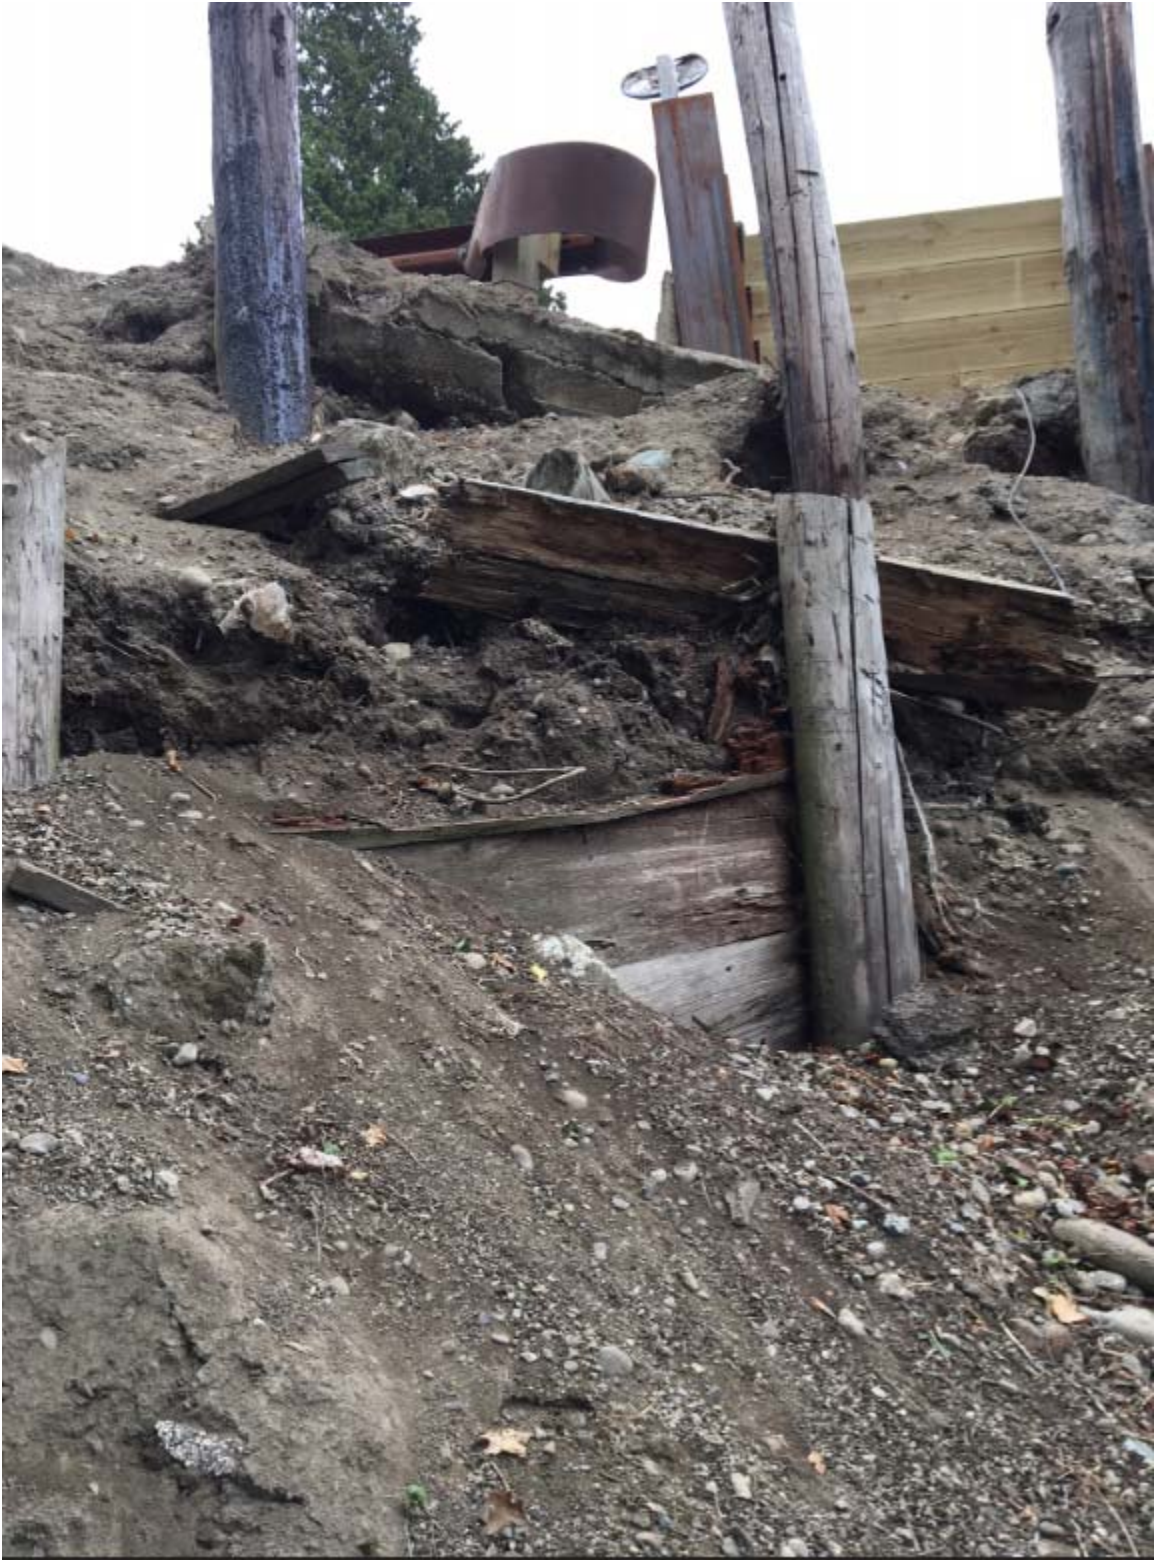
Figure 3 Next up is te slide south of the city waterpipe and

3. The property 3887 West Mercer way at the top of the stairs a huge slide during our rain of 1.7” in 24 hours or so. This took all of the top soil and it took a section of clay and sent it down the hillside in a steam of mud. [Figure 3]

Here is the same area.

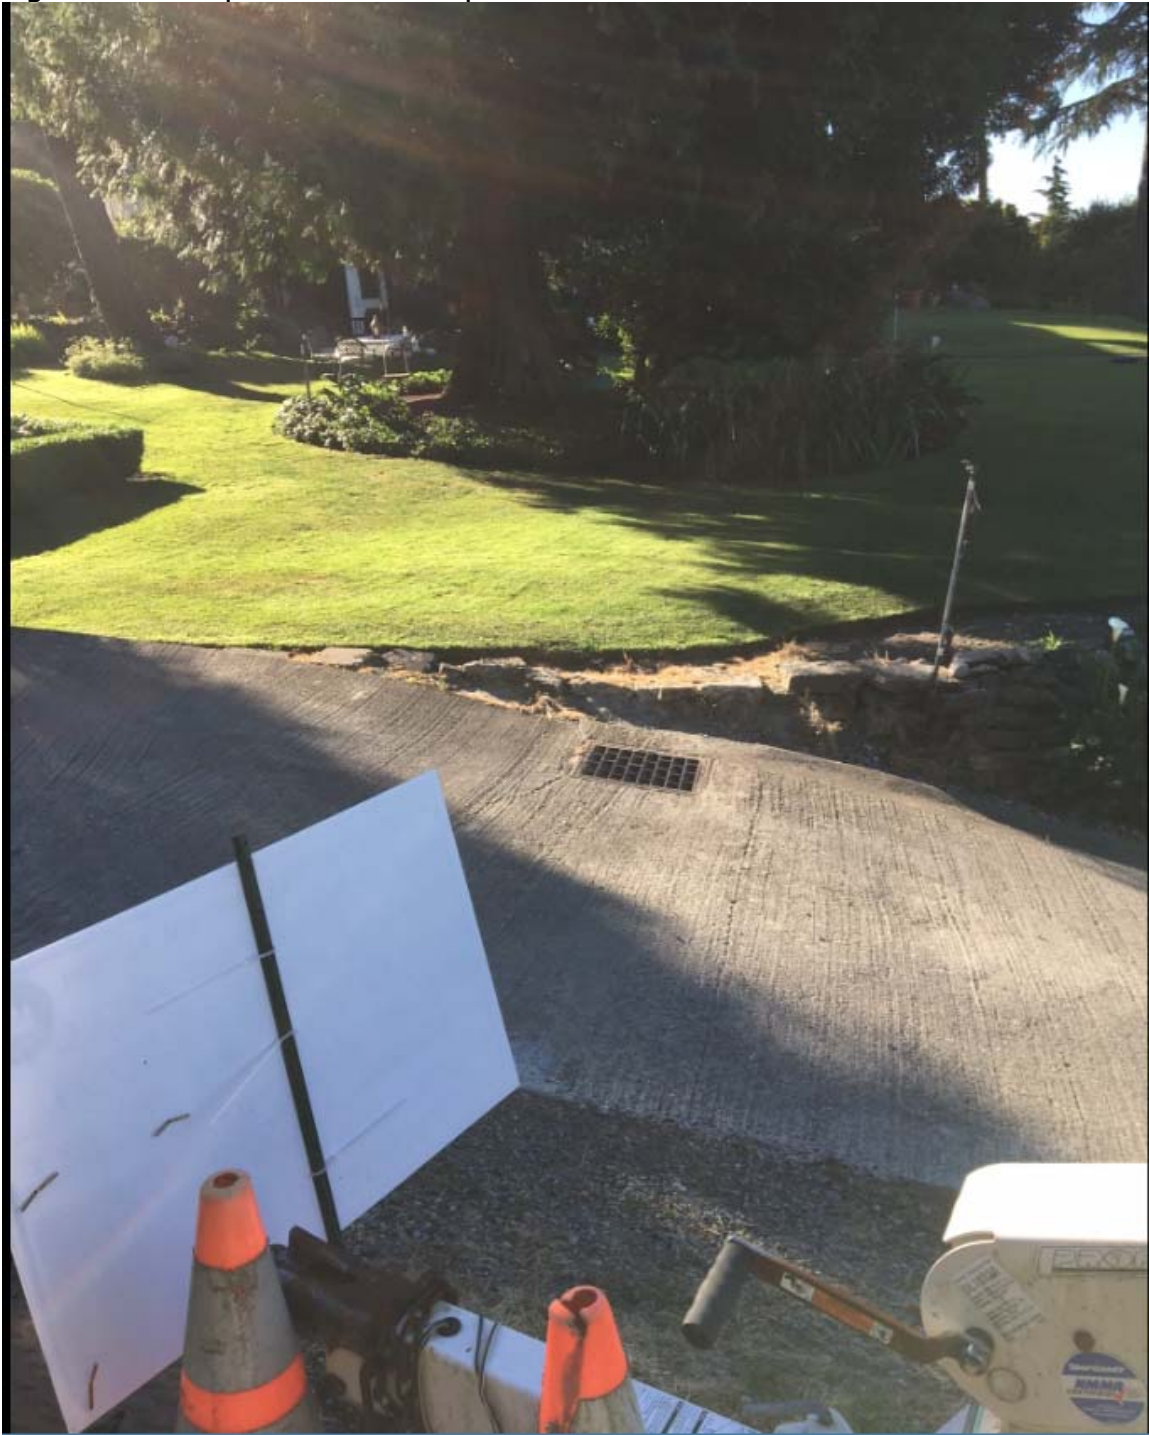
Figure 6

4. Additionally Mr Close has a 5-6’ crowbar and he has dropped it in several spots on the property and without pushing it down it sank down more than 2’ in several spots, critically one was the property line adjacent the city soldier pile 6 or about 6.2, [Figure 6,7]

5. The second areas of excessive water is just on the border of the property that was the city privatization, just next to the existing fence on the North side of the fence, it was never this wet before and it is now. Again, just above the concrete blocks is another area that is now wet and was never wet before. [Figure 6,7]

Here is a crowbar test. . You take a 5' crowbar and drop it at the ground and see where it settles in.

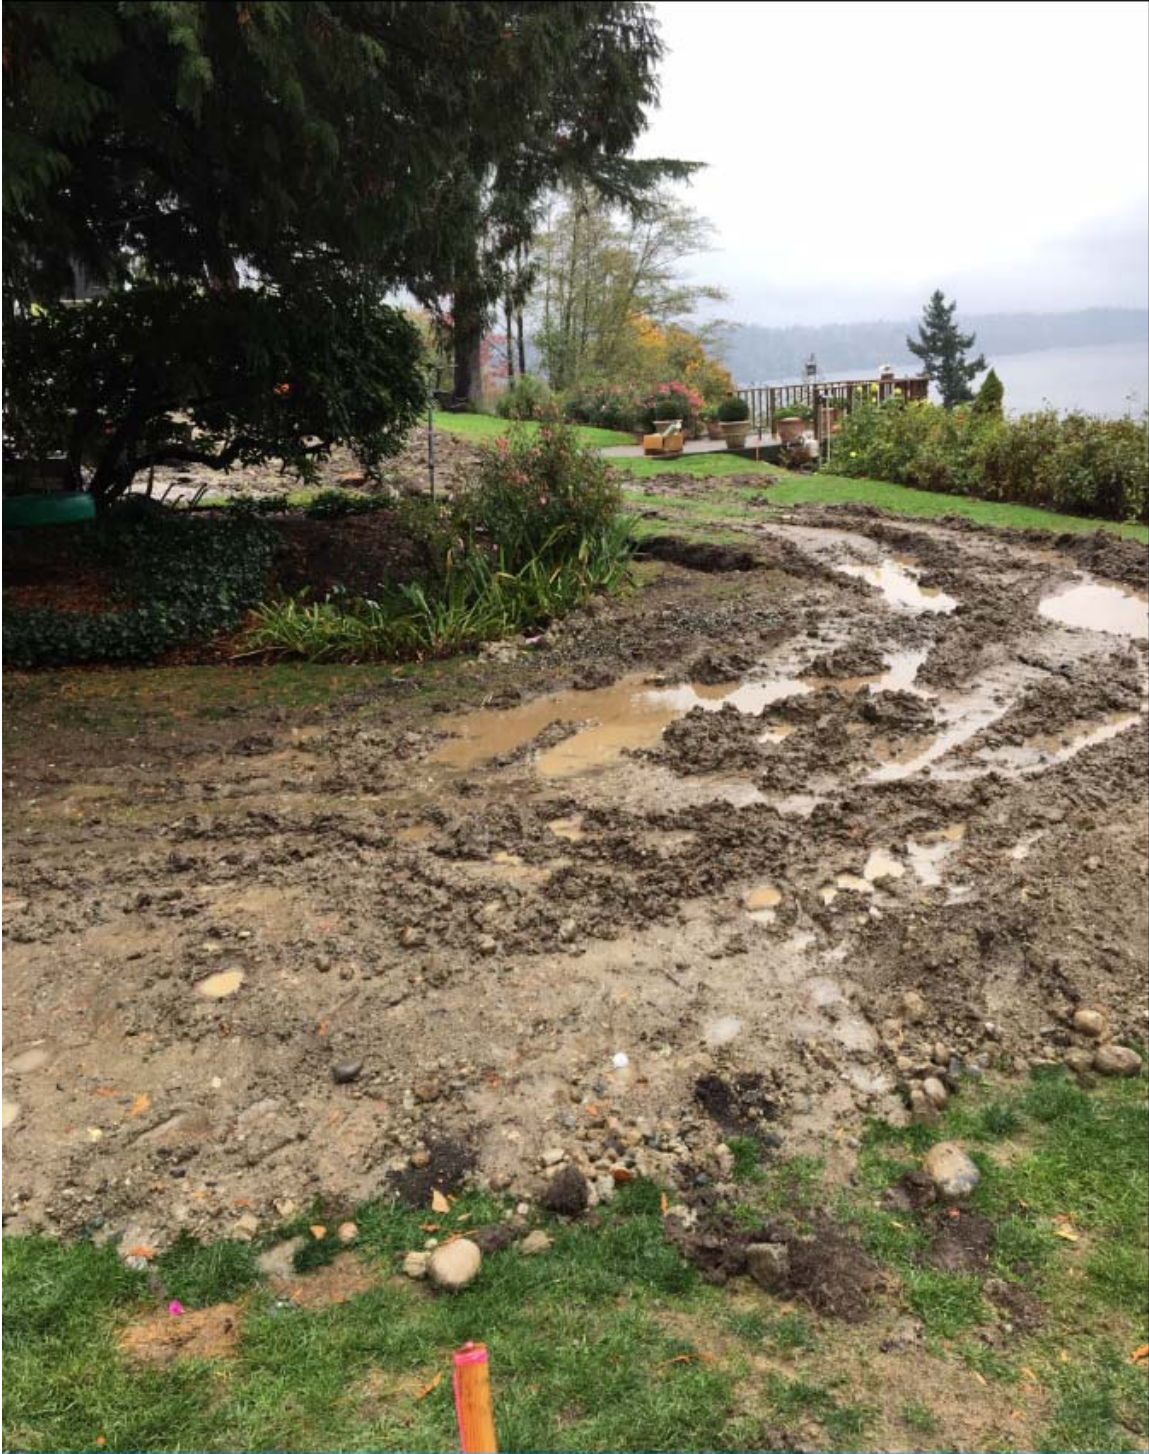
Figure 7

Here is the picture on the property line. It drops about 2.5' on the property border.

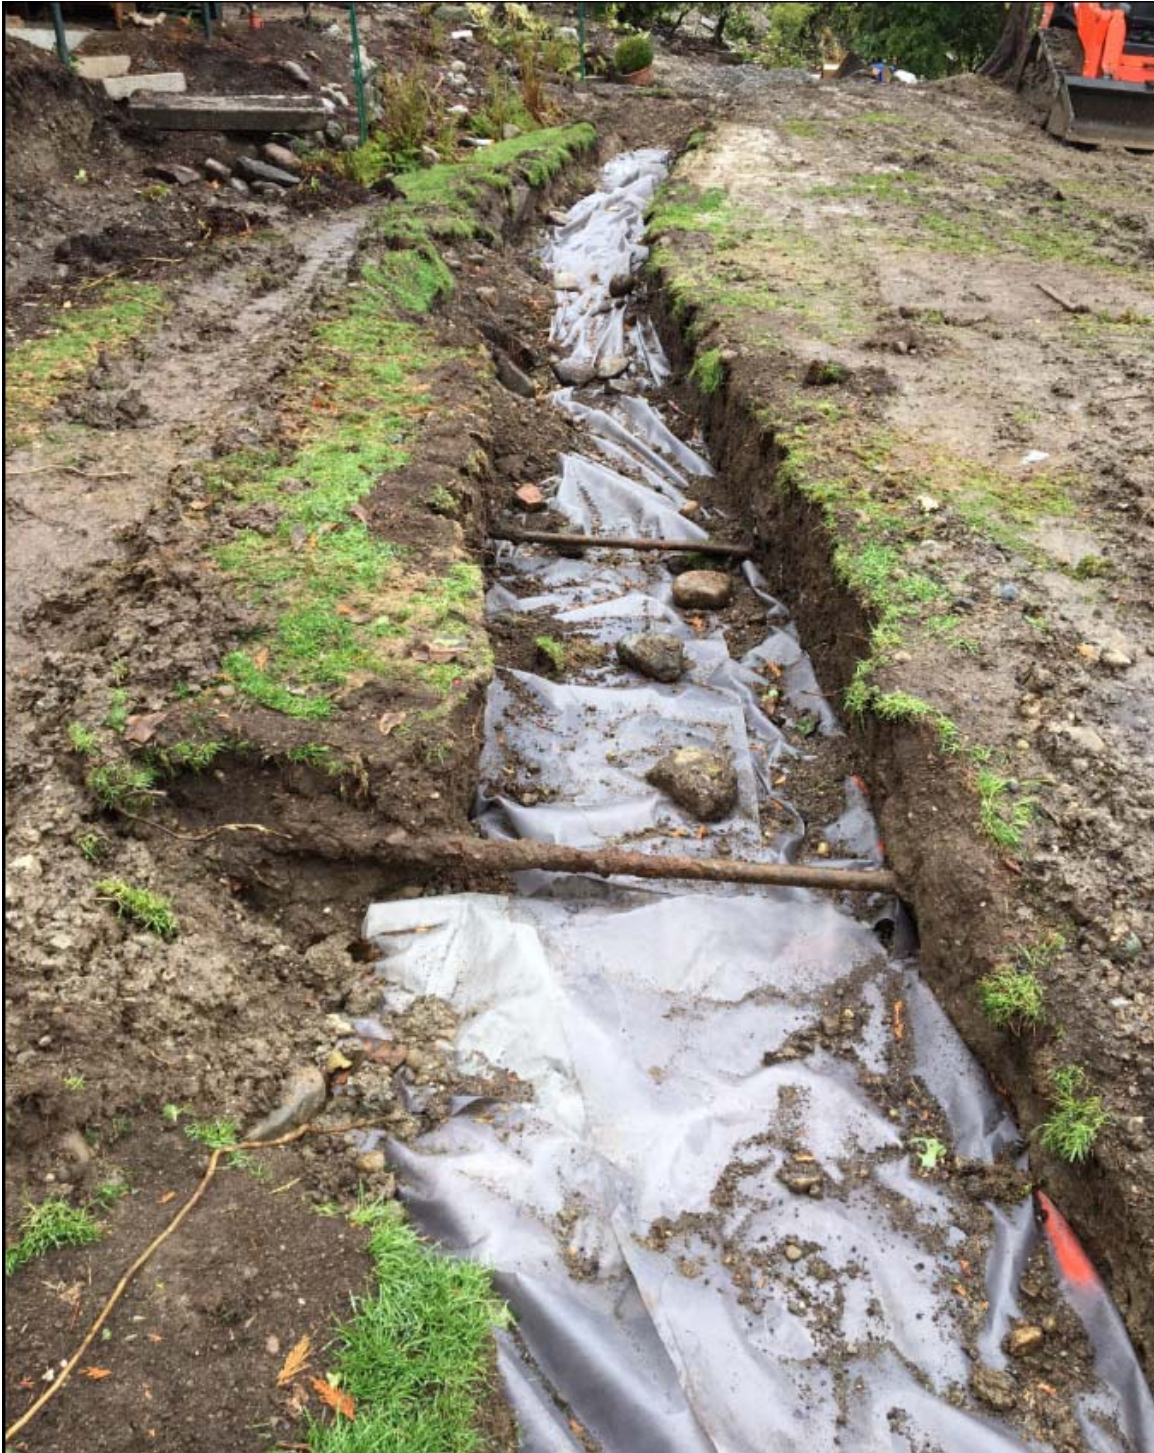
Figure 10 shows during construction

See the work in figure 12 that is done and note the heavy equipment in and around the city tree. Note the trench below and it's width.

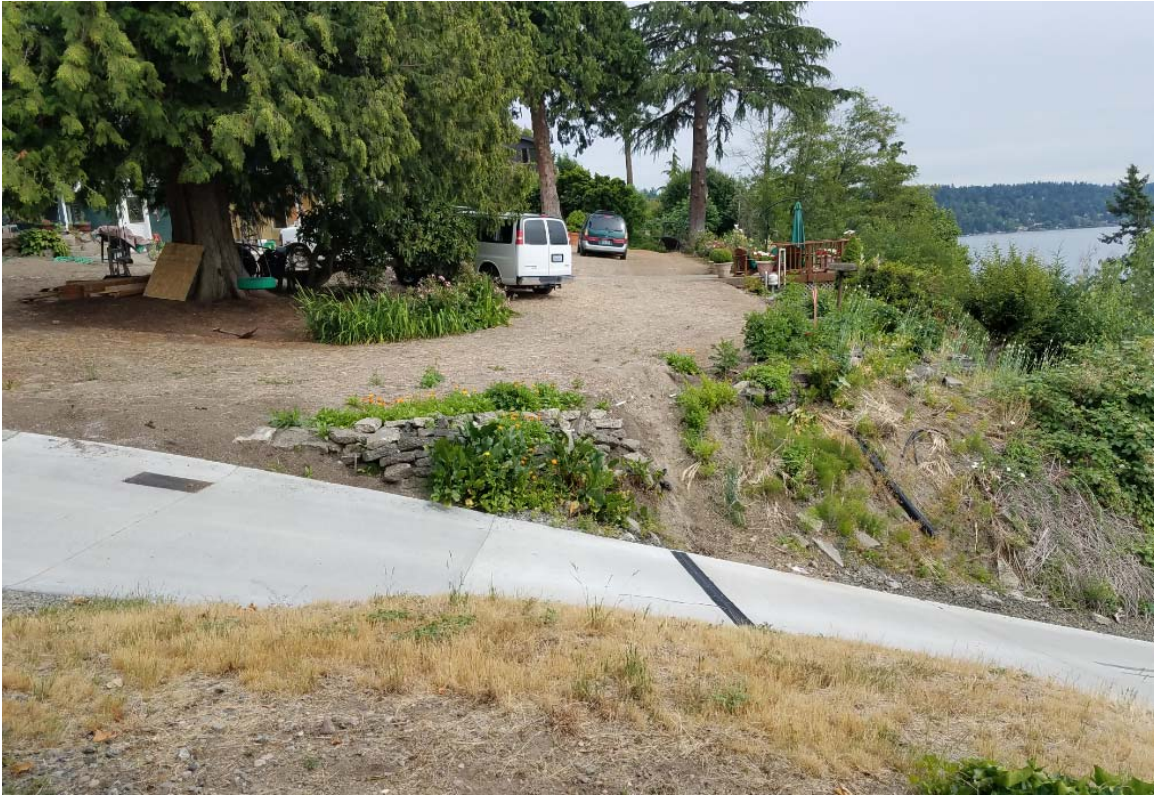
Figure 14

The drainage project and construction was done without a permit. I am concerned that it was done improperly and will lead to degradation and slide on my property.

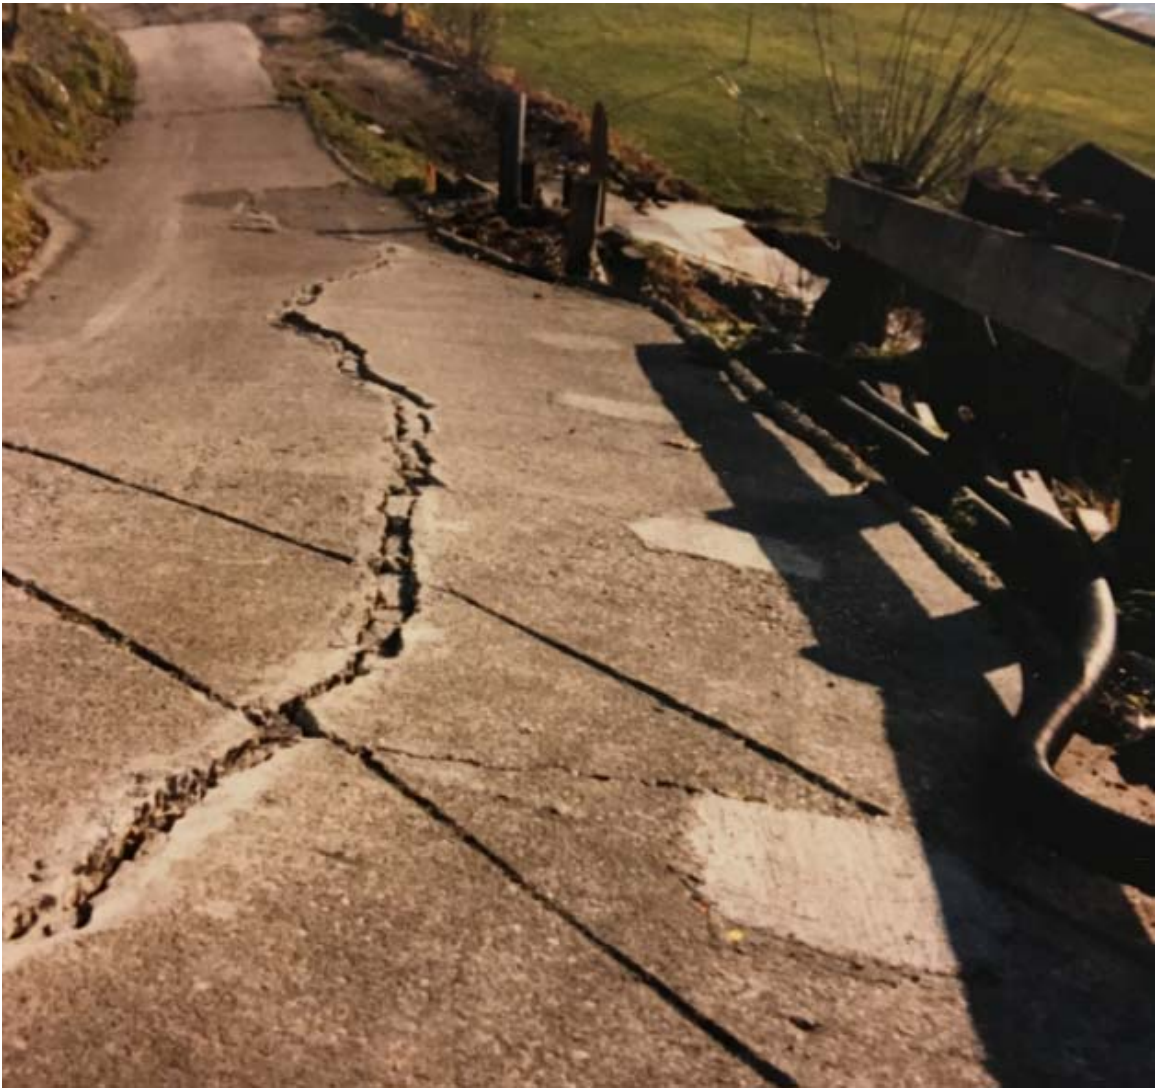
Here is a picture of the old Freeman road

Eventually this road was deemed unsafe by the City and closed to Michael Gladstein's use.

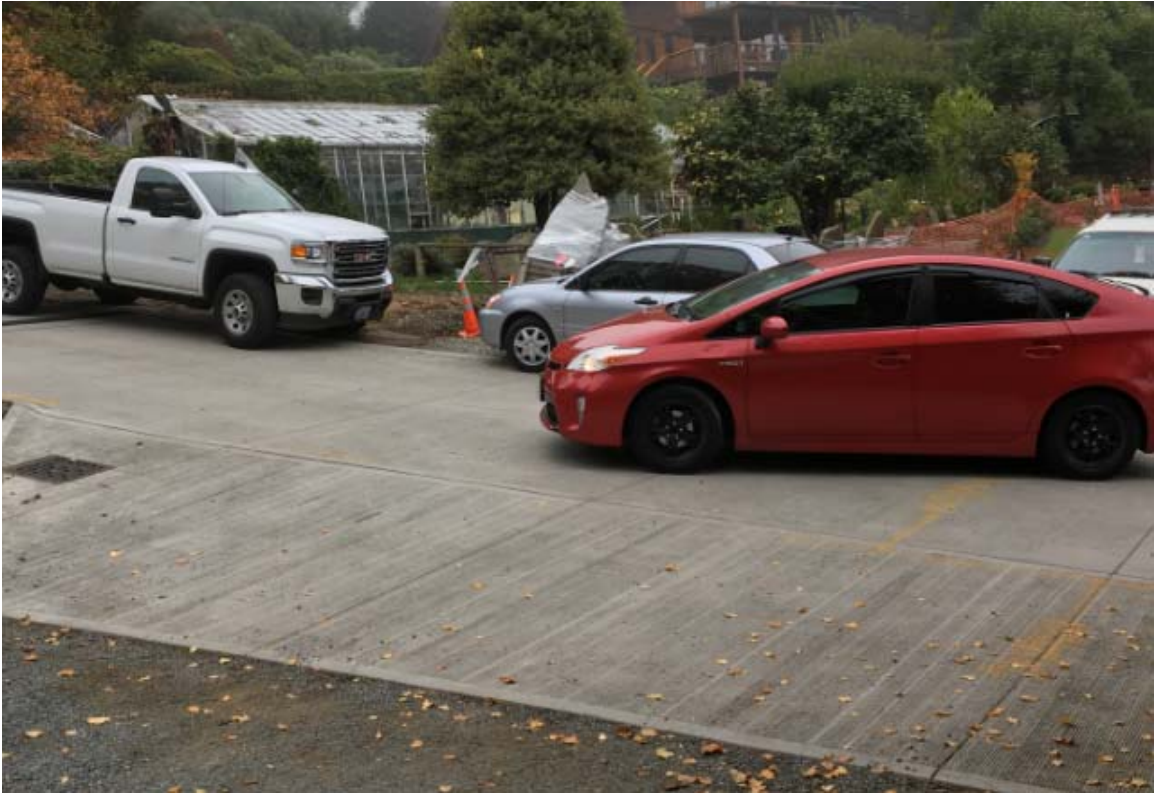
Here is an example of the situation.
