October 3, 2023

Site: 4719 86th Ave SE SP
Mercer Island, WA 98040
TPN: 7598100420
Area: 28,644 sq ft. = .66 acres

Re: Results of air-vac-ing the soil at the CRZ of trees 233, 234, 249, 253, 254

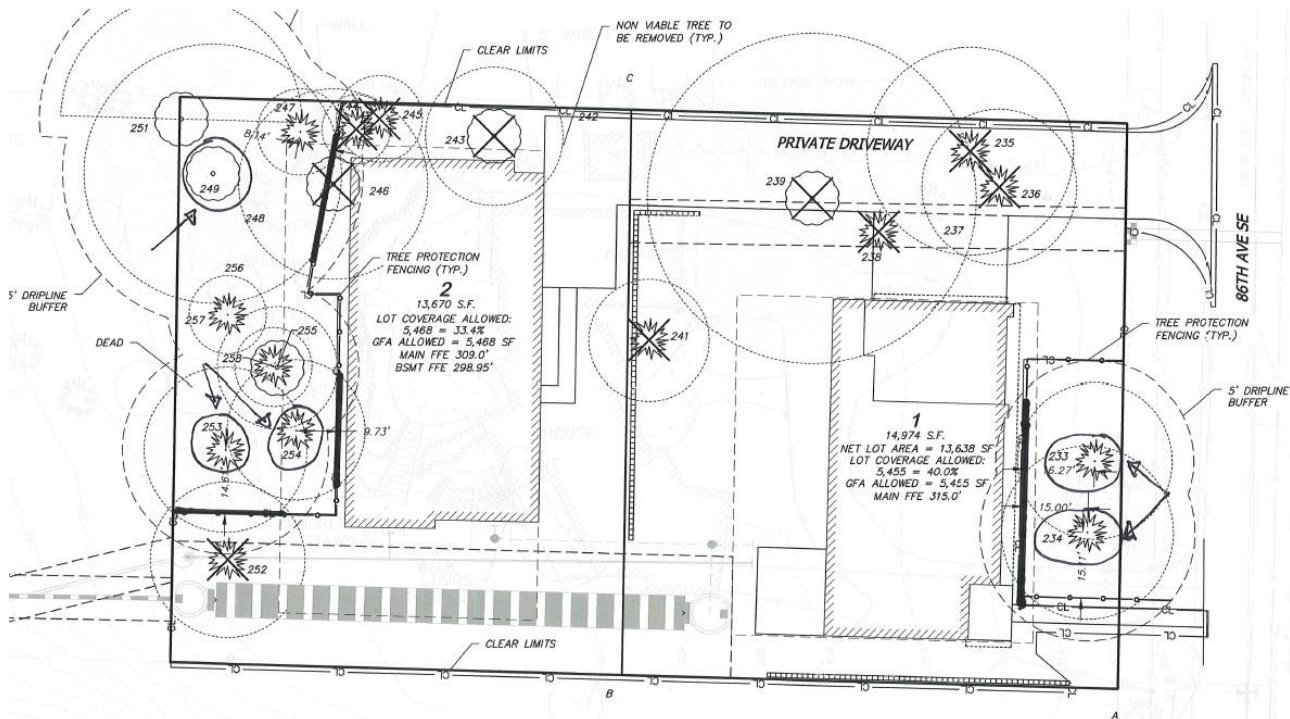
On September 19th, 2023, a team from Root Causes, LLC, exposed the roots of five (5) trees, numbered 233, 234, 249, 253, and 254. The work was completed from the edges of the driplines of each retained tree, to the depth of the proposed excavation as indicated with the dark lines on the exhibit below:
