8215 SE 78th Street

Arborist Report

September 18, 2020

Tom Early, Otak, Inc.
tom.early@otak.com
206-250-8821
Project No. 33331

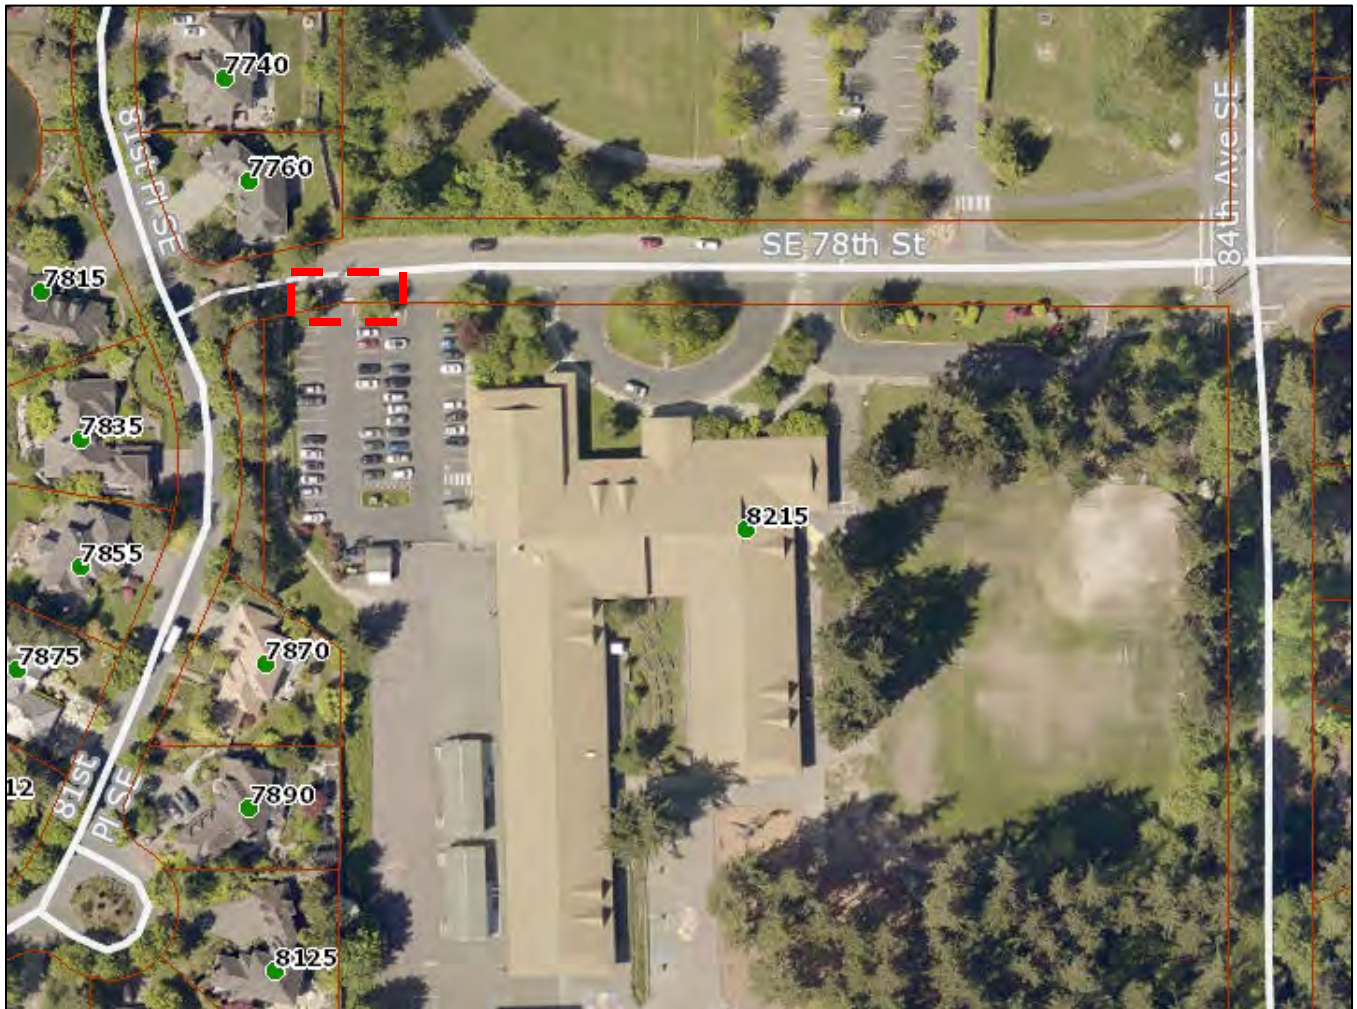
Project Area with four subject trees outlined with red dashed rectangle, Lakeridge Elementary School is southeast of project site; King County Parcel Viewer aerial image
