EVALUATION OF TREES AT

**4825 East Mercer Way
Mercer Island, WA 98040**

September 19, 2017

Brian K. Gilles, Consulting Arborist

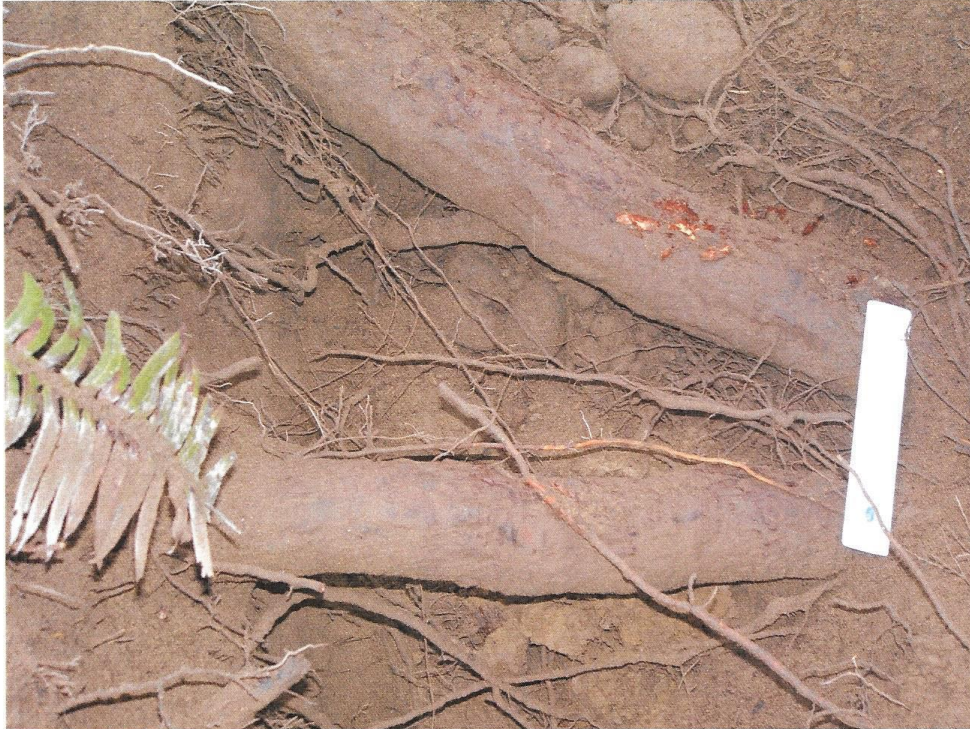
The two intertwined roots on the western end of the wall area are approximately 4 inches and 3 inches in diameter, respectively. The roots are located approximately one foot below the surface (see photo 1) Immediately south of the trench, the roots push toward the surface, requiring that these roots will need to be cut in order to construct the proposed driveway improvements.

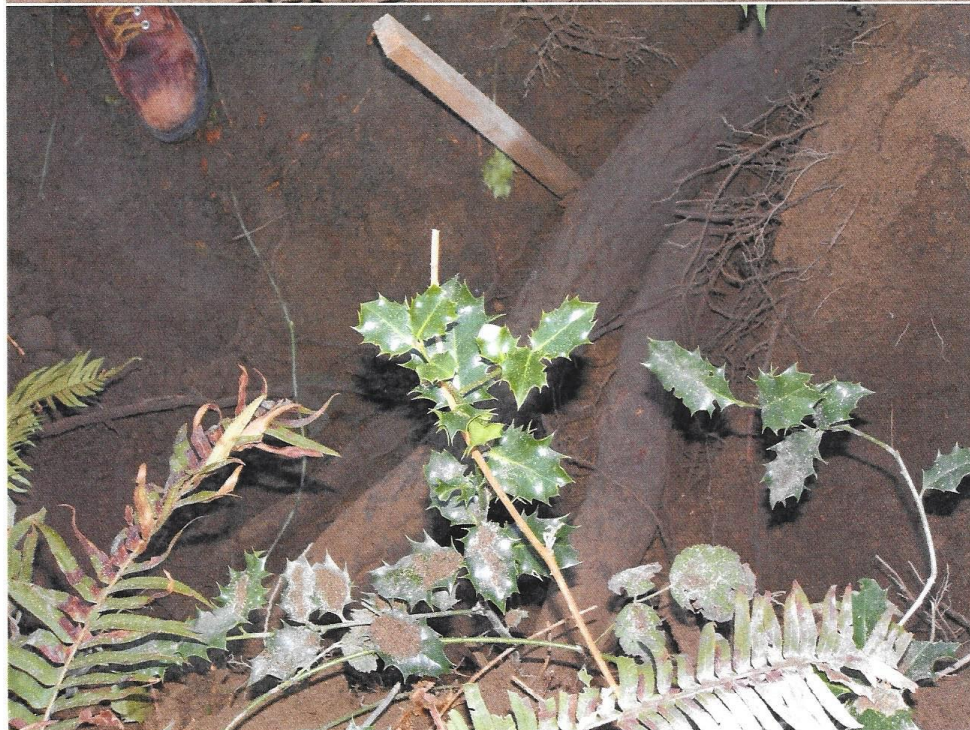
The third root, located on the eastern end of the trench, is approximately 3 inches in diameter. This root is approximately 24 inches deep, but is located at the deepest point of the proposed driveway excavation (see photo 2). As a result, this root will also need to be cut for the excavation for the proposed driveway.

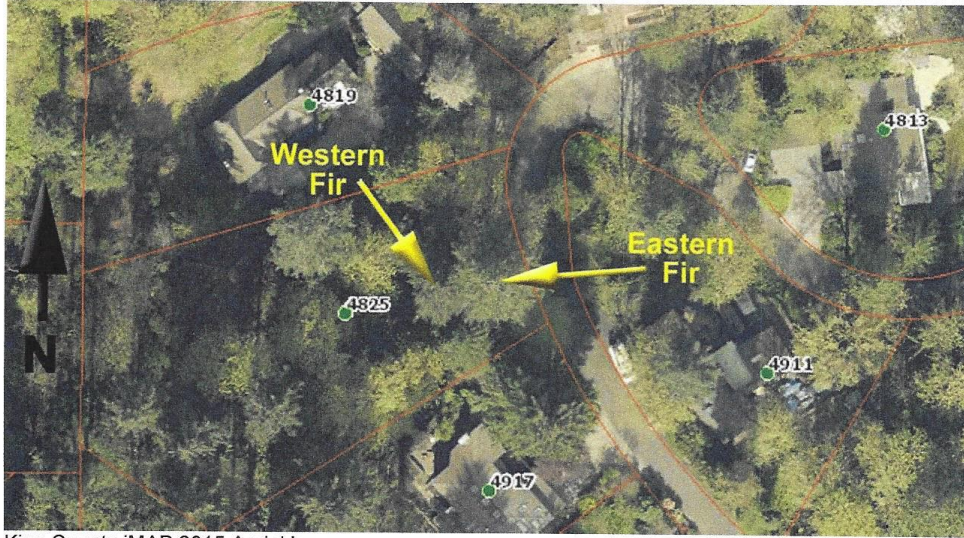
Figure-1

The evaluation identified two mature Douglas fir (*Pseudotsuga menziesii*) (Figure-1). A prior inspection identified locations south of the trunk with significant Douglas fir roots, but information regarding internal trunk wood structure is unknown.

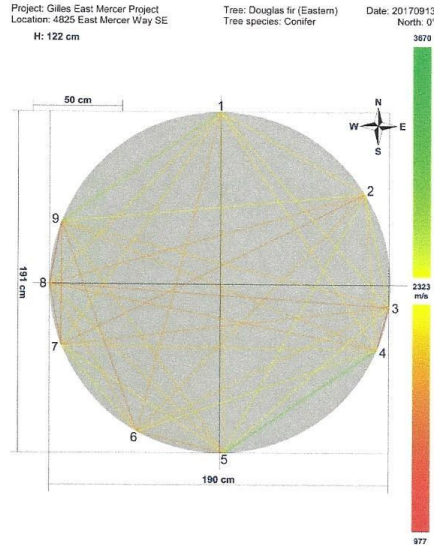
Figure-2A

Nine sensors were placed on eastern fir trunk wood and travel times were recorded with eight impacts or strikes on each sensor (Figure-2A).

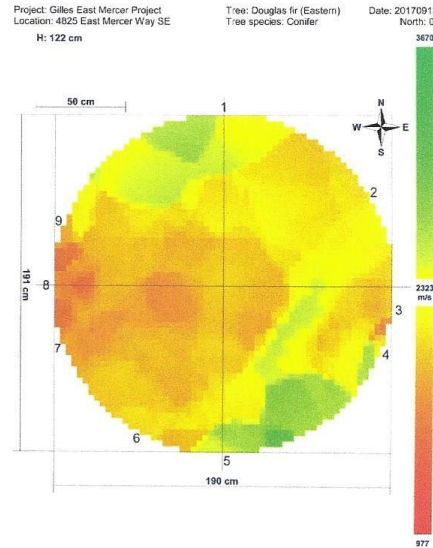
Test results are provided in Figure-2B (Figure-2B) and indicate

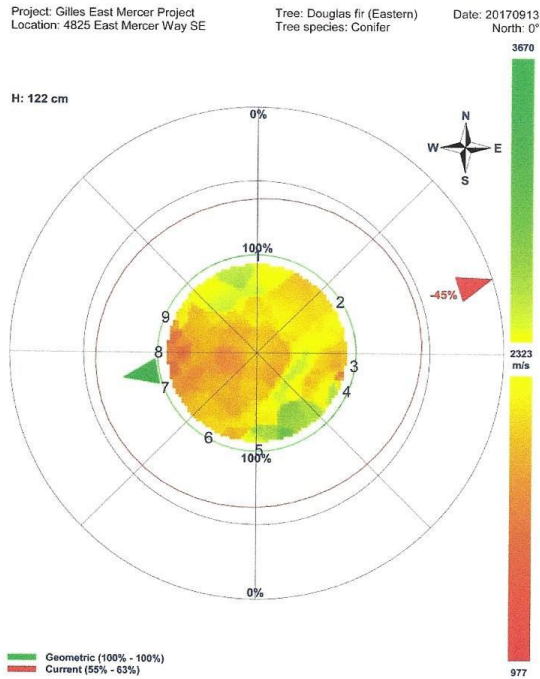
While some strength is lost is present, if forces are applied from the southwest, the tree retains between 55 and 63-percent of structural strength based on Figure-2C (Figure-2C).

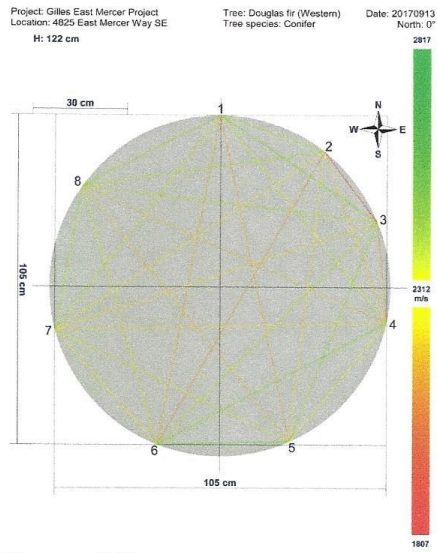
Figure-3A

Eight sensors were placed on western fir trunk wood and travel times were recorded with eight impacts or strikes on each sensor (Figure-3A).

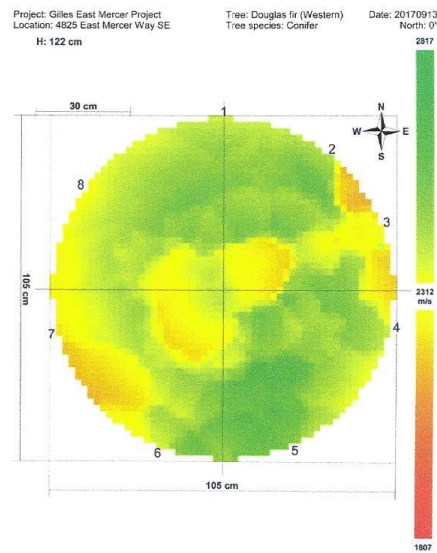
Test results are provided in Figure-3B (Figure-3B) and indicate

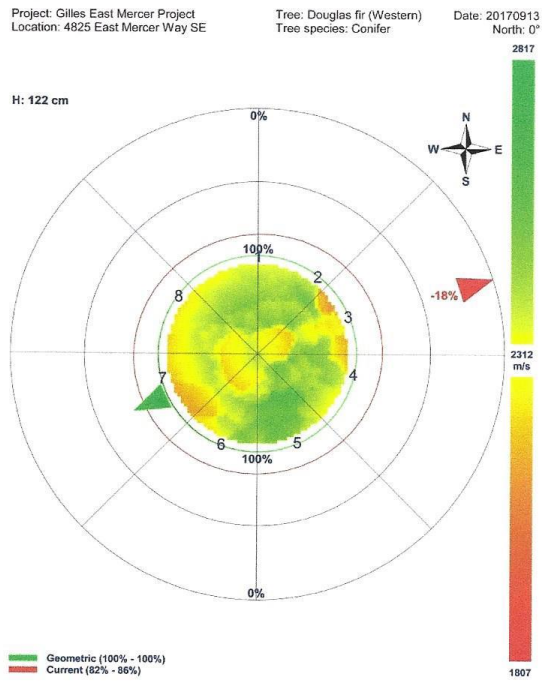
While some strength is lost if forces are applied from the southwest, the tree retains between 82 and 86-percent of structural strength based on Figure-3C (Figure-3C).

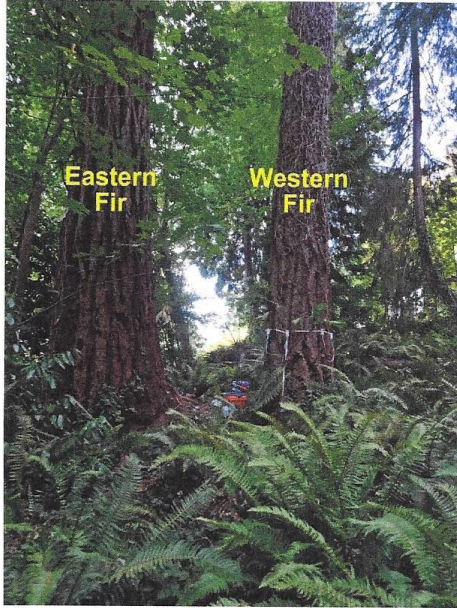
Photo-1

Trunks of the eastern and western Douglas firs are in close proximity at root crown level (Photo-1). Since the trees are identical species and no signs of disturbance were noted at grade level, roots connections below grade are likely

Viewed From North

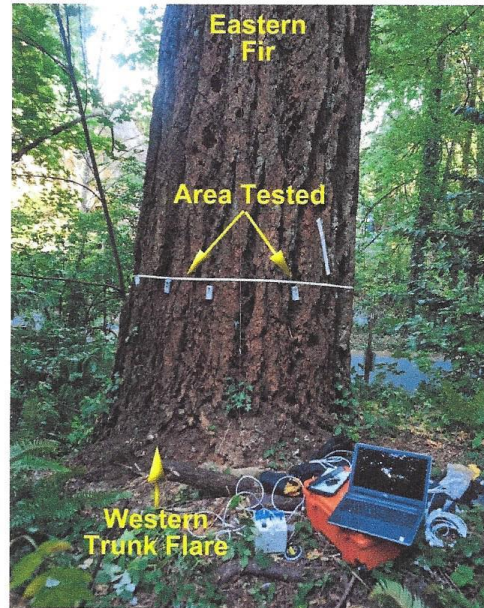
Photo-2

For information on trunk health, structure, and signs indicating defects below grade both trees received internal tomography testing at 48-inches above grade (Photo-2, Photo-3).
