Project/Parcel Number: P192405-9077

Jake Zhen Lin Li & Moon Yanci Wu 5660 E Mercer Way Mercer Island, WA 98040

Date: 5/15/18

**Objective:** To assess tree impacts by the recent construction of retaining walls in the backyard of residential property.

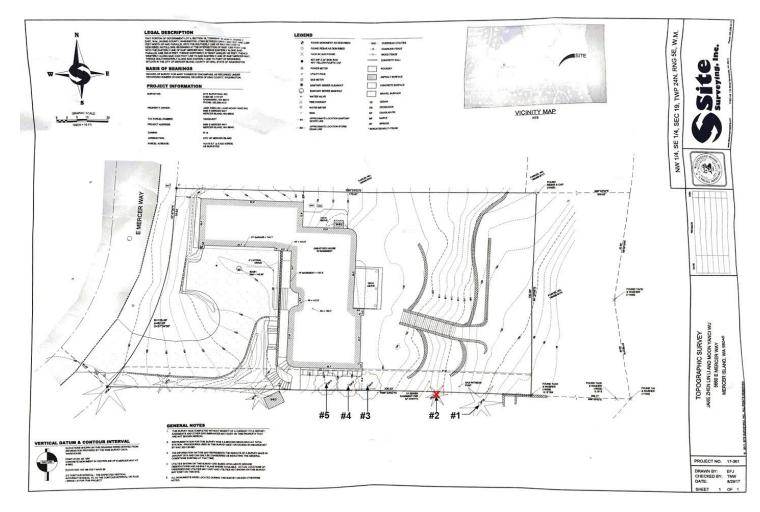
| Tree # | Botanical Name | Common Name | DBH Size<br>(Inches) | Dripline<br>radius<br>(Feet) | Condition | Comments |
| 1 | Pseudotsuga<br>menziesii | Douglas Fir | 22" | ~15' | Good | No visible damage to tree,<br>debris/fill placed over tree<br>roots |
| 2 | Thuja plicata | Western Red<br>Cedar | 12" | ~12' | Poor | Topped tree, debris/fill<br>placed over tree roots |
| 3 | Prunus serrulata | Japanese<br>Flowering Cherry | 14" | ~12' | Good | Some foot traffic over roots, growing very close to fence |
| 4 | Prunus serrulata | Japanese<br>Flowering Cherry | 12" | ~12' | Good | Some foot traffic over roots, growing very close to fence |
| 5 | Prunus serrulata | Japanese<br>Flowering Cherry | 12" | ~12' | Good | Some foot traffic over roots, growing very close to fence |

To avoid further construction impacts, I recommend removing debris/fill material placed over tree roots as well as placing barrier fencing beyond the tree's protected root zone as described here:
