# WEN HU RESIDENCE

8251 West Mercer Way

## Storm Drainage Report

Mercer Island, Washington  
September 21, 2018

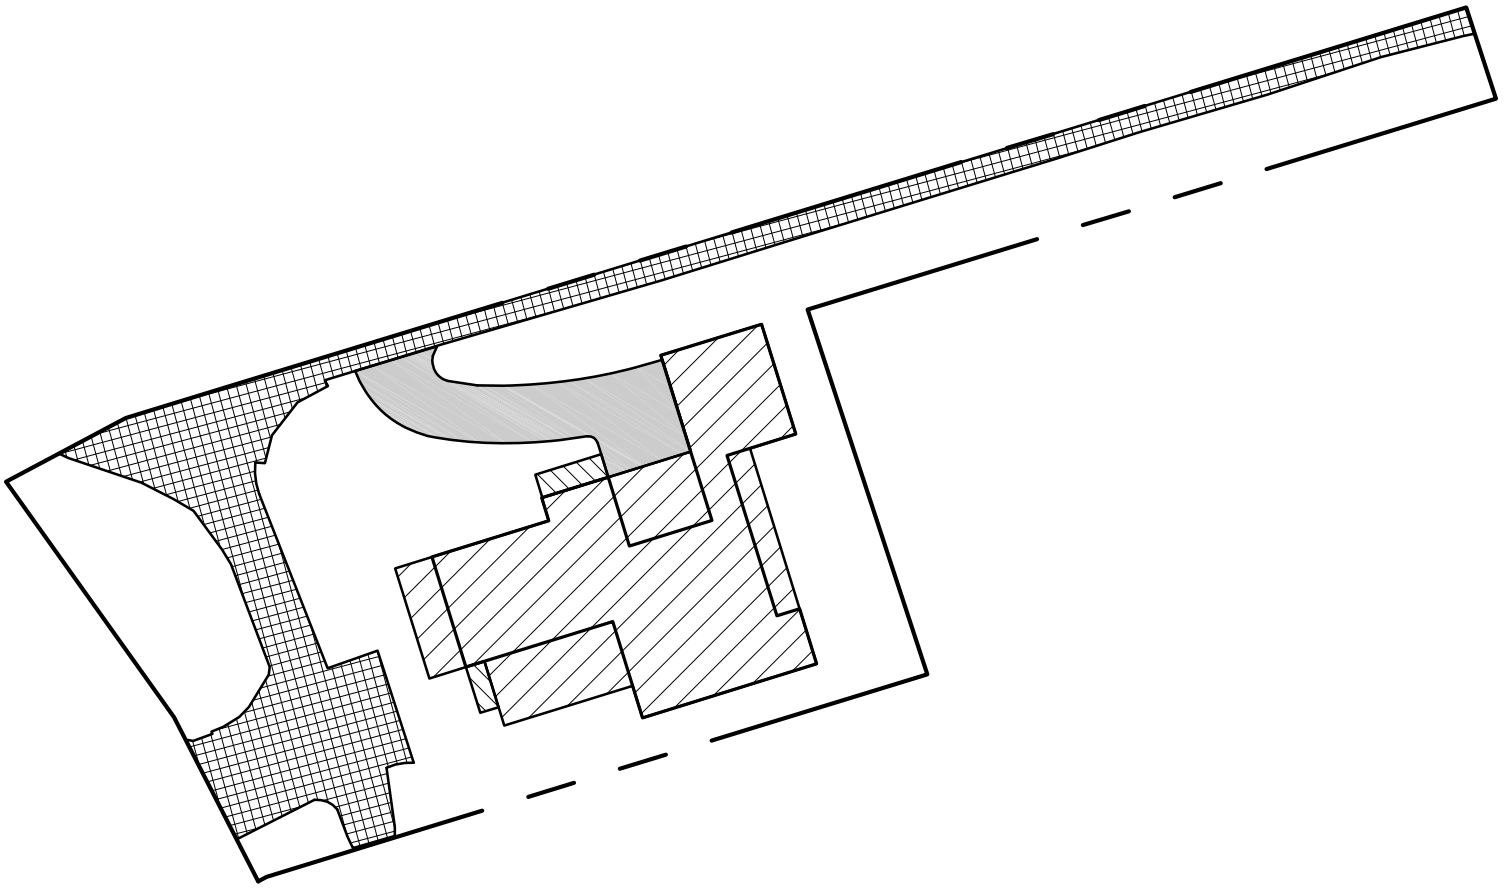
### Proposed Condition Areas:

Building roof:	3,777 sf
Uncovered driveway:	949 sf
Uncovered patio:	112 sf
Existing driveway:	3,660 sf
Total impervious area:	8,498 sf (46%)
Landscaped:	10,118 sf (54%)
Total site:	18,616 sf

UNCOVERED PATIO	112 SF

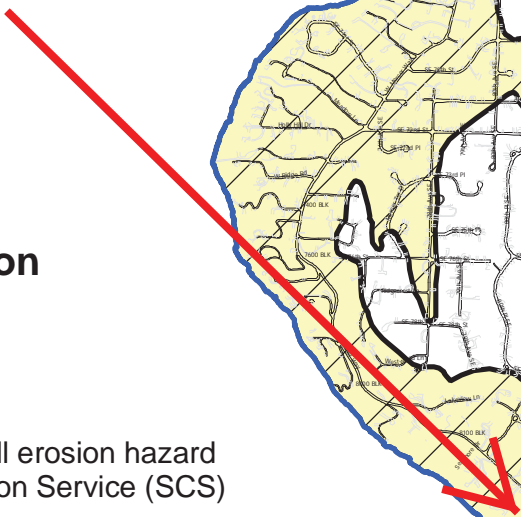
# Erosion Hazard

**SITE**

>15% slope; and soils having "severe" rill and inter-rill erosion hazard according to USDA Soil Conservation Service (SCS)

Downspout dispersion is not feasible because the terrain is too steep. The pervious area downslope of the development is over 15% grade. The site is also in an area mapped by the City as a potential erosion hazard and therefore not compatible with dispersion.
