Ages Engineering, LLC

March 23, 2017
Project No. A-1328

Subject: Geotechnical Evaluation
Appleton Residence
2742 – 71st Avenue SE
Mercer Island, Washington
Parcel Number: 2174501880

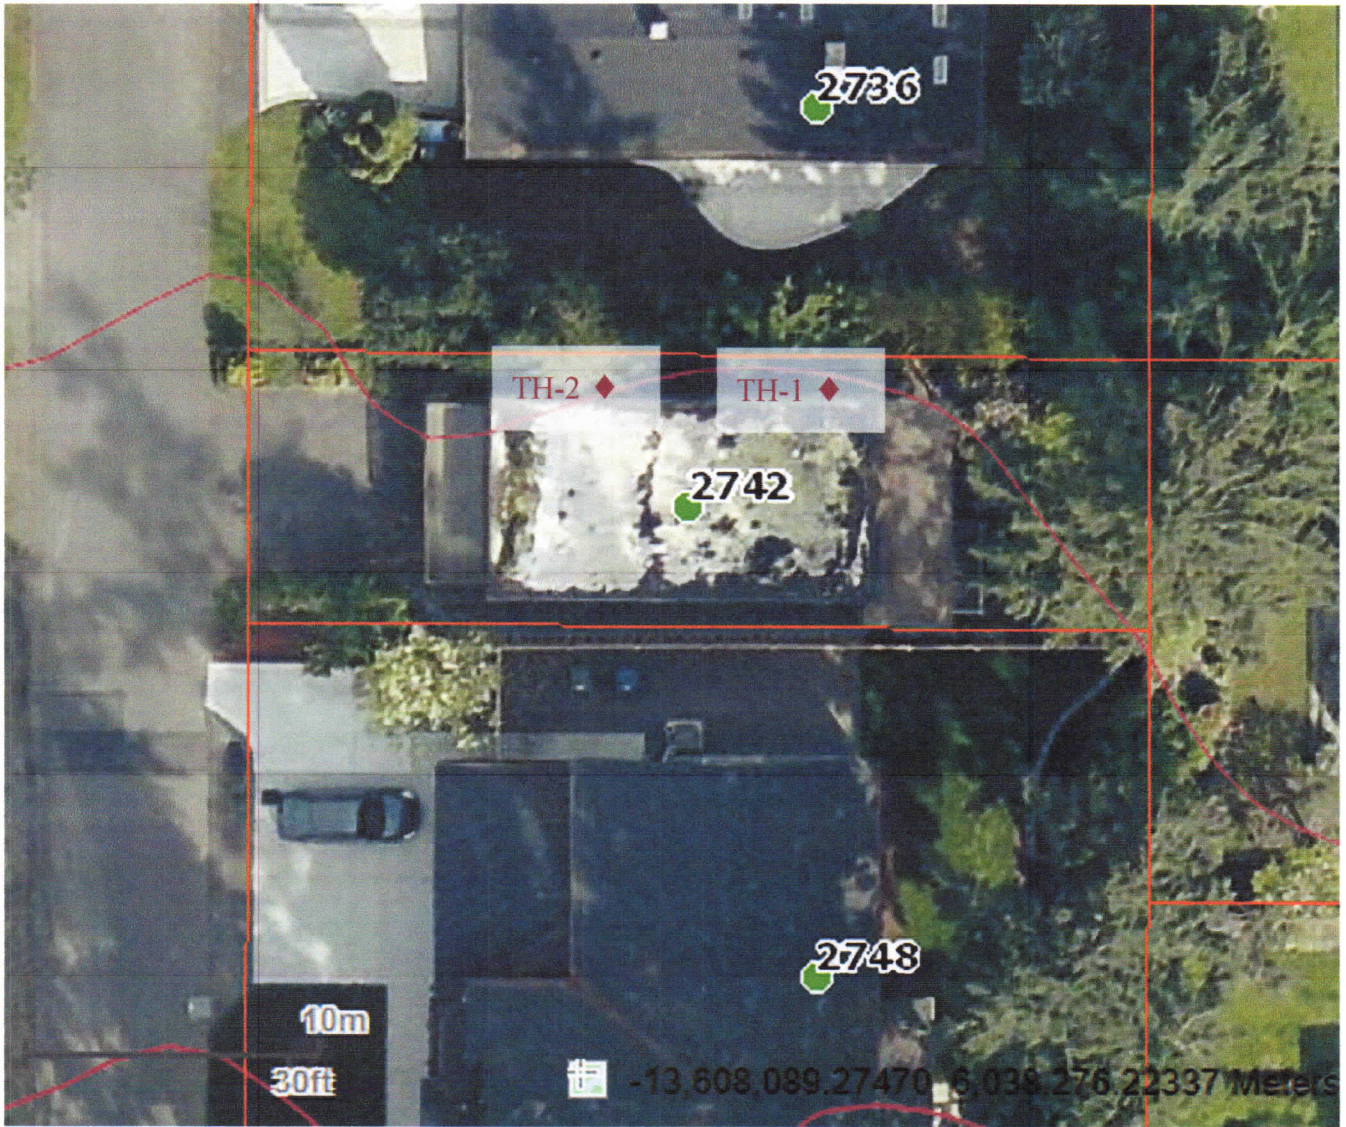
Figure 2

KEY:

APPROXIMATE LOCATION OF TEST HOLE TH-1 ◆

On March 22, 2017, a representative from our office was on site to explore subsurface conditions at the site by advancing two hand-augured test holes to a maximum depth of 7.0 feet below existing surface grades. The approximate Test Hole locations are shown on the Exploration Location Plan provided in Figure 2.
