September 12, 2018  
ES-6182

Earth Solutions NW LLC

**Subject: Geotechnical Evaluation  
Proposed Single-Family Residence  
3440 – 97<sup>th</sup> Avenue Southeast  
Mercer Island, Washington**

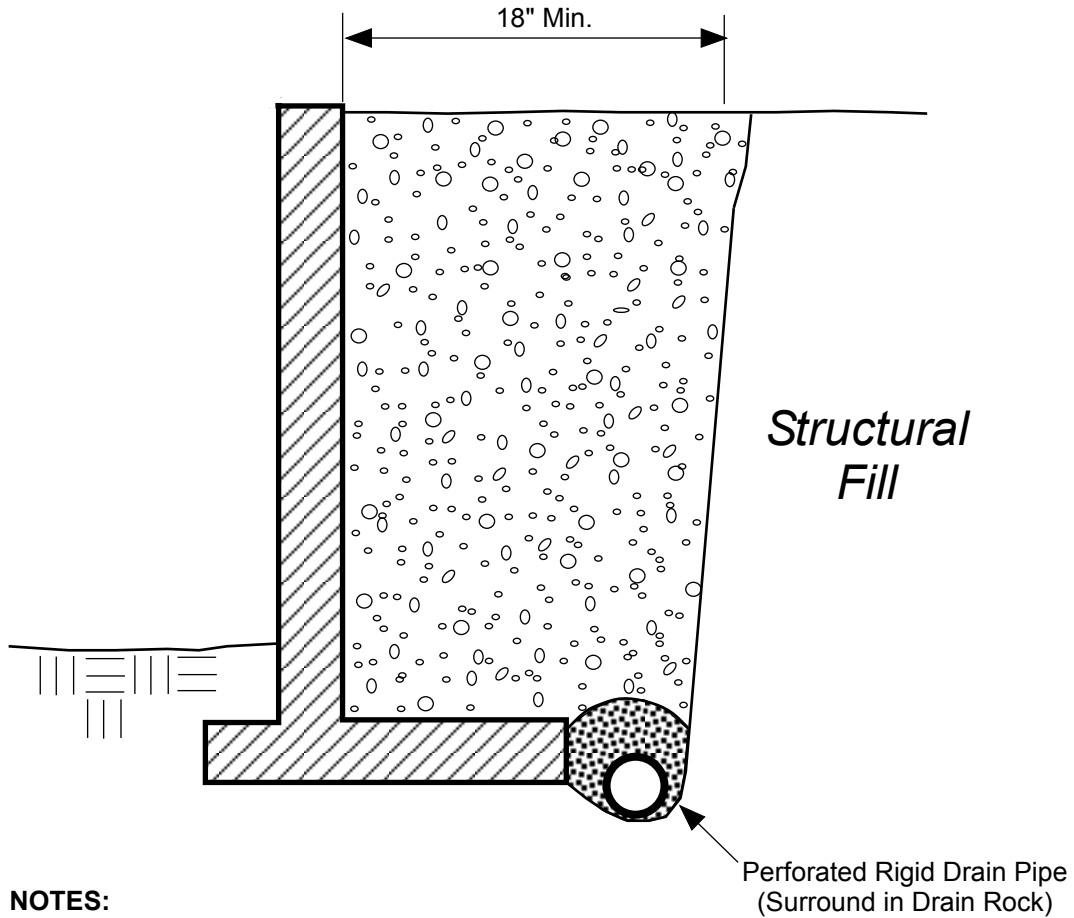
<b>Earth Solutions NW<sub>LLC</sub></b> Geotechnical Engineering Construction Observation/Testing and Environmental Services	
<b>Retaining Wall Drainage Detail</b> 97th Avenue SFR Mercer Island, Washington			
Drwn. MRS	Date 08/08/2018	Proj. No. 6182	
Checked CGH	Date Aug. 2018	Plate	3

- Free-draining Backfill should consist of soil having less than 5 percent fines. Percent passing No. 4 sieve should be 25 to 75 percent.
- Sheet Drain may be feasible in lieu of Free-draining Backfill, per ESNW recommendations.
- Drain Pipe should consist of perforated, rigid PVC Pipe surrounded with 1-inch Drain Rock.

1-inch Drain Rock

Retaining walls should be backfilled with free-draining material that extends along the height of the wall and a distance of at least 18 inches behind the wall. The upper 12 inches of the wall backfill may consist of a less permeable soil, if desired. A perforated drainpipe should be placed along the base of the wall and connected to an approved discharge location. A typical retaining wall drainage detail is provided on Plate 3. If drainage is not provided, hydrostatic pressures should be included in the wall design.

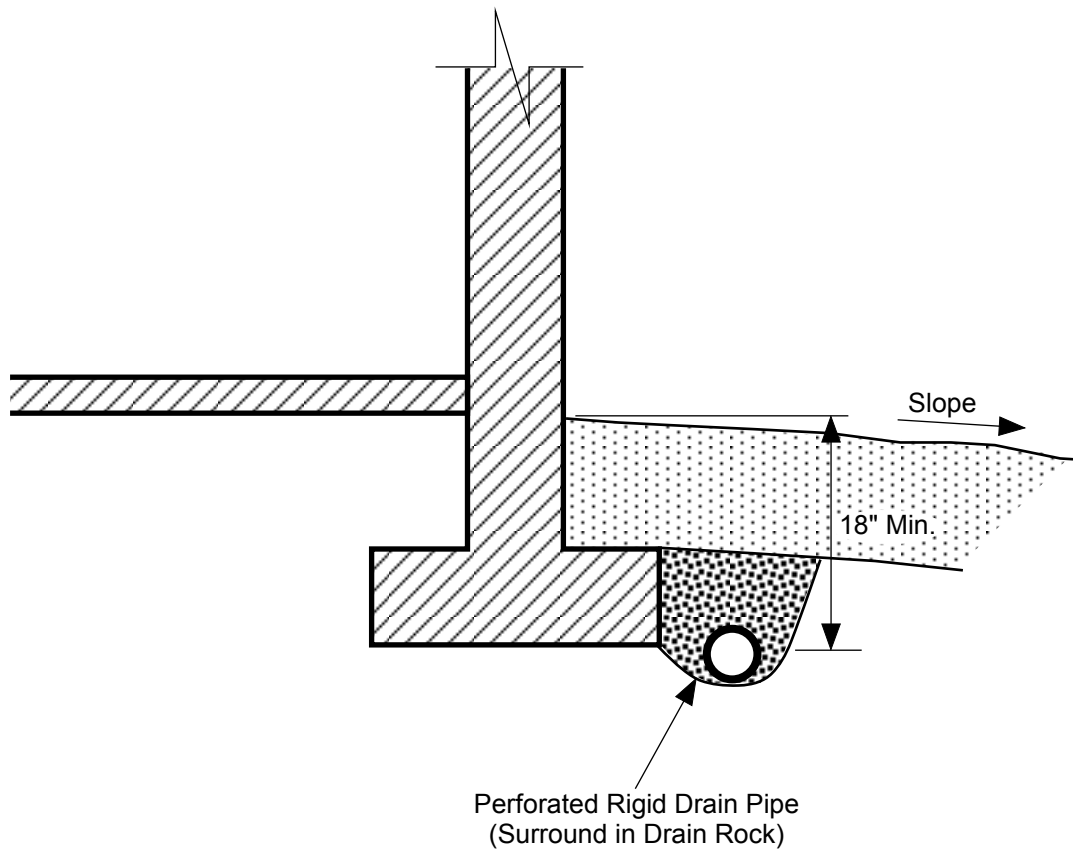
<p><b>Earth Solutions NW LLC</b></p> <p>Geotechnical Engineering, Construction Observation/Testing and Environmental Services</p>	
<p><b>Footing Drain Detail</b> 97th Avenue SFR Mercer Island, Washington</p>		
Drwn. MRS	Date 08/08/2018	Proj. No. 6182
Checked CGH	Date Aug. 2018	Plate 4

- Do NOT tie roof downspouts to Footing Drain.
- Surface Seal to consist of 12" of less permeable, suitable soil. Slope away from building.

Finish grades must be designed to direct surface drain water away from structures and slopes to the extent feasible. Water must not be allowed to pond adjacent to structures or slopes. In our opinion, foundation drains should be installed along building perimeter footings. A typical foundation drain detail is provided on Plate 4.

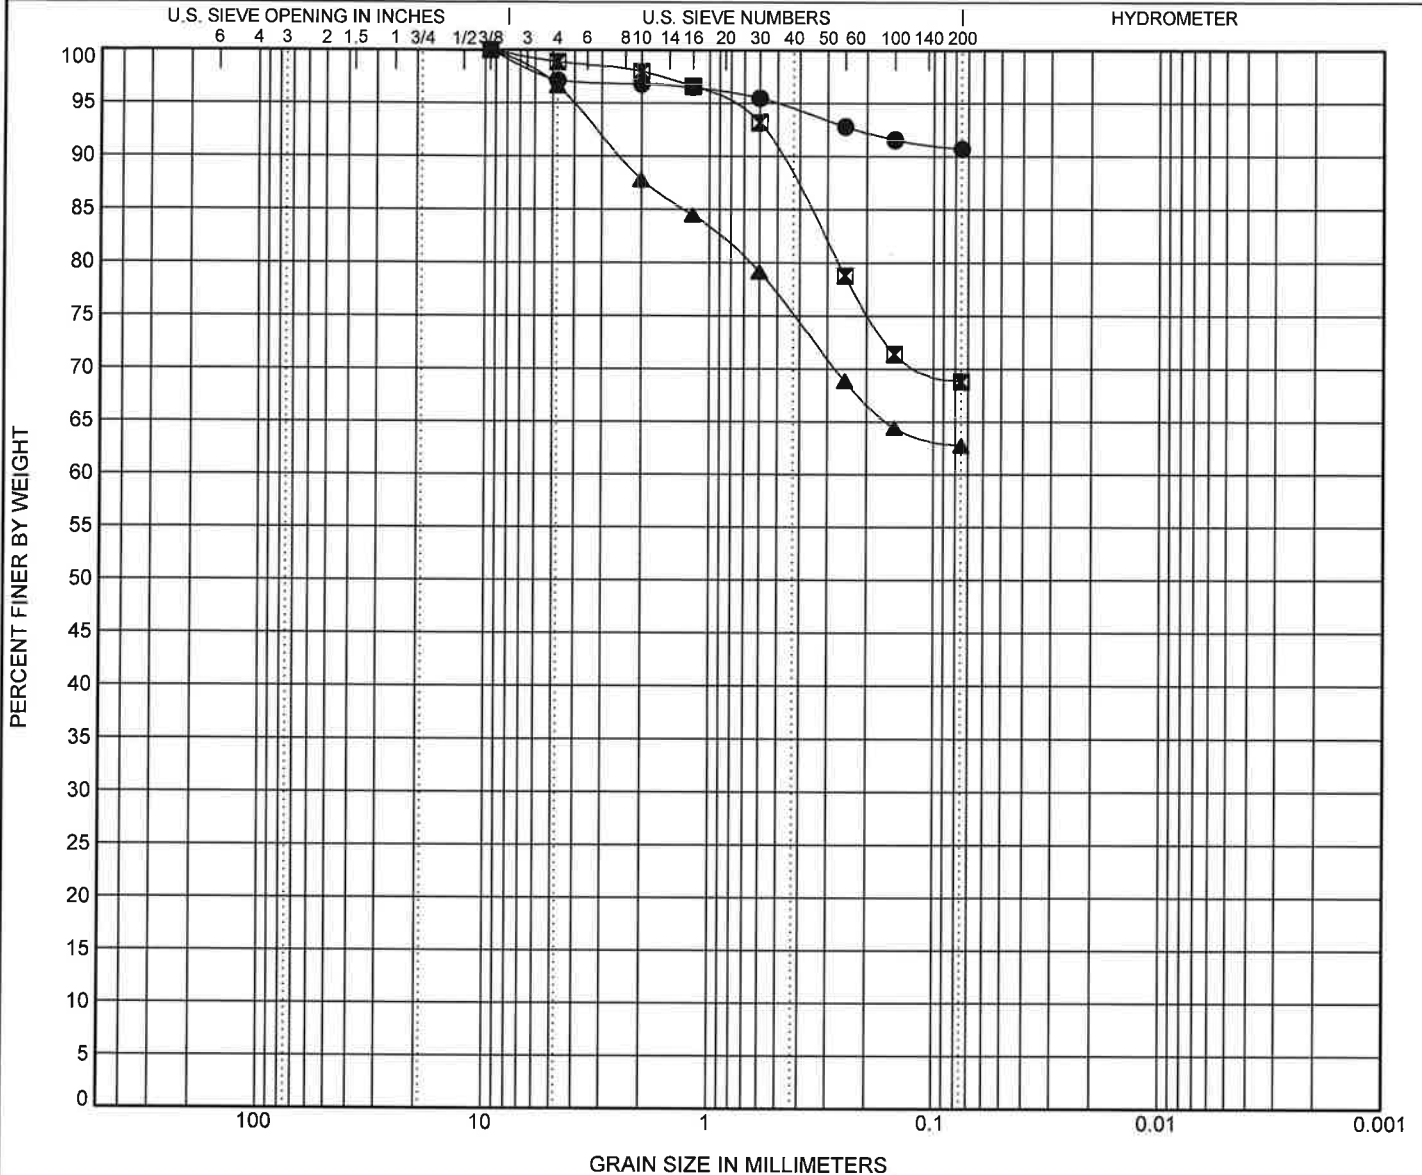
COBBLES	GRAVEL		SAND			SILT OR CLAY
	coarse	fine	coarse	medium	fine

Specimen Identification	Classification								Cc	Cu
● TP-01 5.00ft.	USDA: Gray Slightly Gravelly Loam. USCS: ML.									
☒ TP-02 2.00ft.	USDA: Gray Slightly Gravelly Loam. USCS: Sandy ML.									
▲ TP-03 2.00ft.	USDA: Gray Slightly Gravelly Loam. USCS: Sandy ML.									
Specimen Identification	D100	D60	D30	D10	LL	PL	PI	%Silt	%Clay	
● TP-01 5.0ft.	9.5							90.7		
☒ TP-02 2.0ft.	9.5							68.8		
▲ TP-03 2.0ft.	9.5							62.7
