DRAINAGE MEMORANDUM – REV 1

RE: 3440 97th Ave SE, Mercer Island, WA On-site Drainage System Design Summary

The site at 3440 97th Ave SE on Mercer Island totals 9,146 square feet and will be developed with a single-family residence with an attached garage. The site is currently a vacant vegetated lot with a few large trees. All but one existing tree will be protected to remain. The site is accessed off 97th Ave SE via an existing asphalt driveway which will be replaced for utility installation. The total new plus replaced impervious surfaces is 4,651 square feet. See TABLE 1 for a summary of land cover calculations and Attachment A for photos of the existing site. A summary of the onsite soils is included in the following sections. Since the project will add greater than 2,000 SF but less than 5,000 SF of new plus replaced impervious surfaces, it is subject to Minimum Requirements 1 through 5 as outlined in Section I-2.4, Figure 2.4.2 of The Manual.

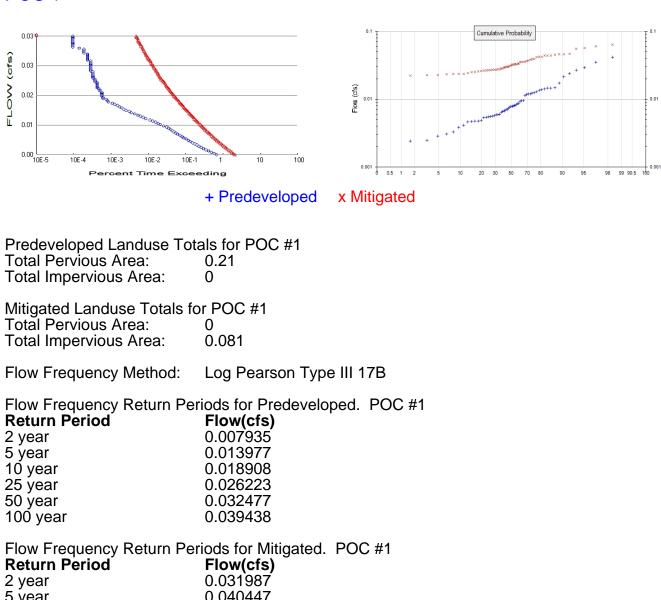
Analysis Results POC 1

5 year	0.040447	
10 year	0.046199	
25 year	0.053665	
50 year	0.059383	100 year flow CFS*
100 year	0.065242	448.8 = 0.0652*448.8
		= 29.3 GPM
