Anstey Engineering

Storm Drainage Report

2423 63rd Avenue SE.
Mercer Island, WA 98040
Parcel # 409950-0430

December 23, 2019

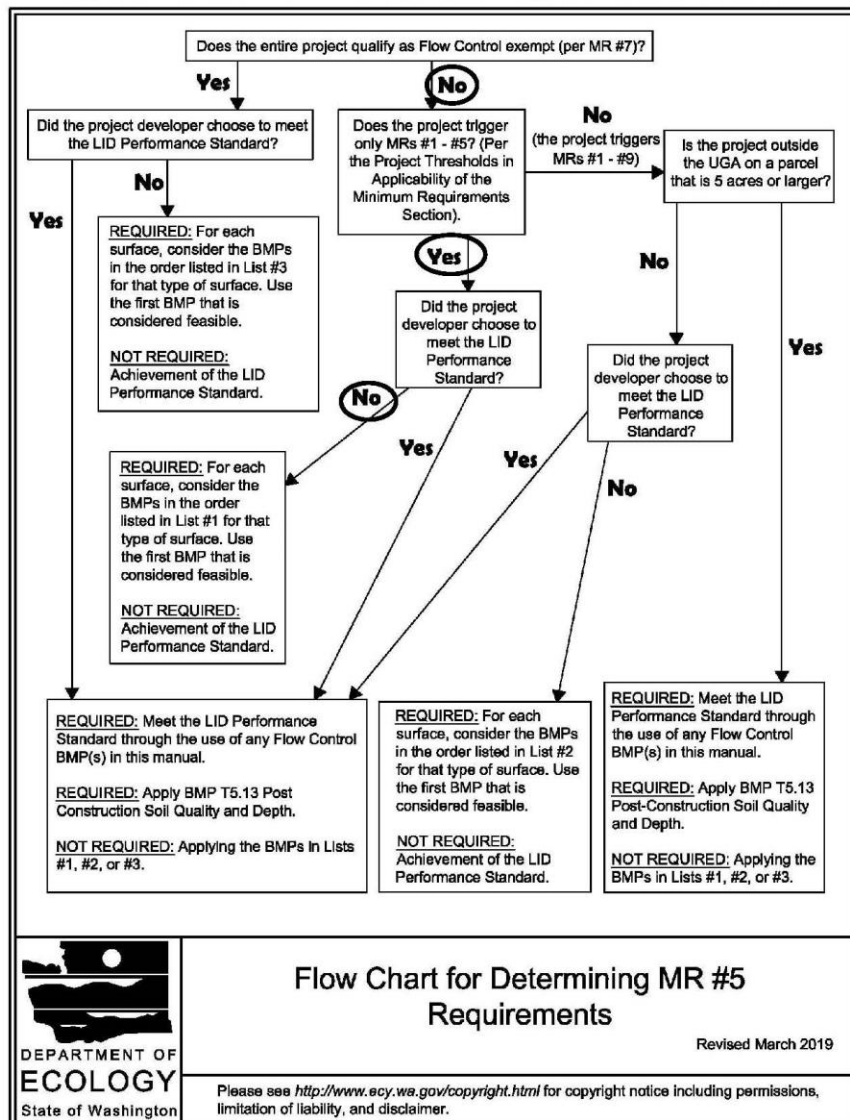
Figure I-3.3: Flow Chart for Determining MR #5 Requirements

As the lot will have less than 5,000sf of impervious surface List 1 will be used per Fig I-3.3: Flow Chart for Determining MR#5 Requirements above. On-site stormwater management BMPs have been examined for their feasibility. Due to the lack of a 100 foot flow path Full Dispersion cannot be used. The soils are unsuitable for infiltration (per Mercer Island Infiltration map below) and there is not adequate space for raingardens.
