Anstey Engineering

Storm Drainage Report

2423 63rd Avenue SE.
Mercer Island, WA 98040
Parcel # 409950-0430

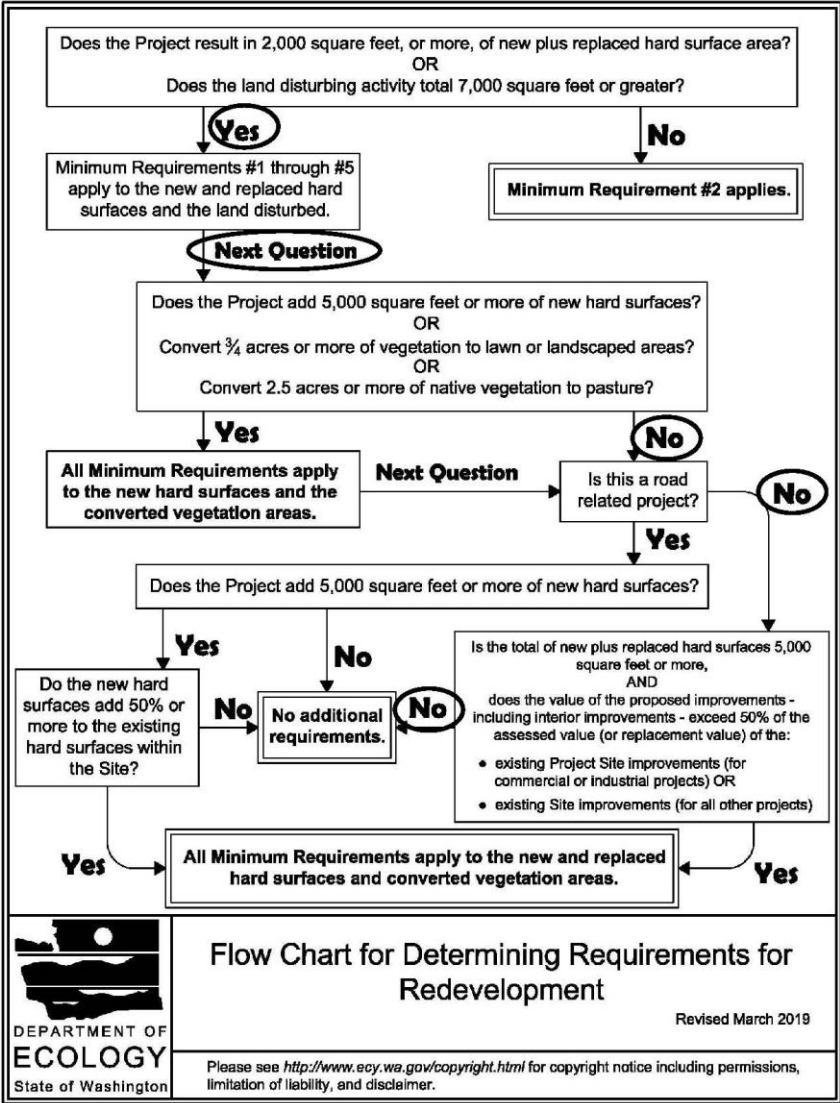
Figure I-3.2: Flow Chart for Determining Requirements for Redevelopment

The project is a re-development project with new and replaced impervious surface totaling 2944.65 sf of the 10,500 sf lot and disturbed area totaling +/- 4,773 sf. The following path addresses Minimum Stormwater Requirements 1 through 5. See the flow chart below. The lot has an existing house, driveway, desks, and brickwalks that will be demolished. See the TESC plan for detail.

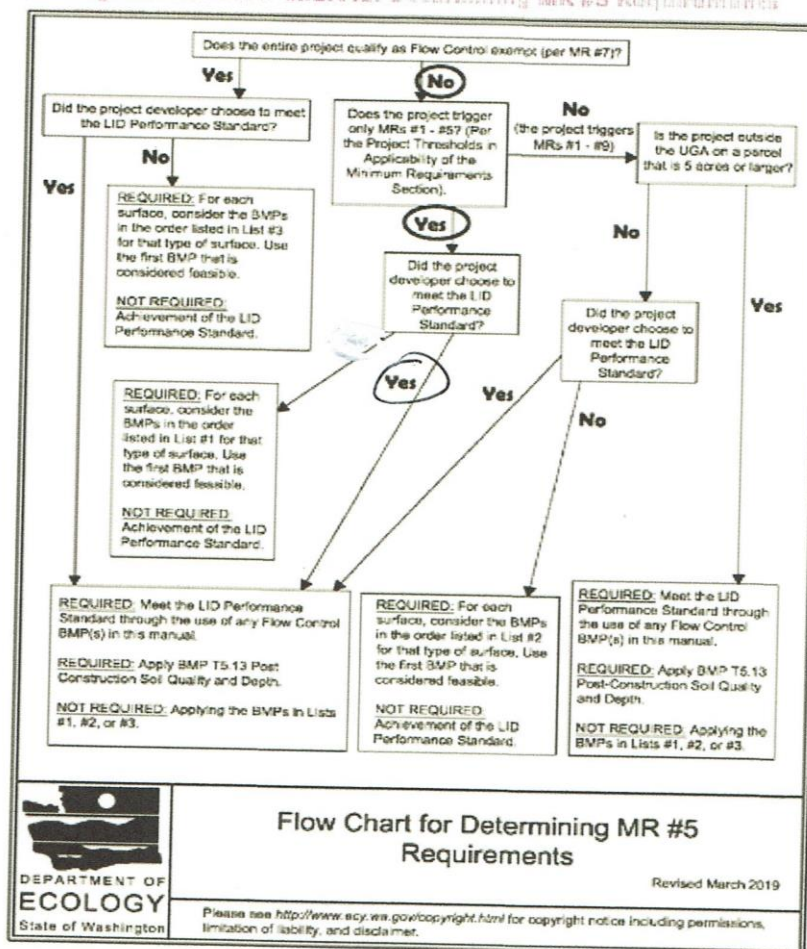
Figure I-3.3: Flow Chart for Determining MR #5 Requirements

As the lot will have less than 5,000sf of impervious surface List 1 will be used per Fig I-3.3: Flow Chart for Determining MR#5 Requirements above. On-site stormwater management BMPs have been examined for their feasibility. Due to the lack of a 100 foot flow path Full Dispersion cannot be used. The soils are unsuitable for infiltration (per Mercer Island Infiltration map below) and there is not adequate space for raingardens.
