# DRAINAGE MEMORANDUM

TO: City of Mercer Island  
 FROM: Ben Iddins, P.E.  
 DATE: March 12, 2020  
 RE: 8720 SE 52<sup>nd</sup> Pl, Mercer Island, WA  
 On-site Drainage System Design Summary

## 1 PROJECT SUMMARY

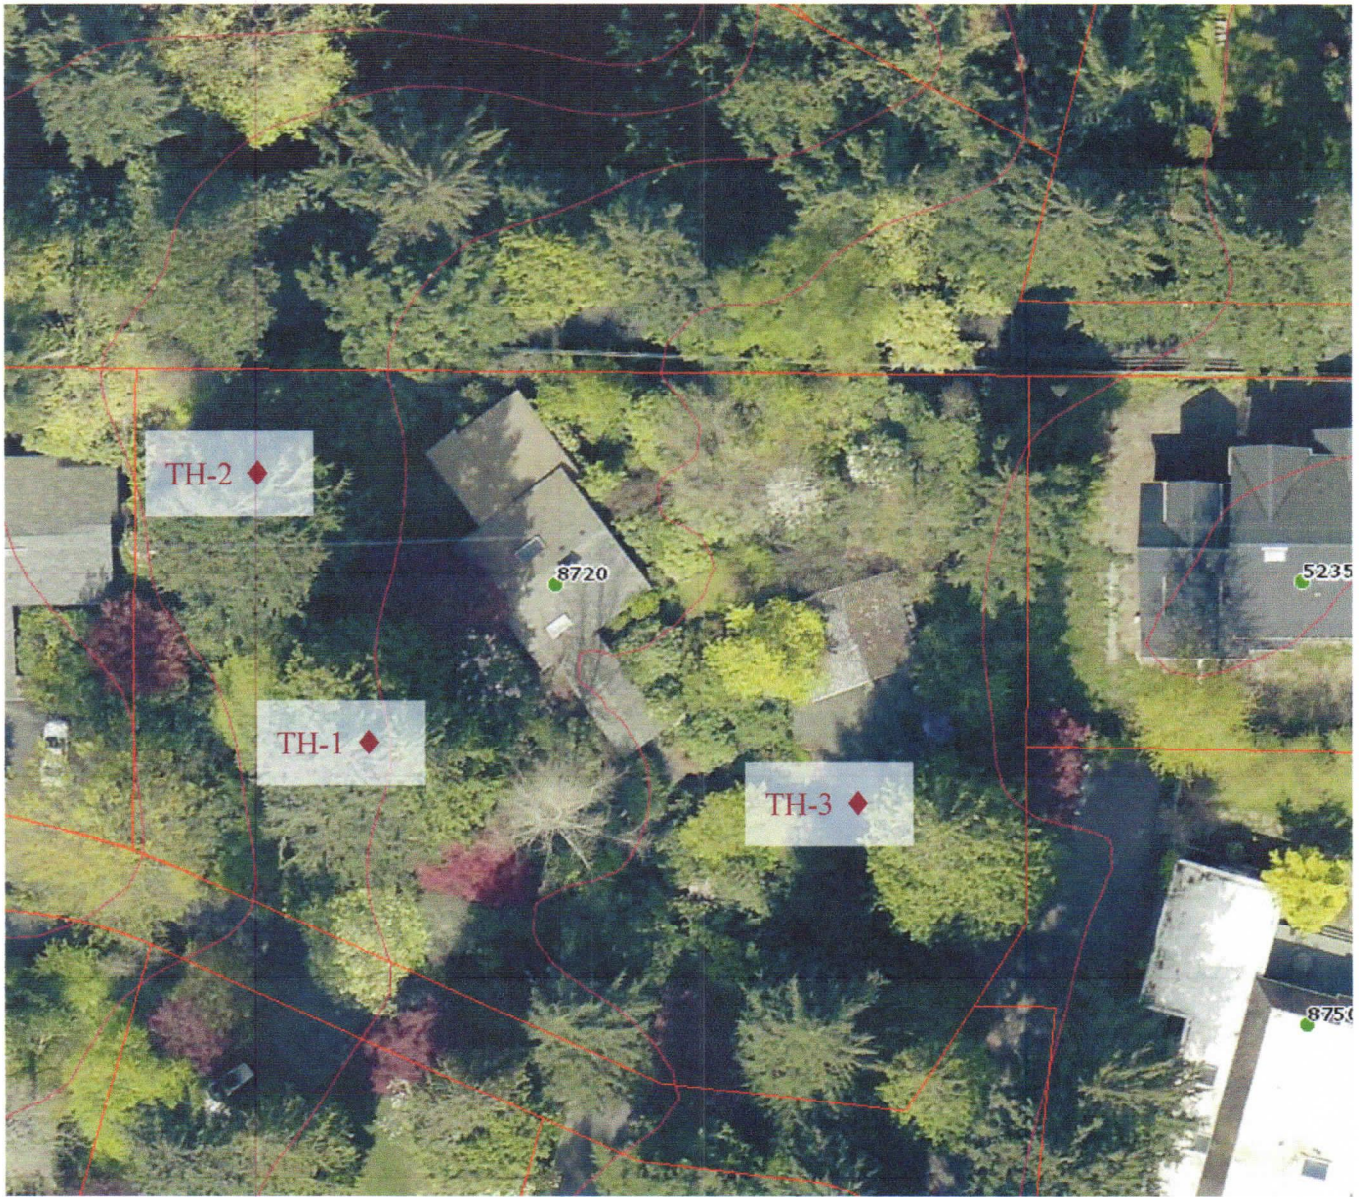
Figure 2

<p><b>KEY:</b></p> <p>APPROXIMATE LOCATION OF TEST HOLE</p>	<p>TH-1 ◆</p>
---	---------------

On October 27, 2016 and November 8, 2016 a representative from our office was on site to explore subsurface conditions at the site by advancing three hand-augured test holes to a maximum depth of 7.0 feet below existing surface grades. The approximate Test Hole locations are shown on the Exploration Location Plan provided in Figure 2.

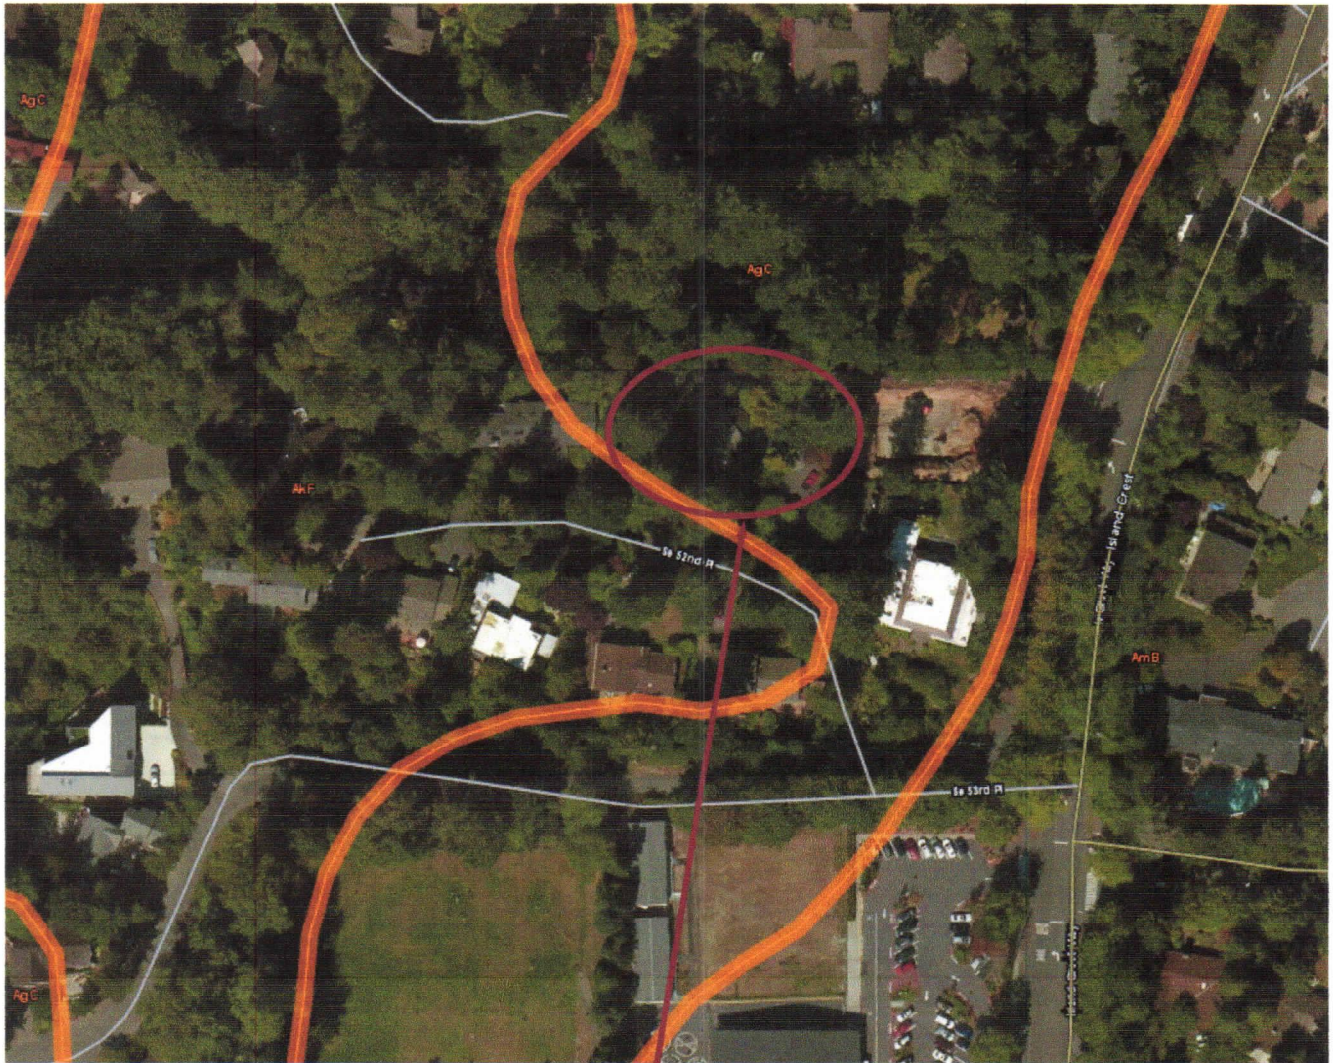
**Figure 4**

Approximate Site Location

The United States Department of Agriculture (USDA) Natural Resource Conservation Service (NRCS) maps the soils in the vicinity of the site as Alderwood gravelly sandy loam (AgC) soils that form on 8 to 15 percent slopes. According to the NRCS the Alderwood soils at the site are described as glacial till deposits and are classified as having a “moderate” potential for erosion when exposed. A copy of the USDA NRCS map for the subject site is provided in Figure 4.
