4207 West Mercer Way: Critical Areas Compliance and Mitigation Plan

Vaney-Shinde Residence

July 10, 2020
Project No. 20016

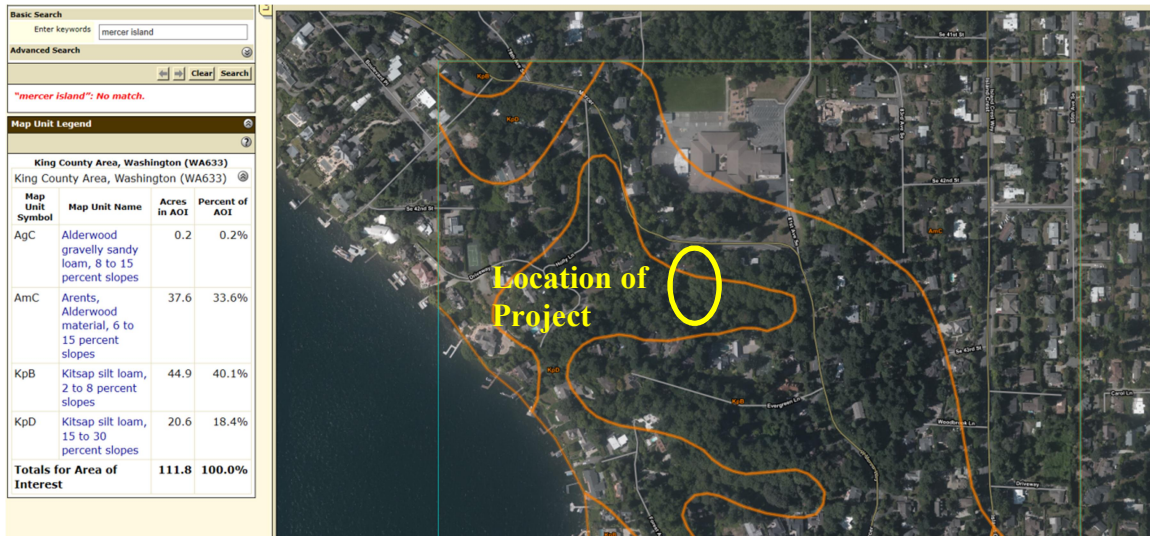
Figure 2 – Soils Map

Based on the USGS Soils map, the site is predominantly underlain by Kitsap silt loam (KpD) soils (see map below) which is a Type D soil. A small portion at the north end of the site is mapped as KpB which is the same material as KpD, but it characterized by flatter slopes. The flatter areas at the north end of the site appear to have been created by

grading for the roadway and building pad, so the current condition does not reflect the underlying or original soil classification.
