FINAL
STORM DRAINAGE REPORT

Foo Property

CITY OF MERCER ISLAND, WASHINGTON

Project Manager: Michael A. Moody, P.E.
Prepared by: Daniel J. Larson, E.I.T.
Approved by: Michael A. Moody, P.E.
Date: June 2020
Revised: December 2020
Core No.: 20034

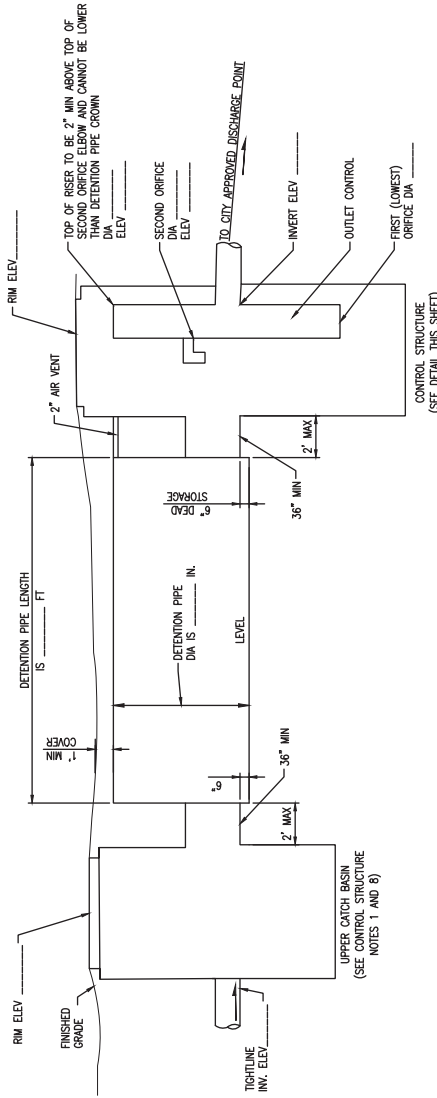
**ON-SITE DETENTION SYSTEM
NOT TO SCALE (ENGINEER TO FILL IN BLANKS)**

OWNER: _____ ADDRESS: _____ PREPARED BY: _____
 PERMIT #: _____ PHONE: _____
 DATE: _____
 NEW PLUS REPLACED IMPERVIOUS SURFACE AREA (SF): _____ DETENTION PIPE LENGTH (FT): _____ ORIFICE #1 DIA _____ INCH, ELEV _____
 SOIL TYPE: _____ PIPE MATERIAL: _____ DETENTION PIPE DIA (INCH): _____ ORIFICE #2 DIA _____ INCH, ELEV _____

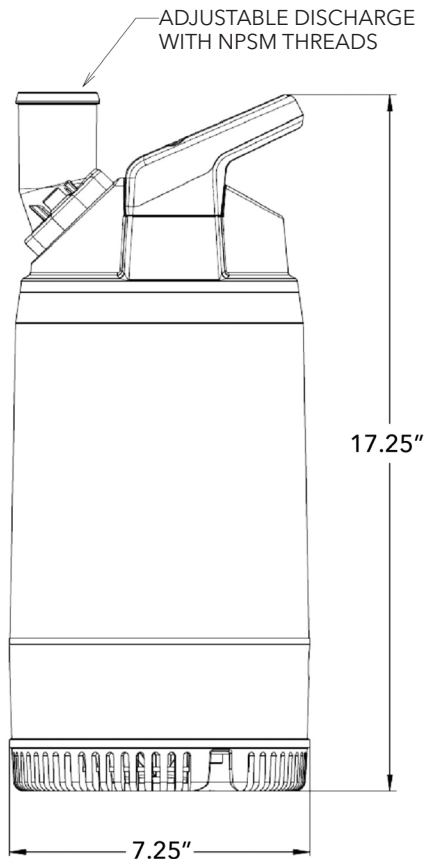
DIMENSIONS

Order No.	HP	Volts	Phase	Maximum Amp	RPM	Height (in.)	Weight (lbs.)
2DW0511	½	115	1	5.5	3500	17.25	26
2DW0512		230		2.9			
2DW1011	1	115		9.8			
2DW1012		230		4.9			32

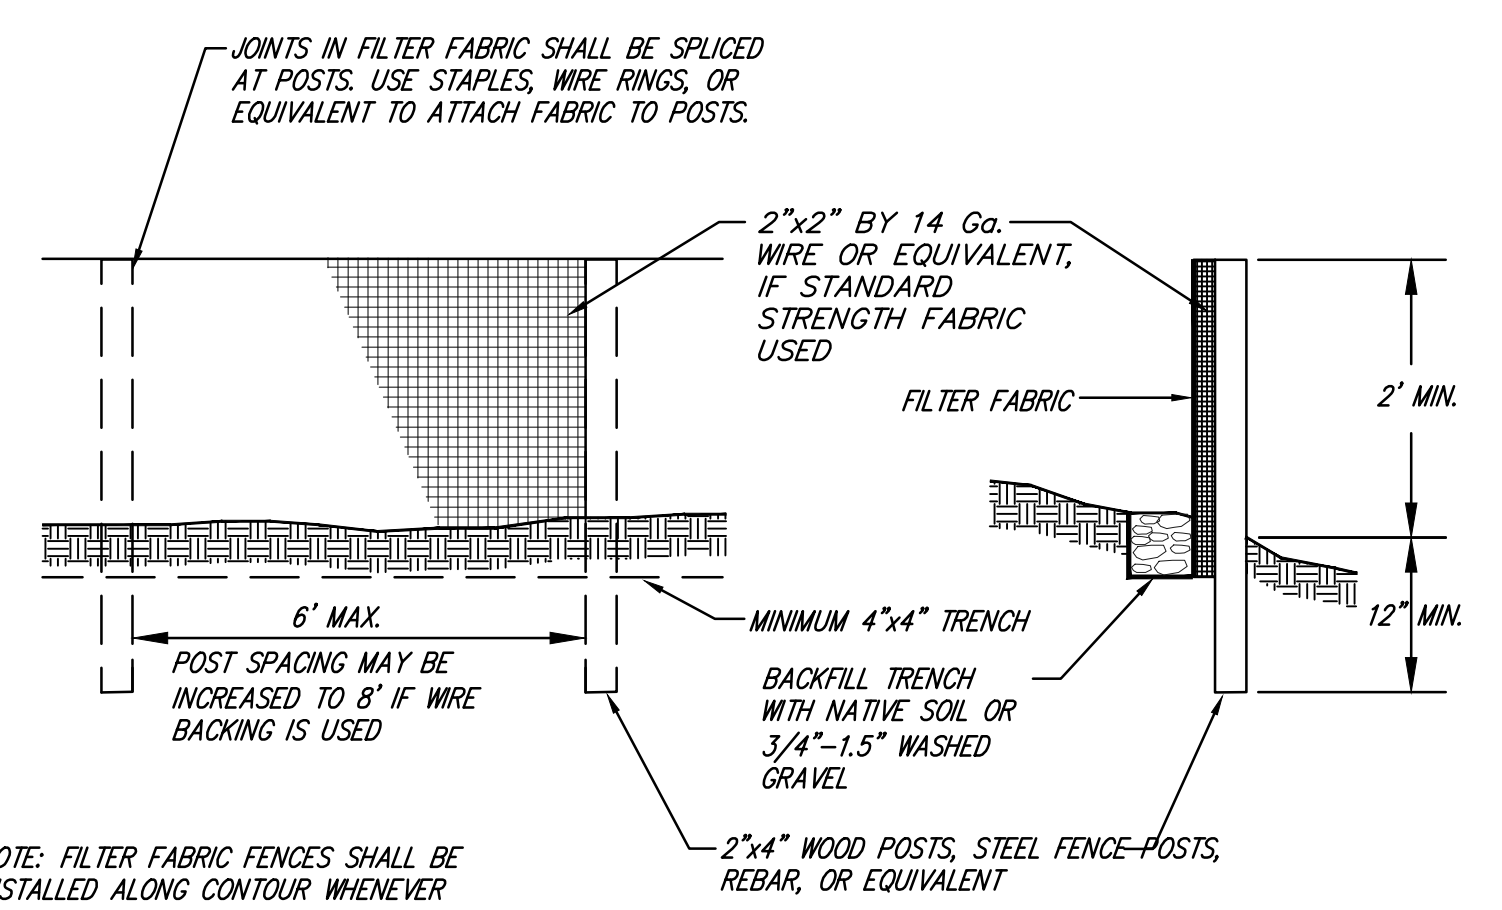
FILTER FABRIC FENCE DETAIL

NOTE: FILTER FABRIC FENCES SHALL BE INSTALLED ALONG CONTOUR WHENEVER POSSIBLE
