FINAL STORM DRAINAGE REPORT

Foo Property

CITY OF MERCER ISLAND, WASHINGTON

Project Manager: Michael A. Moody, P.E.
Prepared by: Daniel J. Larson, E.I.T.
Approved by: Michael A. Moody, P.E.
Date: June 2020
Core No.: 20034

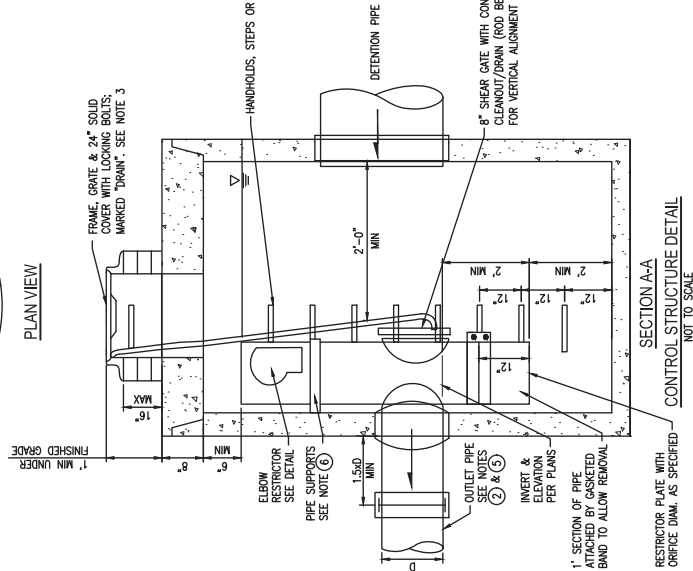
**SECTION A-A
CONTROL STRUCTURE DETAIL
NOT TO SCALE**

- CONTROL STRUCTURE NOTES:**
- USE A MINIMUM OF A 54 IN. DIA. TYPE 2 CATCH BASIN. THE ACTUAL SIZE IS DEPENDENT ON CONNECTING PIPE MATERIAL AND DIAMETER.
 - OUTLET PIPE: MIN. 6 INCH.
 - METAL PARTS: CORROSION RESISTANT. NON-GALVANIZED PARTS PREFERRED. GALVANIZED PIPE PARTS TO HAVE ASPHALT TREATMENT 1.
 - FRAME AND LADDER OR STEPS OFFSET SO:
 - CLEANOUT GATE IS VISIBLE FROM TOP.
 - CLEAR-DOWN SPACE IS CLEAR OF RISER AND CLEANOUT GATE.
 - FRAME IS CLEAR OF CURB.
 - IF METAL OUTLET PIPE CONNECTS TO CEMENT CONCRETE PIPE, OUTLET PIPE TO HAVE SMOOTH O.D. EQUAL TO CONCRETE PIPE I.D. LESS 1/4 IN.

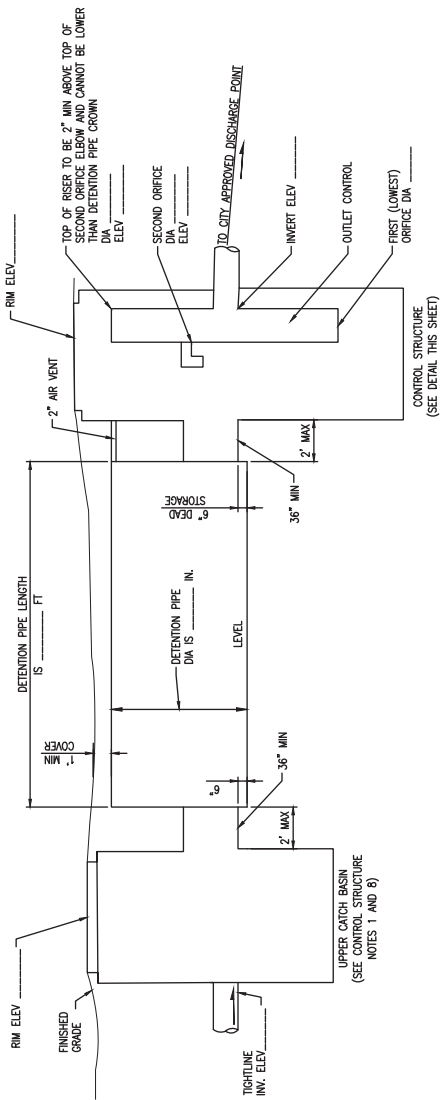
**ON-SITE DETENTION SYSTEM
NOT TO SCALE (ENGINEER TO FILL IN BLANKS)**

Sized per MR#5 in the Stormwater Management Manual for Puget Sound Basin (1992 Ecology Manual)
 SBUH, Type 1A, 24-hour hydrograph
 2-year, 24-hour storm = 2 in; 10-year, 24-hour storm = 3 in; 100-year, 24-hour storm = 4 in
 Predeveloped = second growth forest (CN = 72 for Type B soils, CN = 81 for Type C soils)
 Developed = impervious (CN = 98)
 0.5 foot of sediment storage in detention pipe
 Overland slope = 5%

**ATTACHMENT 1
CITY OF MERCER ISLAND
ON-SITE DETENTION SYSTEM WORKSHEET
(FOR NEW PLUS REPLACED IMPERVIOUS
AREA OF 9,500 SF OR LESS)**

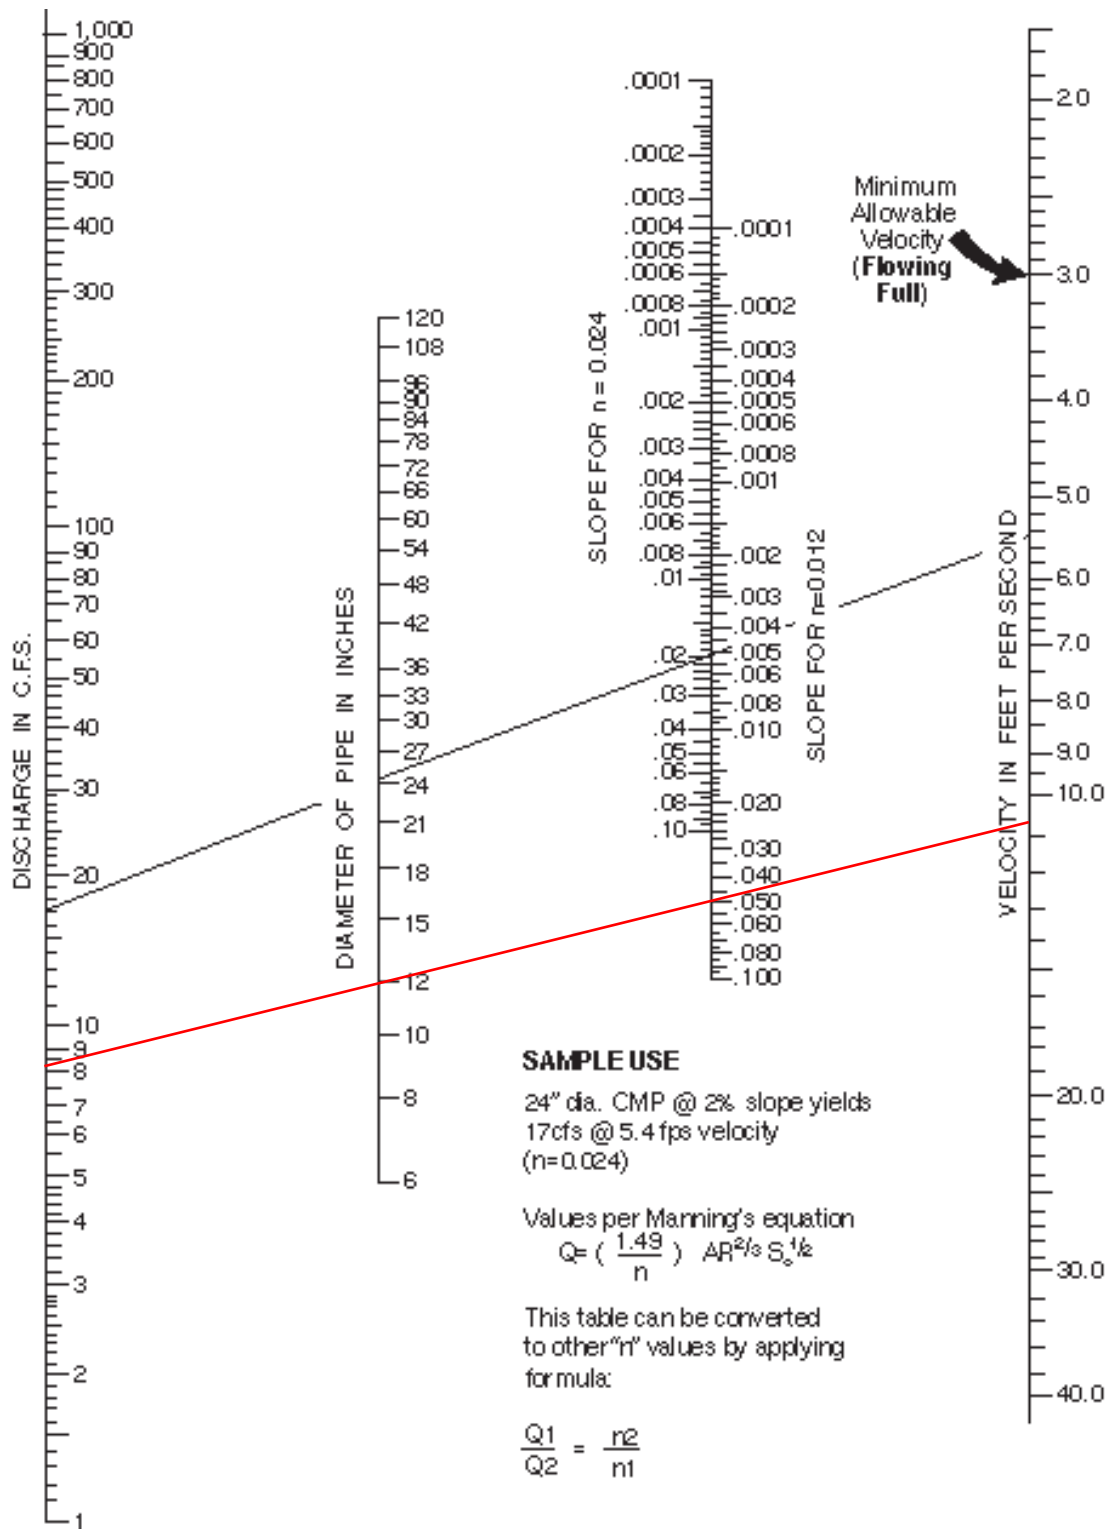
FIGURE 4.2.1.F NOMOGRAPH FOR SIZING CIRCULAR DRAINS FLOWING FULL

Refer to the Nomograph for sizing circular drainage flowing full, from the 2016 King County Surface Water Design Manual (KCSWDM). The nomograph is used as an approximation of the Manning's equation. Note that a 12" pipe at 0.5% yields 8 cfs at 10.5 fps velocity. The 100-year flow for the site is 0.162 cfs, as determined using MGS Flood. Therefore, the capacity of the proposed pipe system is sufficient.
