# **STORM DRAINAGE REPORT**

## **PROPOSED RESIDENCE**

**3404 72<sup>ND</sup> PL. S.E.**

**MERCER ISLAND, WA**

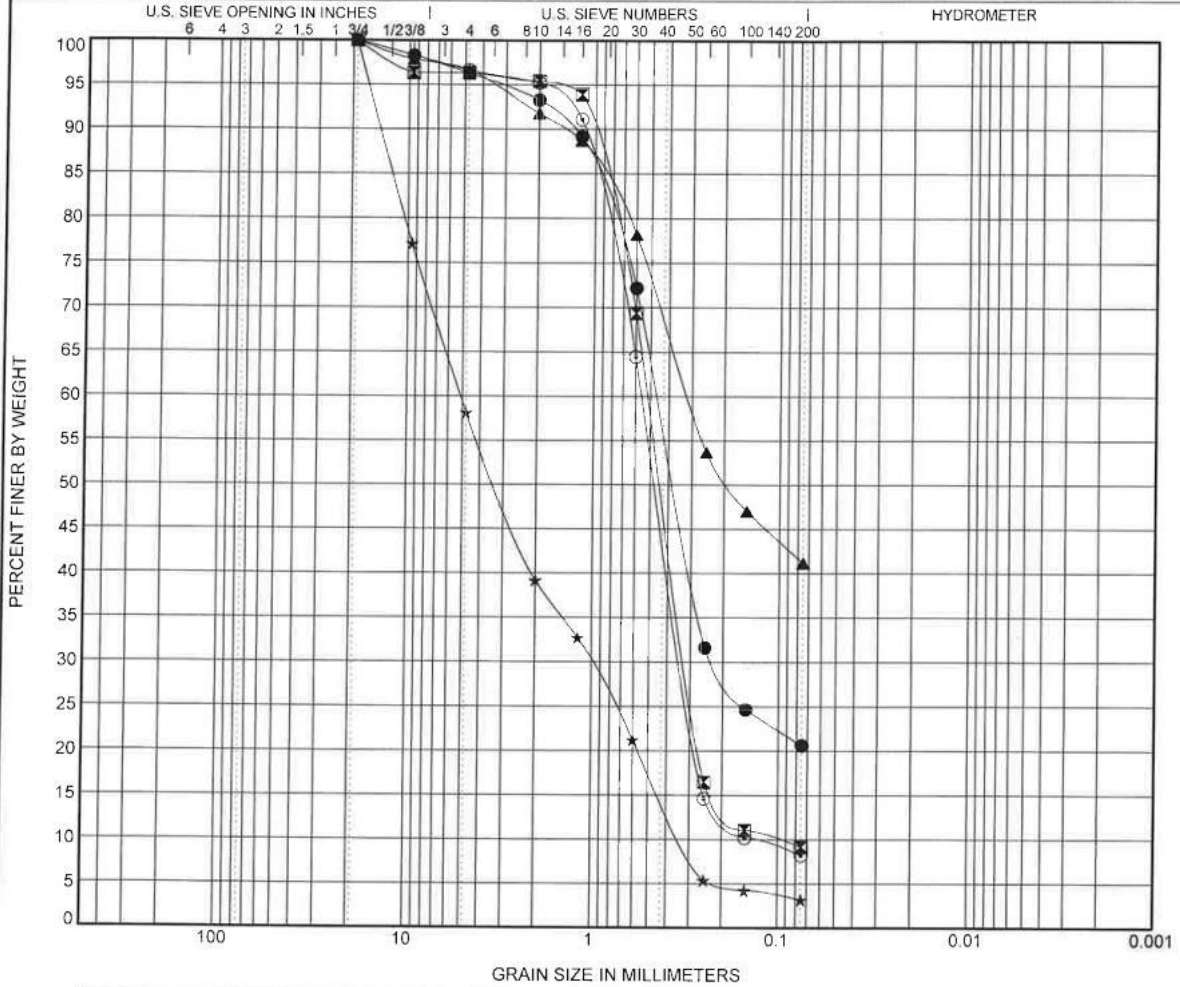
COBBLES	GRAVEL		SAND			SILT OR CLAY
	coarse	fine	coarse	medium	fine

Specimen Identification	Classification		Cc	Cu						
● TP-01 3.0ft.	USDA: Brown Slightly Gravelly Loamy Sand. USCS: SM.									
☒ TP-01 8.5ft.	USDA: Brown Slightly Gravelly Sand. USCS: SP-SM.		1.88	5.07						
▲ TP-02 3.0ft.	USDA: Brown Slightly Gravelly Sandy Loam. USCS: SM.									
★ TP-02 9.0ft.	USDA: Brown Extremely Gravelly Coarse Sand. USCS: SP with Gravel.		0.61	15.75						
⊙ TP-05 5.0ft.	USDA: Brown Slightly Gravelly Sand. USCS: SP-SM.		1.36	3.92						
Specimen Identification	D100	D90	D60	D30	D10	LL	PL	PI	%Silt	%Clay
● TP-01 3.0ft.	19	1.315	0.461	0.222					20.6	
☒ TP-01 8.5ft.	19	1.059	0.514	0.313	0.101				9.2	
▲ TP-02 3.0ft.	19	1.479	0.313						41.2	
★ TP-02 9.0ft.	19	14.034	5.088	1.004	0.323				3.2	
⊙ TP-05 5.0ft.	19	1.148	0.555	0.328	0.142				8.2

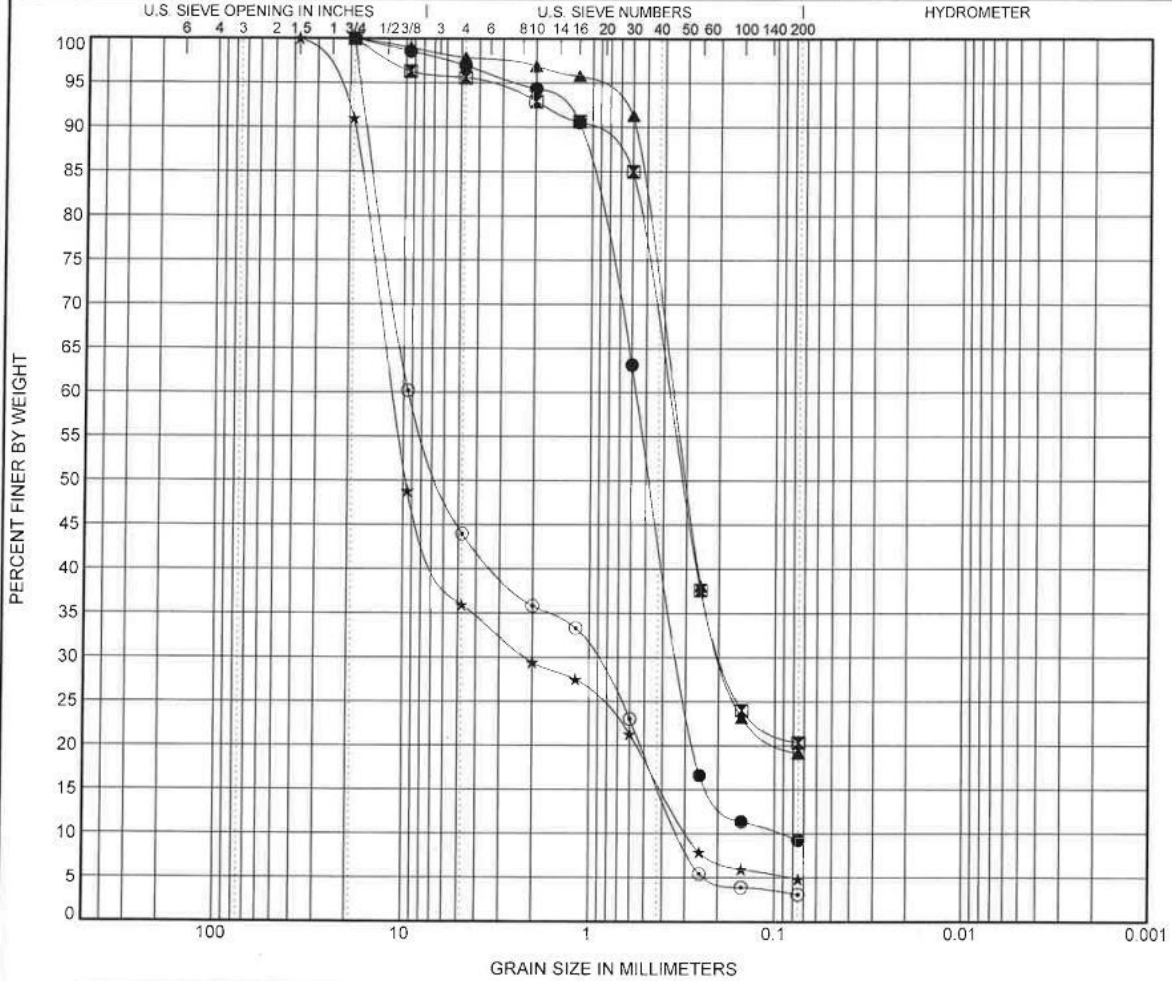
GRAIN SIZE USDA WITH D90 ES-6695 LEVENSON PROPERTY.GPJ\_GINT US.LAB.GDT\_5/15/19

COBBLES	GRAVEL		SAND			SILT OR CLAY
	coarse	fine	coarse	medium	fine

Specimen Identification	Classification		Cc	Cu						
● TP-05 8.5ft.	USDA: Brown Slightly Gravelly Coarse Sand. USCS: SP-SM.		1.92	5.93						
⊠ TP-06 5.0ft.	USDA: Brown Slightly Gravelly Loamy Sand. USCS: SM.									
▲ TP-06 8.5ft.	USDA: Brown Slightly Gravelly Loamy Sand. USCS: SM.									
★ TP-07 5.0ft.	USDA: Brown Extremely Gravelly Loamy Coarse Sand. USCS: GW with Sand.		1.42	39.82						
⊙ TP-07 8.0ft.	USDA: Brown Extremely Gravelly Coarse Sand. USCS: GP with Sand.		0.31	30.04						
Specimen Identification	D100	D90	D60	D30	D10	LL	PL	PI	%Silt	%Clay
● TP-05 8.5ft.	19	1.165	0.566	0.322	0.095				9.3	
⊠ TP-06 5.0ft.	19	1.092	0.378	0.188					20.3	
▲ TP-06 8.5ft.	19	0.587	0.359	0.19					19.1	
★ TP-07 5.0ft.	37.5	18.701	11.422	2.161	0.287				4.8	
⊙ TP-07 8.0ft.	19	15.964	9.423	0.949	0.314				3.1
