April 28, 2016
PanGEO Project No. 16-106

Subject: **GEOTECHNICAL REPORT**
Proposed Short Plat
7233-80th Avenue Southeast
Mercer Island, Washington

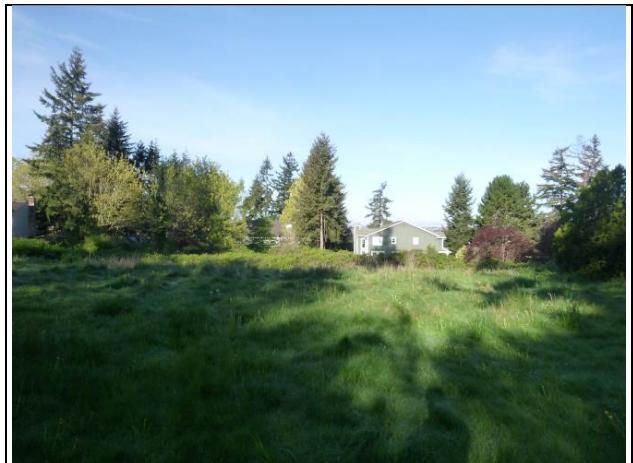
Plate 1. Partial site view facing west from west side of existing residence.

The subject site consists of an approximately 94,525 square foot single-family residence lot located at 7233-80th Avenue Southeast in Mercer Island, Washington (see Figure 1, Vicinity Map). The site is bound to the north, south, east, and west by single-family residence lots. Access to the site is off of an existing gravel private drive on the east side of the site and off of 78th Avenue Southeast on the west side of the site. Existing onsite structures include a single-family residence with a daylight basement and two detached structures. The existing residence and detached buildings are located in the eastern portion of the site. Topography at the site generally slopes down to the west with an average gradient of about 8 percent. Vegetation at the site is largely grass. Please refer to Plate 1, below, to view the site conditions at the time of our reconnaissance on March 8, 2016.

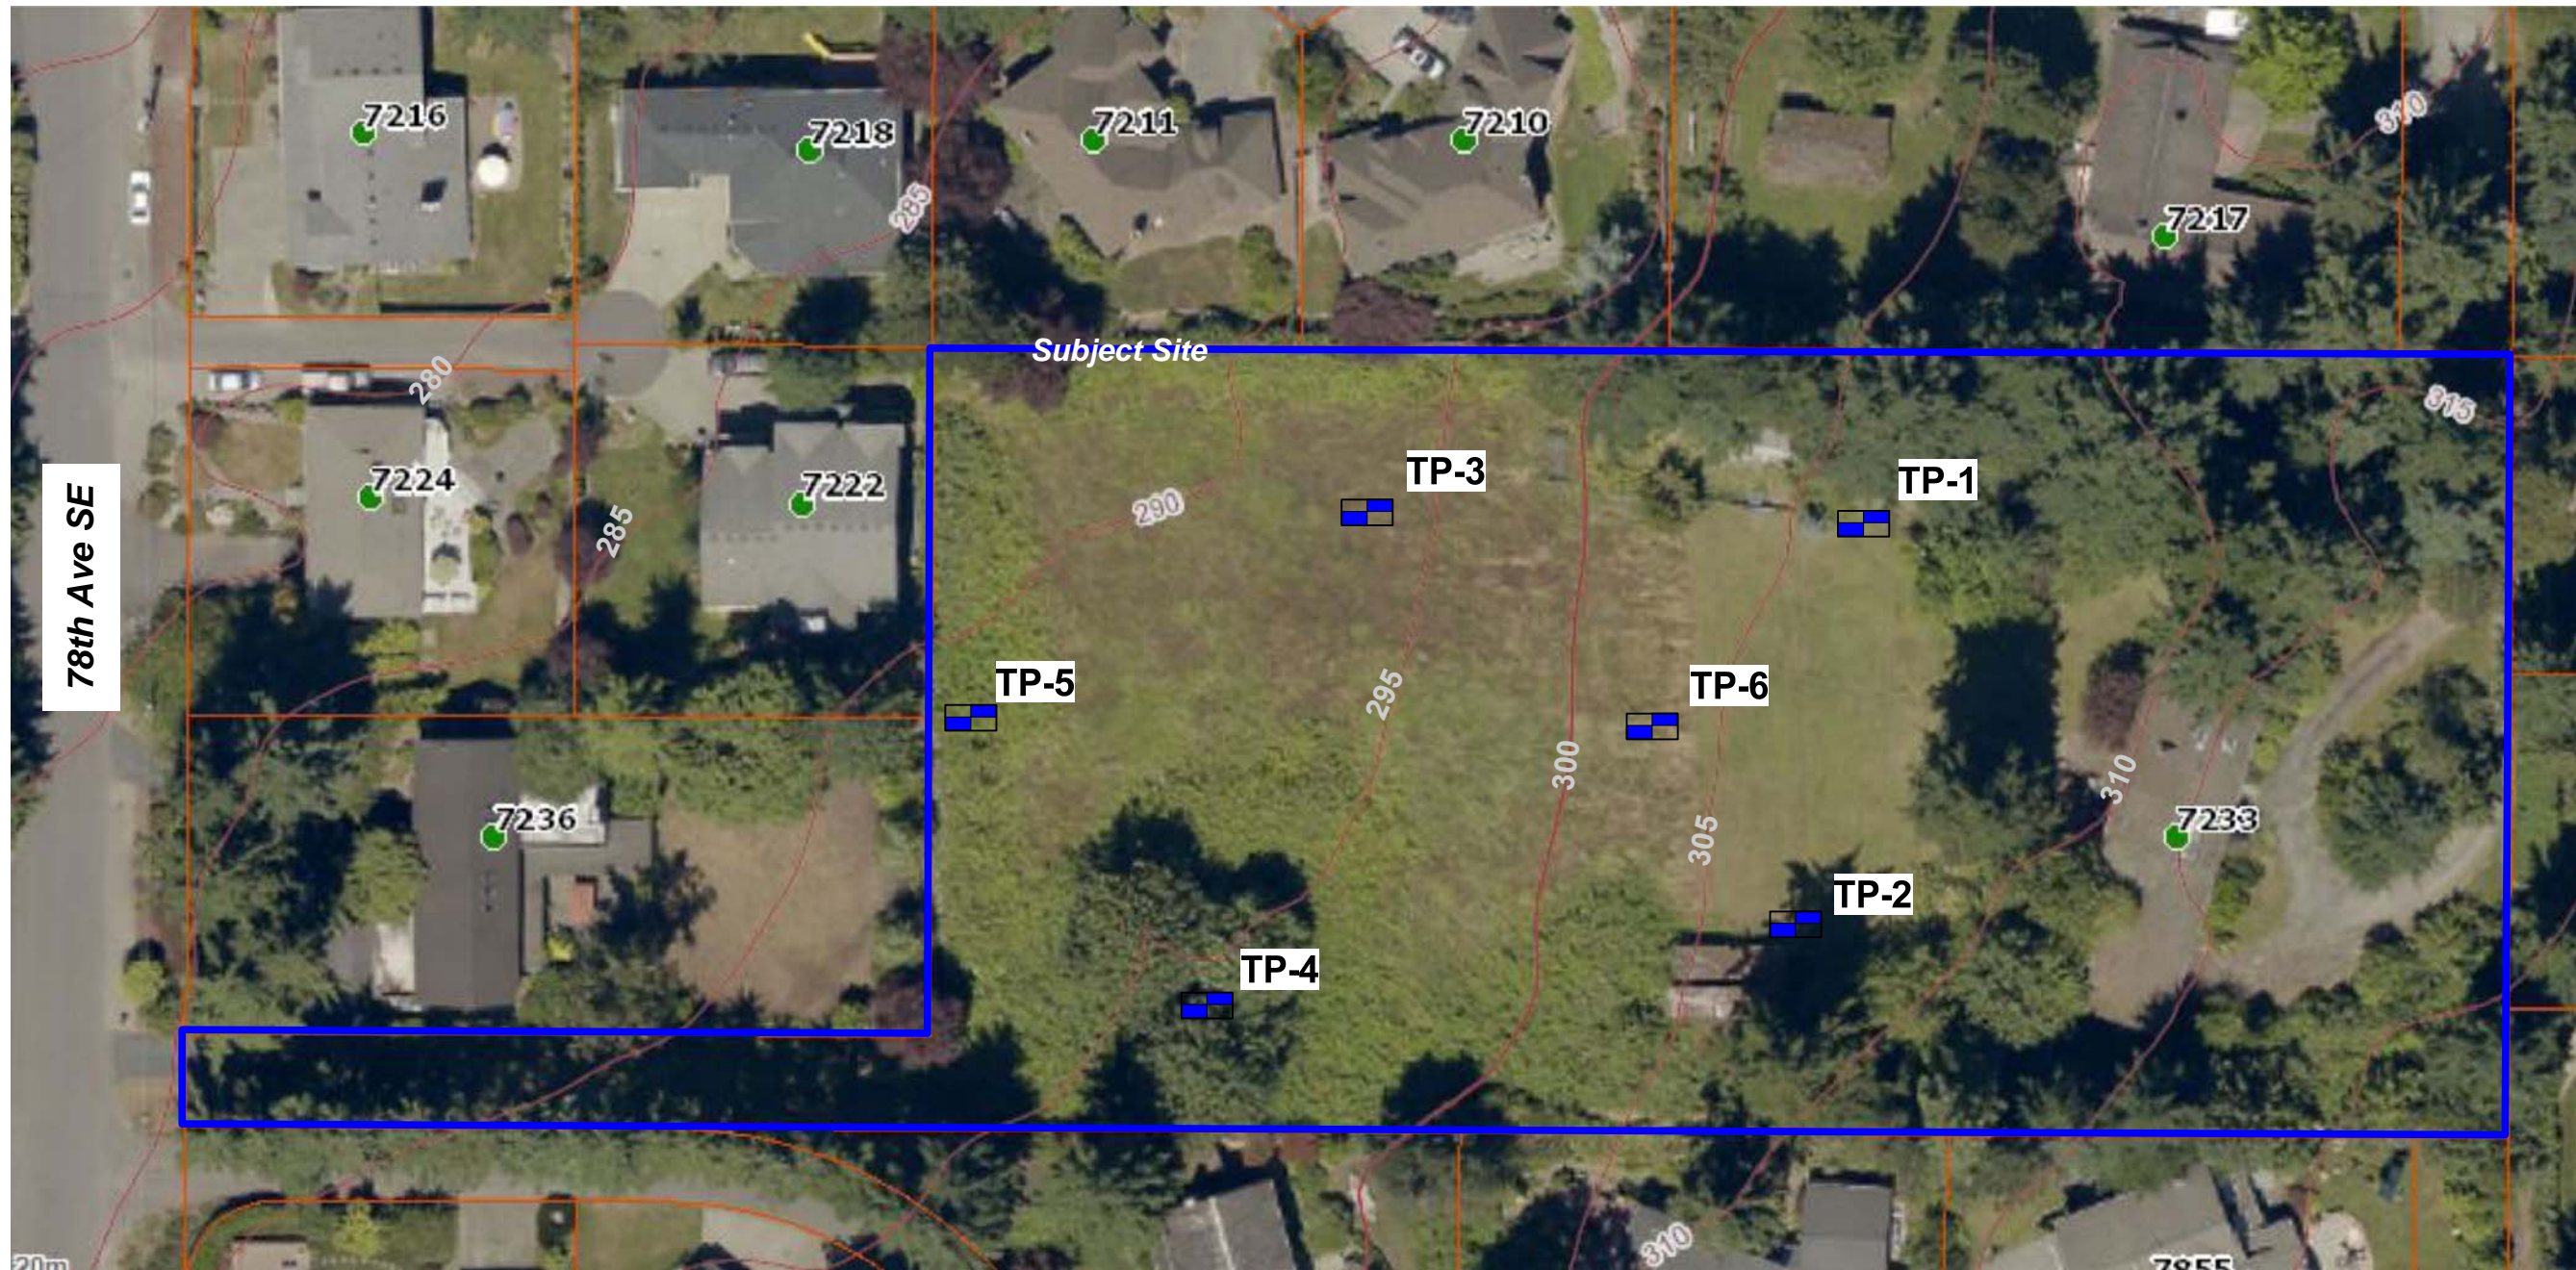
Figure 2. Site and Exploration Plan

Approx. Scale
1" = 50'
0' 25' 50'

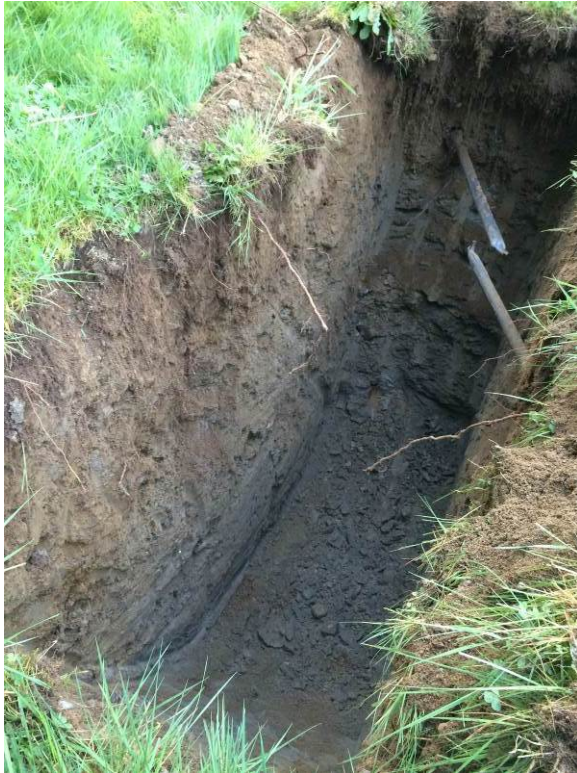
Test Pit TP-2

Ground Surface Conditions: Grass

Depth (ft)	Material Description
0 – ½	Loose, dark brown to black, SILT with sand, moist. (Topsoil & Sod) -Abundant fine roots
½ – 2	Loose to medium dense, orangish-brown, silty SAND with gravel, moist. (Weathered Glacial Till) -Contains charcoal fragments -Numerous roots
2 – 7	Medium dense to dense, brownish-gray, silty SAND with gravel, moist. (Glacial Till) -Iron oxide staining near top of unit -Contains pockets of clean sand and cobbles -Becomes dense to very dense around 5 feet -Groundwater seepage at 5 feet, slight caving
	Test Pit terminated approximately 7 feet below ground surface. Groundwater was encountered at 5 feet below grade at the time of excavation.

Perched groundwater was encountered at depths ranging from 1 to 5½ feet below grade in test pits TP-2 through TP-5 at the time of excavation. In addition, iron oxide staining and mottling were observed within the near surface weathered glacial till soils. The iron oxide staining and mottling were typically noted near the transition from weathered glacial till to fresh glacial till and is likely indicative of a seasonal perched groundwater condition in which groundwater collects above the low permeability glacial till.

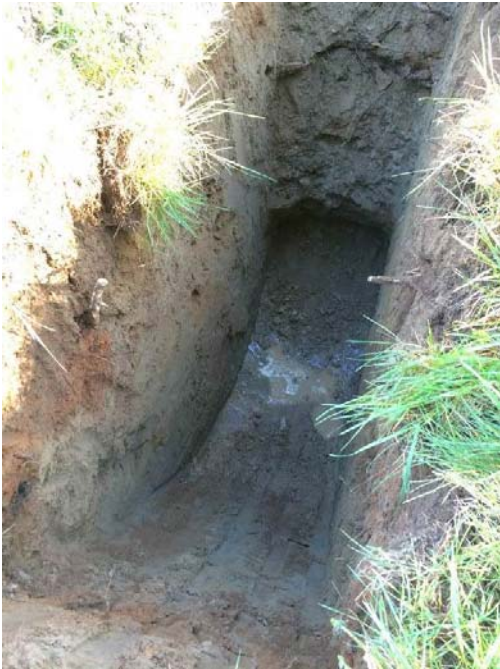
Test Pit TP-3

Ground Surface Conditions: Grass

Depth (ft)	Material Description
0 – 1	Loose, dark brown to black, SILT with sand, moist. (Topsoil & Sod) -Abundant fine roots
1 – 2½	Loose to medium dense, orangish-brown, silty SAND with gravel, moist. (Weathered Glacial Till) -Groundwater seepage at 1-foot -Heavy mottling
2½ – 5	Very dense, gray, silty SAND with gravel, moist. (Glacial Till)
	Test Pit terminated approximately 5 feet below ground surface due to practical excavation refusal. Groundwater was encountered at 1 foot below grade at the time of excavation.

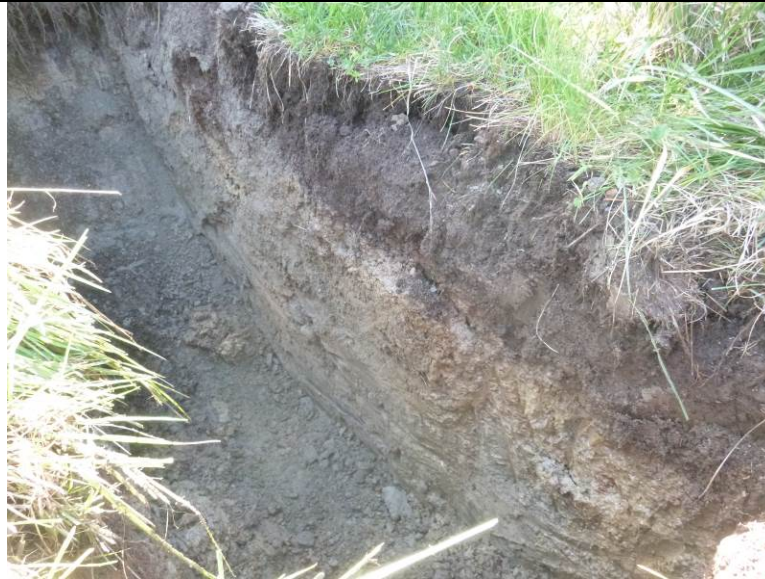
Test Pit TP-4

Ground Surface Conditions: Blackberry brambles

Depth (ft)	Material Description
0 – ½	Loose, dark brown to black, SILT with sand, moist. (Topsoil & Duff) -Abundant fine roots
½ – 1½	Loose to medium dense, orangish-brown, silty SAND with gravel, moist. (Weathered Glacial Till) -Iron oxide staining -Contains charcoal fragments -Numerous roots
1½ – 6	Dense, light gray, silty SAND with gravel, moist to wet. (Glacial Till) -Heavy mottling to 3 feet -Becomes moist around 3 feet -Contains cobbles -Groundwater seepage at 5½ feet
	Test Pit terminated approximately 6 feet below ground surface. Groundwater was encountered at 5½ feet below grade at the time of excavation.

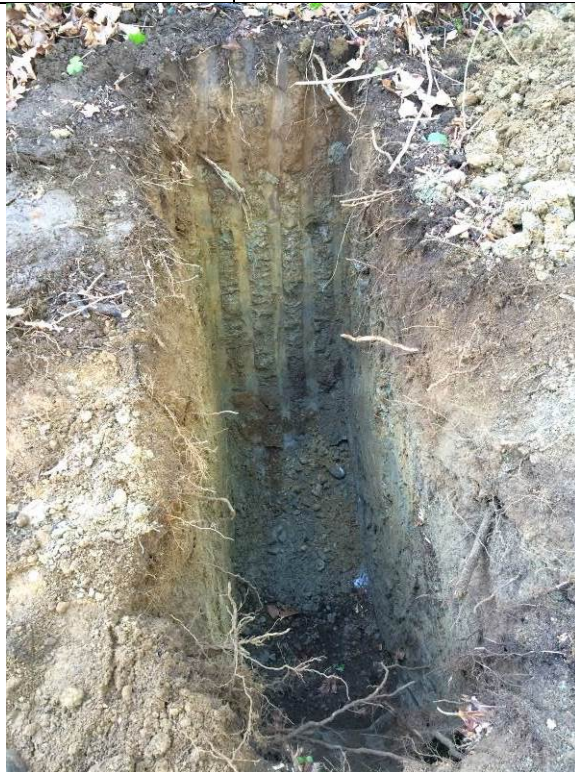
Test Pit TP-5

Ground Surface Conditions: Grass

Depth (ft)	Material Description
0 – ½	Loose, dark brown to black, SILT with sand, moist. (Topsoil & Sod) -Abundant fine roots
½ – 1½	Loose to medium dense, orangish-brown, silty SAND with gravel, moist. (Weathered Glacial Till) -Heavy iron oxide staining -Groundwater seepage at 1½ feet
1½ – 3	Very dense, gray, silty SAND with gravel, moist to wet. (Glacial Till)
	Test Pit terminated approximately 3 feet below ground surface due to practical excavation refusal. Groundwater was encountered at 1½ feet below grade at the time of excavation.

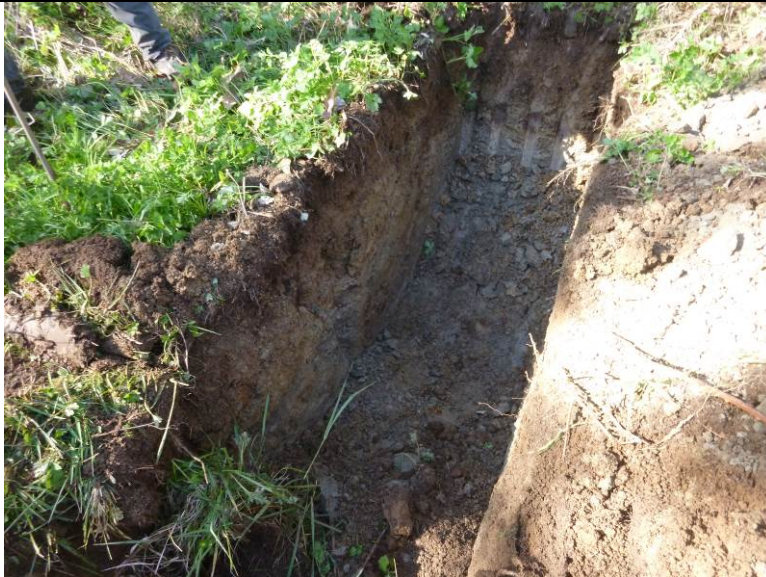
Test Pit TP-6

Ground Surface Conditions: Grass

Depth (ft)	Material Description
0 – ¾	Loose, dark brown to black, SILT with sand, moist. (Topsoil & Sod) -Abundant fine roots
¾ – 2¾	Loose to medium dense, orangish-brown, silty SAND with gravel, moist. (Weathered Glacial Till) -Becomes moist to wet around 2 feet
2¾ - 6	Medium dense to dense, gray, silty SAND with gravel, moist. (Glacial Till) -Iron oxide staining near top of unit -Becomes very dense around 5 feet
	Test Pit terminated approximately 6 feet below ground surface. Groundwater was not encountered at the time of excavation.
