MR 1-9 Storm Drainage Summary

Miller Residence
7238 SE 32nd Street
Mercer Island, WA 98040

6,155 SF
(NEW & REPLACED Impervious)

September 16, 2020

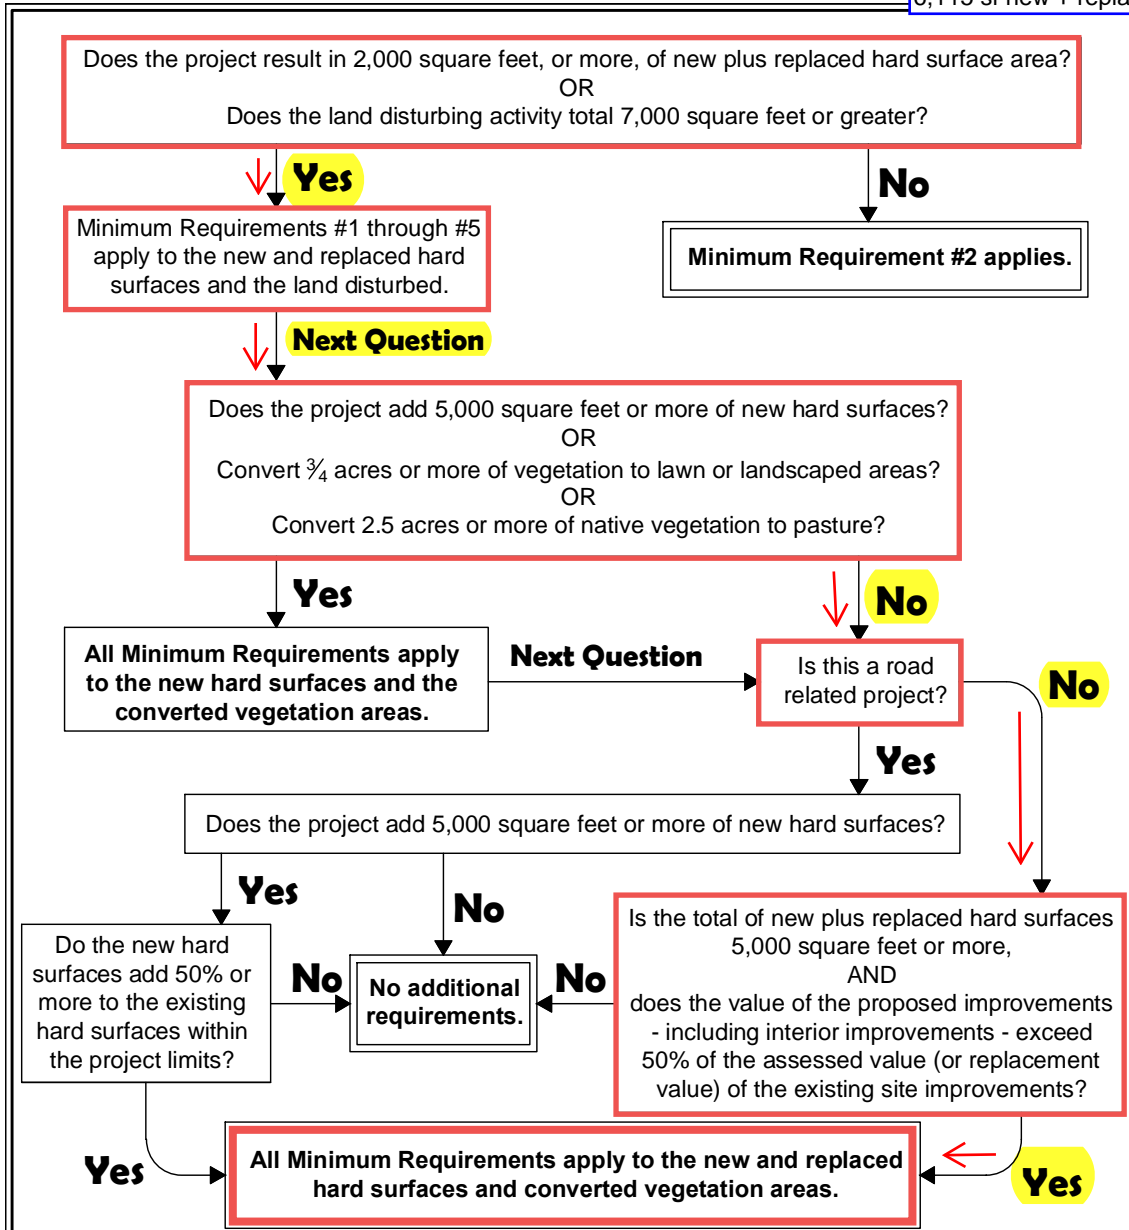
16,128 sf site area
 (1,314) sf new impervious area
 6,115 sf new + replaced impervious area

Figure I-2.4.2
 Flow Chart for Determining Requirements for Redevelopment

- Impervious Area Spreadsheet
- DOE Flowchart for Determining Requirements for New Development pointing to redevelopment
- DOE Flowchart for Determining Requirements for Re-Development showing MR1-9
- Infiltration Evaluation, Earth Solutions NW, August 2020
- WWHM infiltration drywell sizing reports
 - North drywell
 - South drywell

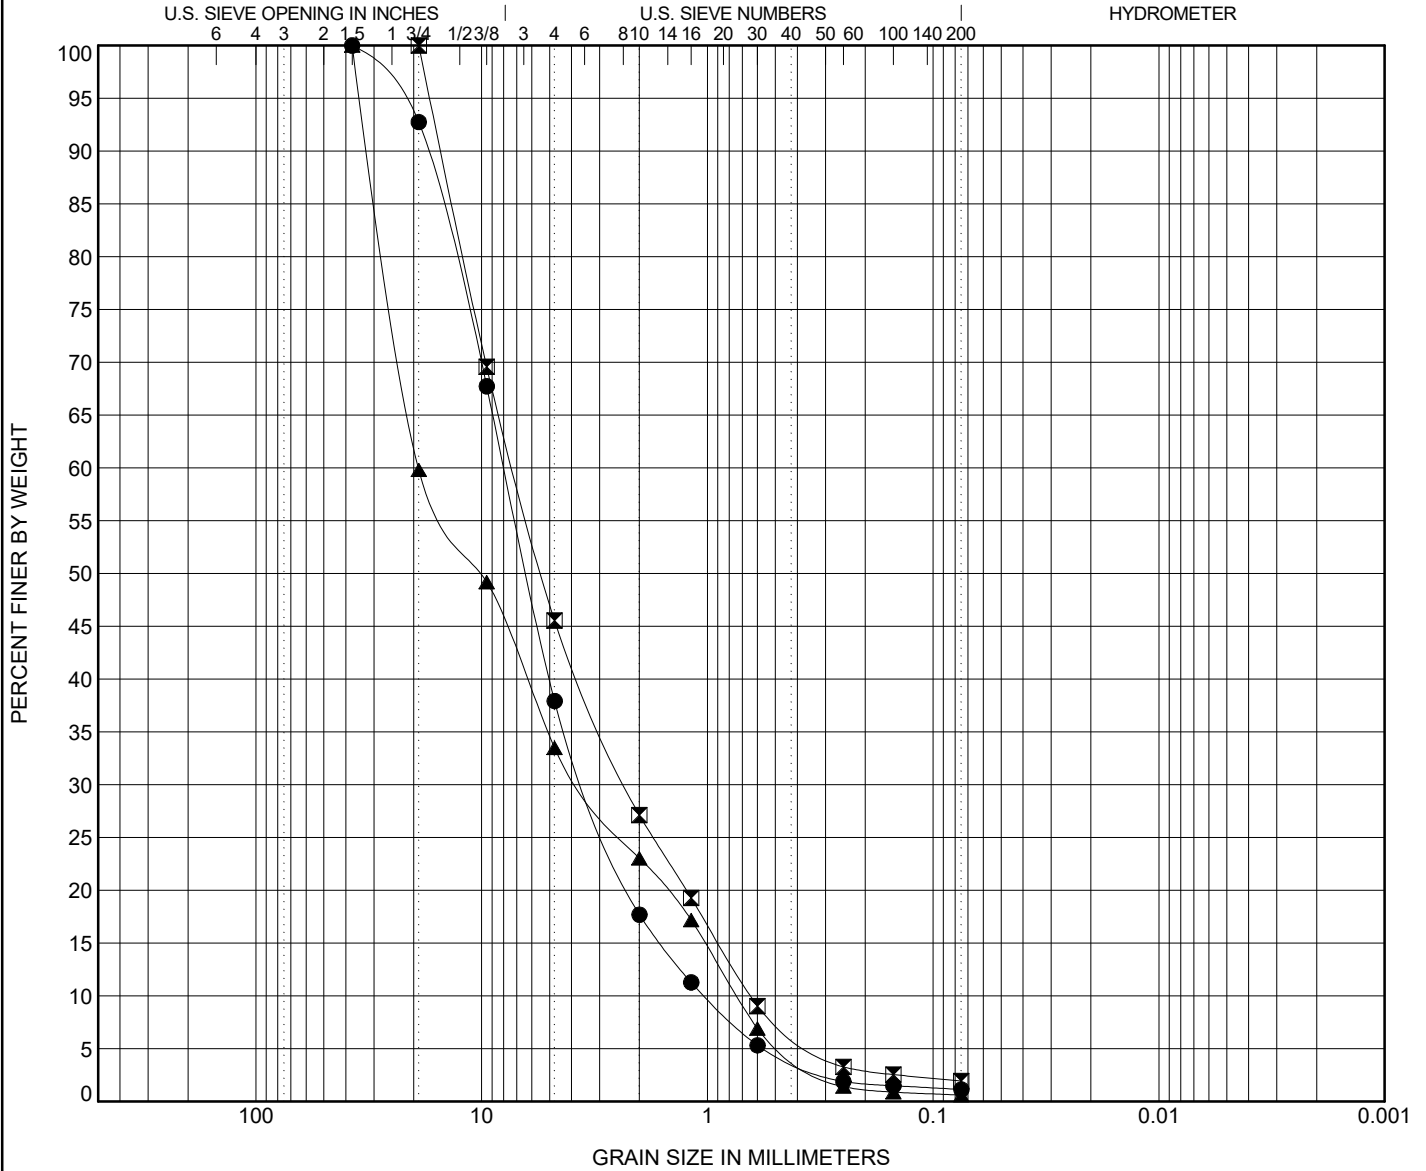
COBBLES	GRAVEL		SAND			SILT OR CLAY
	coarse	fine	coarse	medium	fine

Specimen Identification	Classification				Cc	Cu
● TP-01 4.00ft.	USDA: Gray Extremely Gravelly Coarse Sand. USCS: GW with Sand.				1.41	7.77
⊠ TP-02 4.50ft.	USDA: Gray Extremely Gravelly Coarse Sand. USCS: GW with Sand.				1.14	11.28
▲ TP-02 8.00ft.	USDA: Gray Extremely Gravelly Coarse Sand. USCS: GP with Sand.				0.90	25.93

Underlying about six inches of topsoil and roughly three to four feet of silty sand (USCS: SM) overburden, the native soil was comprised largely of free-draining gravel (USCS: GW or GP) to the maximum exploration depth of approximately eight feet below the existing ground surface (bgs). The in-situ density of the native soil was characterized mainly as medium dense, and caving was not observed at the test locations.
