Anstey Engineering

Storm Drainage Report

7036 81st Avenue SE. Mercer Island, WA 98040

Parcel # 873230-0240

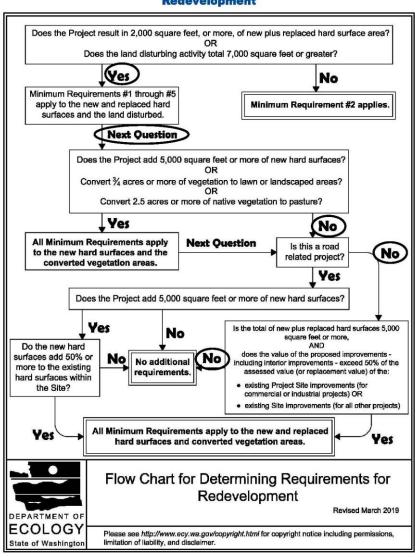
Figure I-3.2: Flow Chart for Determining Requirements for Redevelopment

The project is a re-development project with new plus replaced hard surface totaling 2,751sf of the 10,323-sf lot and disturbed area totaling +/- 3,650 sf. The following path addresses Minimum Stormwater Requirements #1 through 5 need to be satisfied. See the flow chart below. The lot has an existing house, garage, shed/storage, driveway. Garage and shed will be demolished. Driveway will be replaced. New asphalt parking will be installed. See the TESC plan for detail.

As the lot will have less than new/replaced 5,000sf of impervious surface List 1 will be used per Fig I-3.3: Flow Chart for Determining MR#5 Requirements above. On-site stormwater management BMPs have been examined for their feasibility. Due to the lack of a 100 foot flow path Full Dispersion cannot be used. The soils are unsuitable for infiltration (per Mercer Island Infiltration map below) and there is not adequate space for raingardens.

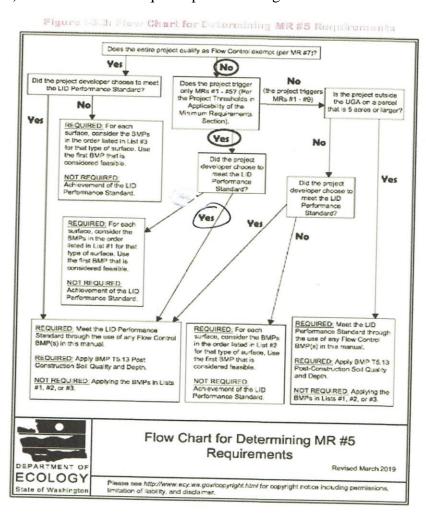
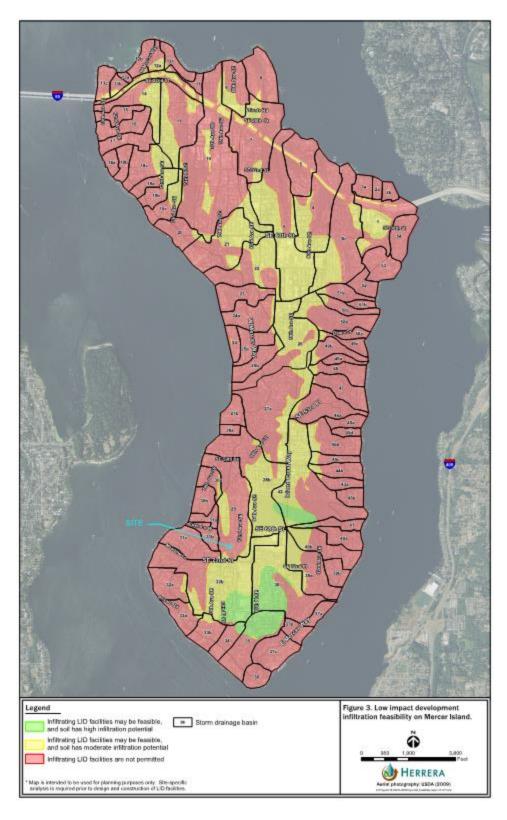
Per Geologic Map of Mercer Island below, the soils are Vashon advance outwash (Qva) which is unsuitable for infiltration. Per Natural Resource Conservation Service Soil Report, the soils are AmC – Arents Alderwood (Gravelly Sandy loam), 6 to 15 percent slopes- which is a Till Type C soil and unsuitable for infiltration.

Full infiltration cannot be used per Mercer Island Infiltration map, and the Till soils are unsuitable for infiltration.

Per Geologic Map of Mercer Island below, the soils are Vashon Advance outwash (Qva) which is unsuitable for infiltration, and Mercer Island infiltration map shows that the site is infeasible for infiltration.

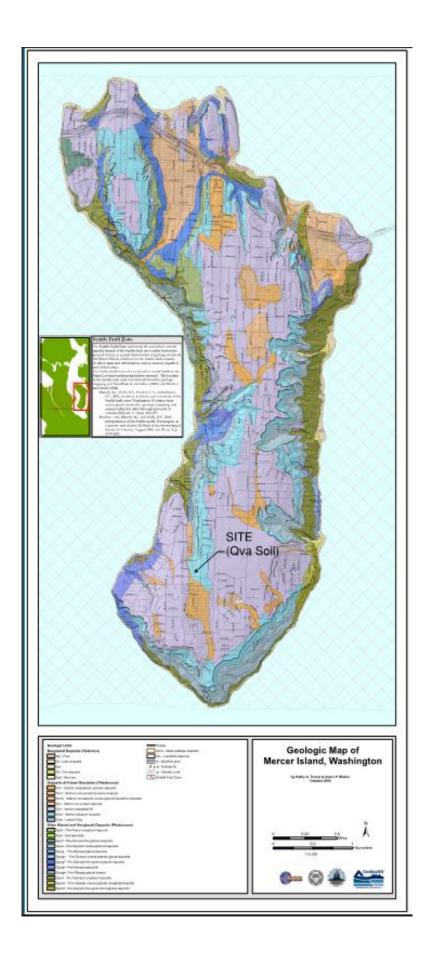
H1 - 0 to 26 inches: Gravelly sandy loam

H2 - 26 to 60 inches: Very Gravelly sandy loam
