Mercer Island Mixed-Use

2885 78th Avenue Southeast
Mercer Island, WA

Drainage Report

Geotechnical Engineering Design Report
Mercer Island Multi-Family
Development
Seattle, Washington

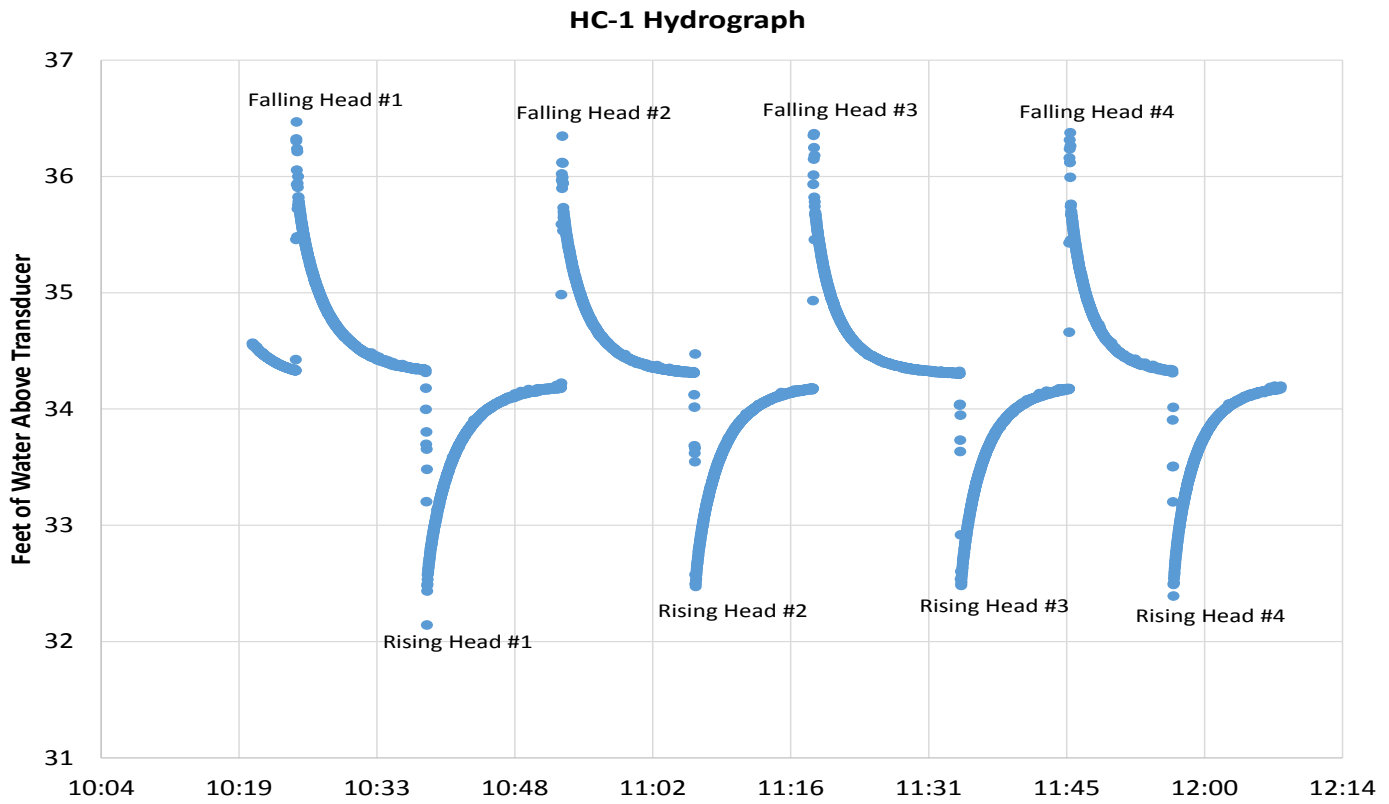
1

HC-1 and HC-2 Hydrographs

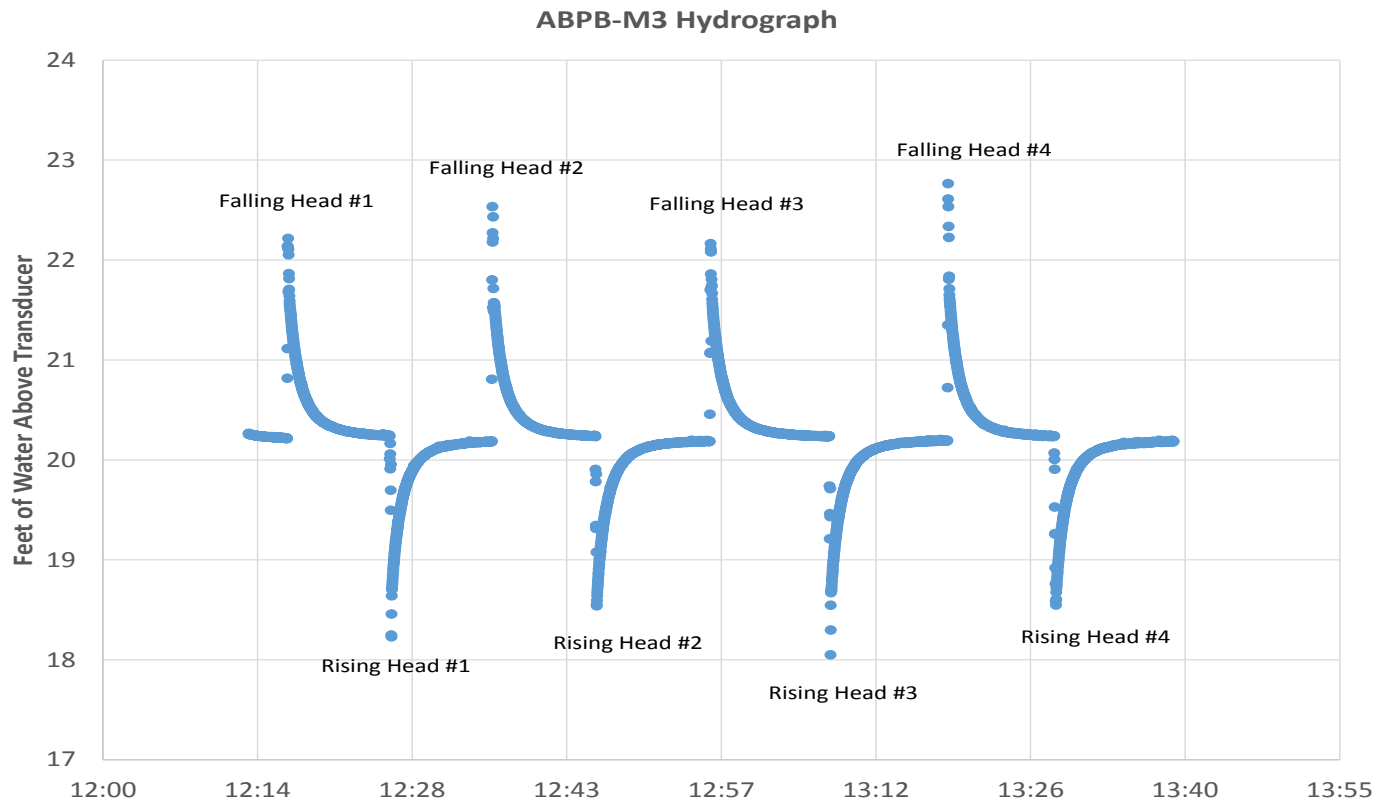
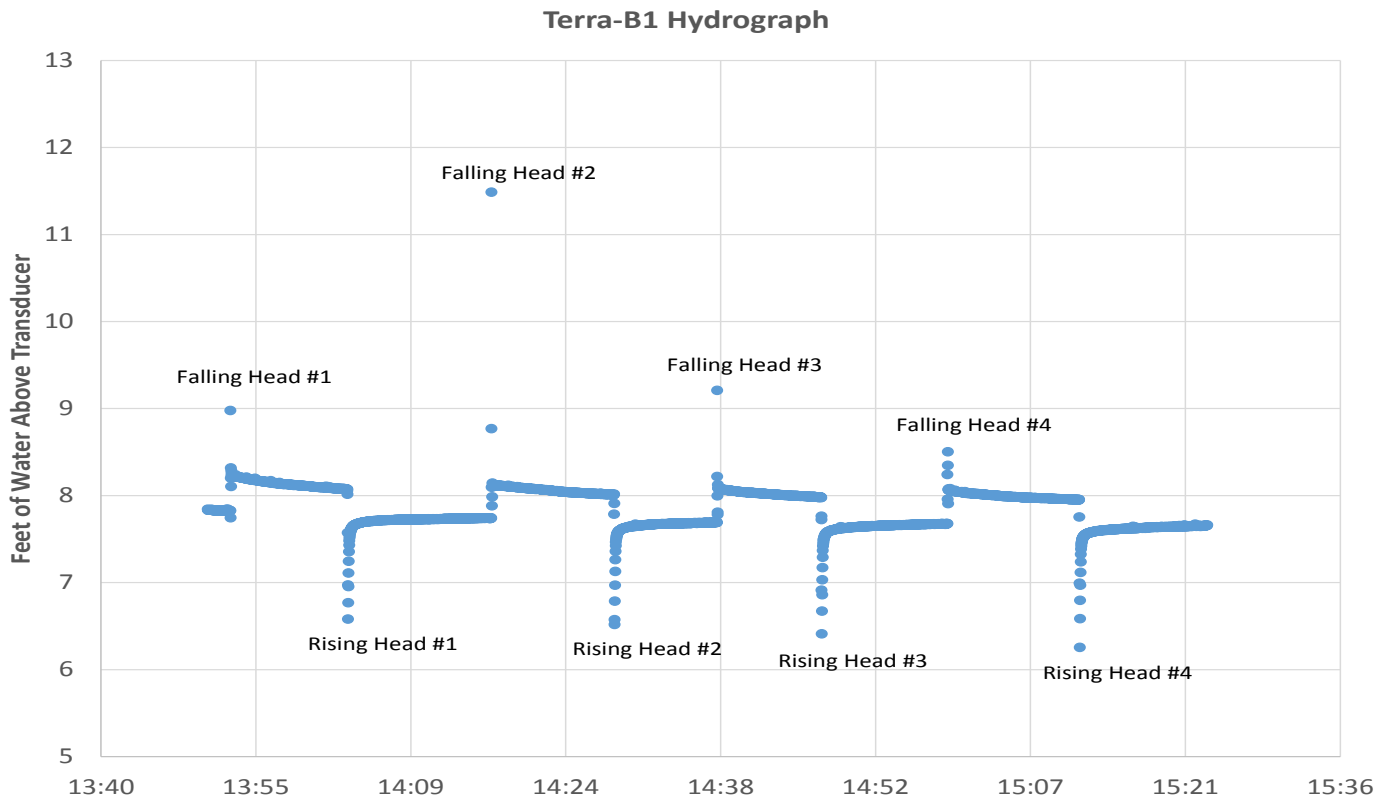
2

ABPB-M3 and Terra B-1 Hydrographs

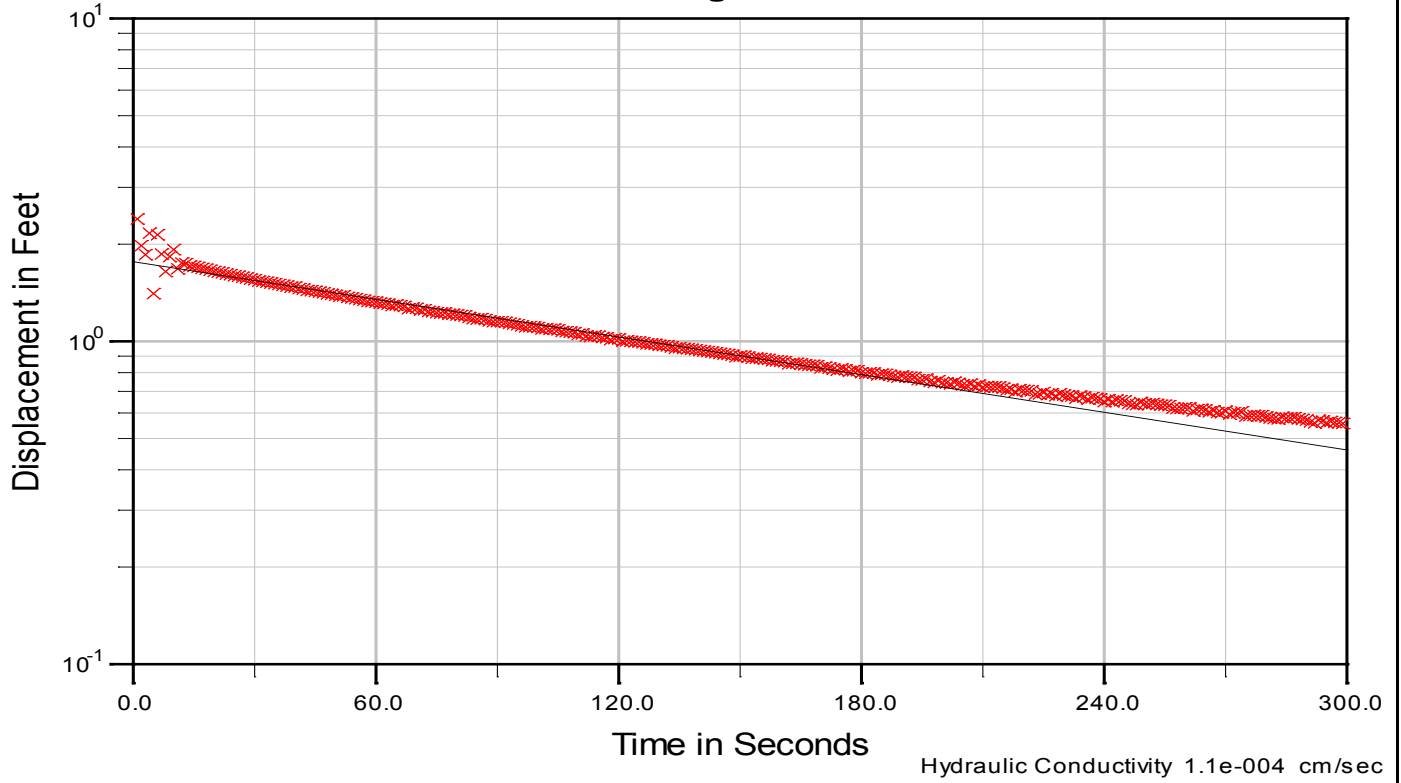
HC-1 Falling Head Test #1

HC-1 Rising Head #1

Note:
Bouwer and Rice method was used for the slug test analysis.

Well ID	Test Type	Test Number	Bouwer and Rice	
			K in ft/day	K in cm/sec
HC-1	Falling Head	Test 1	0.3	1.1E-04
	Rising Head	Test 1	0.4	1.4E-04
	Falling Head	Test 2	0.3	1.2E-04
	Rising Head	Test 2	0.4	1.5E-04
	Falling Head	Test 3	0.4	1.5E-04
	Rising Head	Test 3	0.4	1.5E-04
	Falling Head	Test 4	0.4	1.4E-04
	Rising Head	Test 4	0.4	1.5E-04
		<i>Average</i>	<i>0.4</i>	<i>1.4E-04</i>
HC-2	Falling Head	Test 1	2.4	8.4E-04
	Rising Head	Test 1	2.6	9.2E-04
	Falling Head	Test 2	2.1	7.5E-04
	Rising Head	Test 2	2.2	7.7E-04
	Falling Head	Test 3	2.6	9.3E-04
	Rising Head	Test 3	2.4	8.6E-04
	Falling Head	Test 4	1.9	6.6E-04
	Rising Head	Test 4	2.7	9.4E-04
		<i>Average</i>	<i>2.4</i>	<i>8.3E-04</i>
ABPB-M3	Falling Head	Test 1	1.8	6.3E-04
	Rising Head	Test 1	1.8	6.2E-04
	Falling Head	Test 2	1.8	6.5E-04
	Rising Head	Test 2	1.9	6.6E-04
	Falling Head	Test 3	1.6	5.7E-04
	Rising Head	Test 3	1.9	6.8E-04
	Falling Head	Test 4	1.9	6.7E-04
	Rising Head	Test 4	2.1	7.3E-04
