Subject: **Transmittal Letter – Geotechnical Engineering Study and Critical Area Study**
Proposed New Residence
8163 West Mercer Way
Mercer Island, Washington

GEOTECHNICAL ENGINEERING STUDY
Proposed New Residence
8163 West Mercer Way
Mercer Island, Washington

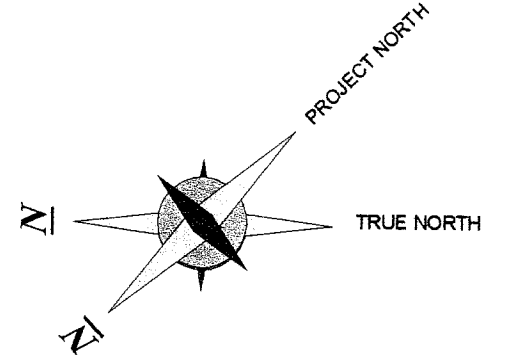
SITE EXPLORATION PLAN
8229 West Mercer Way
Mercer Island, Washington

- FIRE HYD.
- WATER VALVE
- POWER POLE
- EXISTING CATCH BASIN
- SET 1" BY 2' STAKE
- SET "PK" NAIL WITH SHINER
- FOUND REBAR & CAP 18077
- FOUND REBAR
- FOUND PLAT MONUMENT
- MAPLE TREE 1 TO 2 FEET
- ALDER TREE 18" +/-
- MADONNA TREE 18" +/-
- B-1 APPROXIMATE LOCATION
of GEOTECH CONSULTANTS
BORING SEPTEMBER 1999

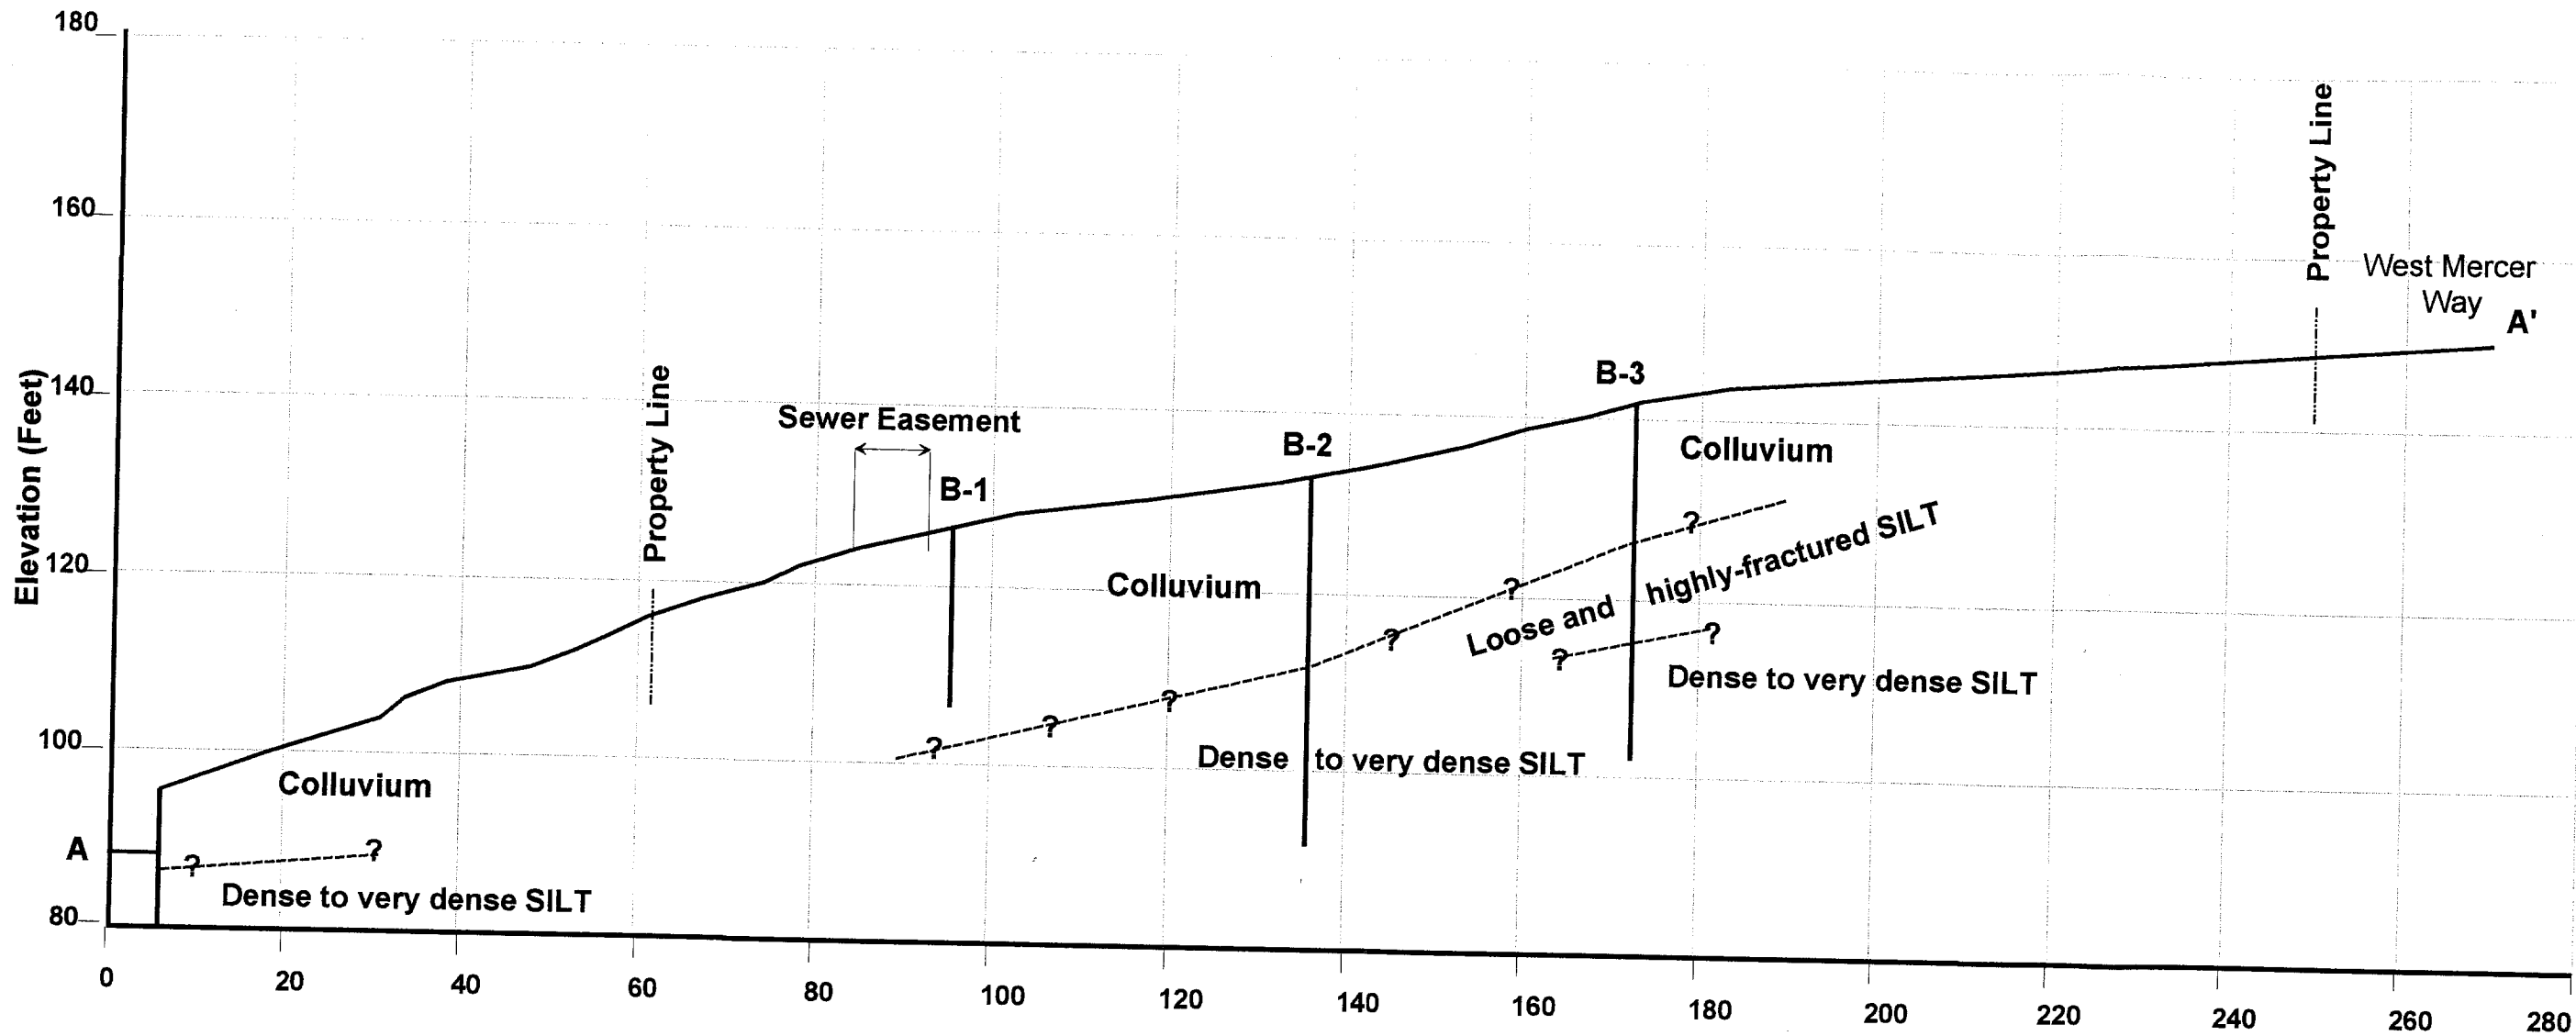
SUBSURFACE CROSS SECTION
 8229 West Mercer Way
 Mercer Island, Washington

**Test Borings completed by Geotech Consultants on September 15, 1999**
