# **GEO TECHNICAL REPORT**

**Mercer Island Residence  
3310 – 97th Avenue SE  
Mercer Island, Washington**

**Project No. T-8257**

**Terra Associates, Inc.**

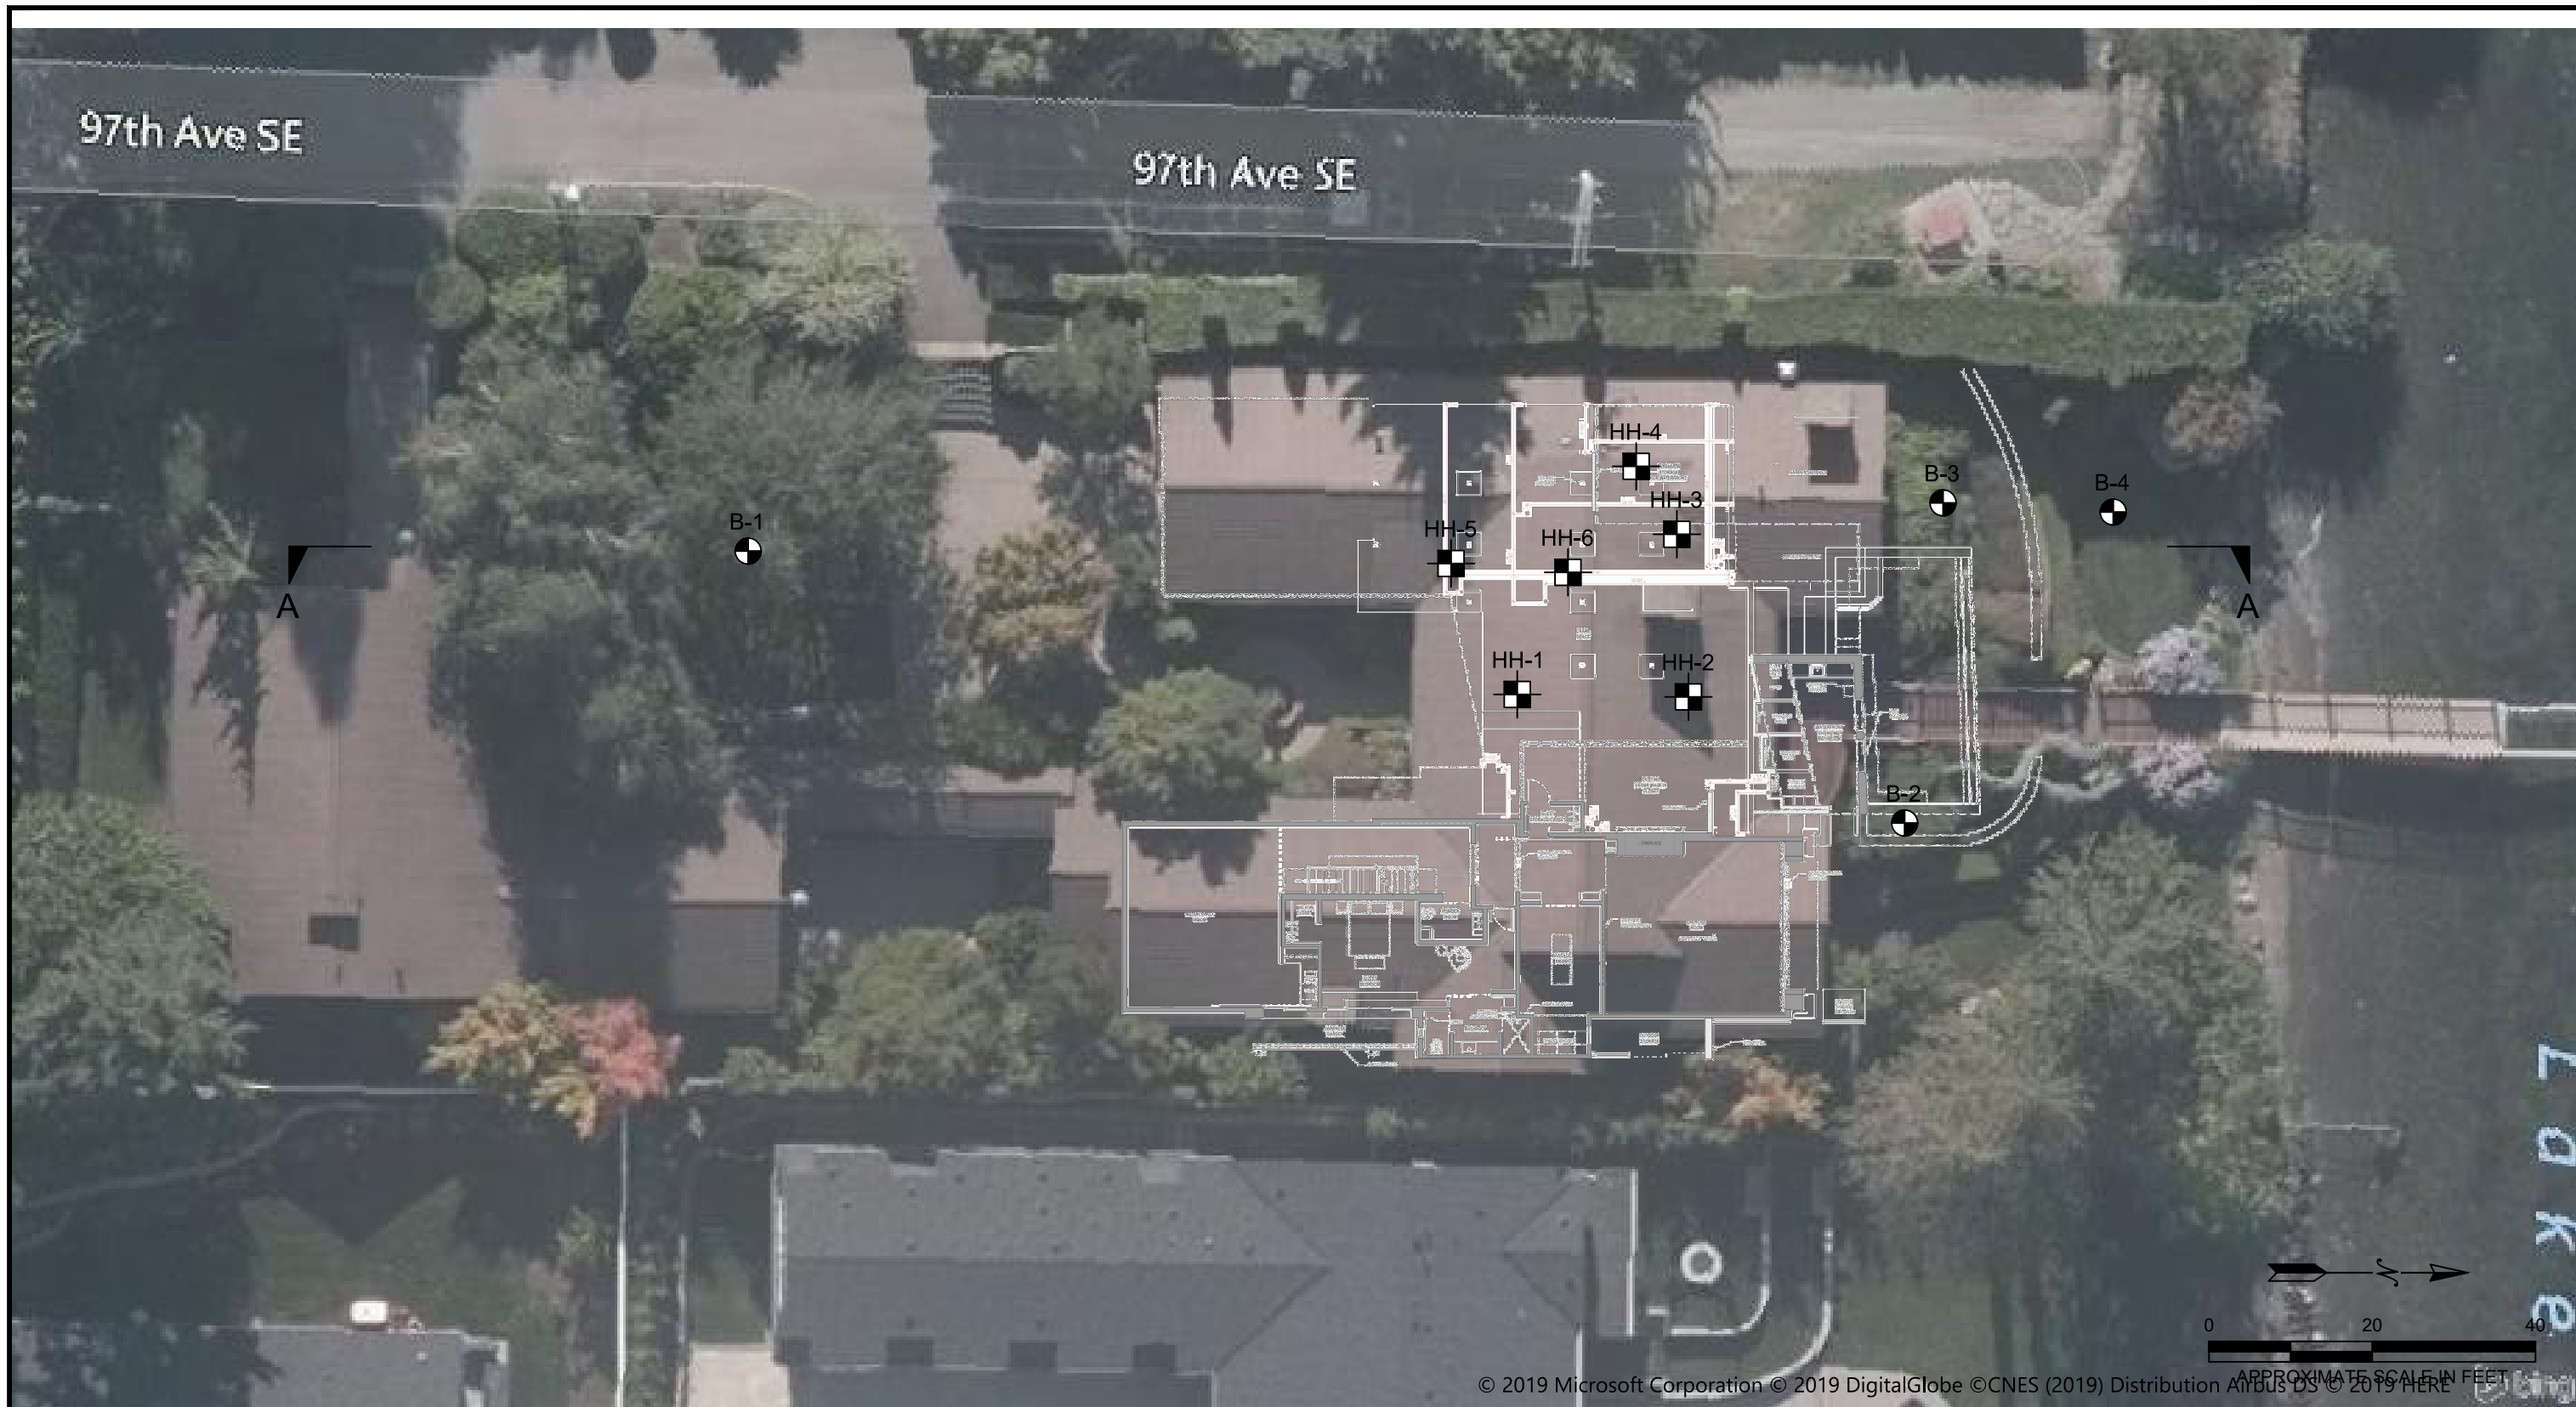
Proj.No. T-8257	Date: JAN 2021	Figure 2
-----------------	----------------	----------

**EXPLORATION LOCATION PLAN  
 MERCER ISLAND RESIDENCE  
 MERCER ISLAND, WASHINGTON**

The preceding discussion is intended to be a general review of the soil conditions encountered. For more detailed descriptions, please refer to the Test Boring and Hand Hole logs in Appendix A. The approximate location of the Test Borings and Hand Holes are shown on Figure 2.

Since part of the proposed construction includes replacing the soil at the toe of the slope with a pool, we completed a slope stability analysis to determine if this could potentially cause some instability. Our analysis was completed at a location designated as Cross-Section A-A’ using the computer program Slide 2018. The approximate cross-section location is shown on Figure 2.

On November 18, 2019, we completed our site exploration by observing soil and groundwater conditions at 4 test borings and 6 hand holes. The machine operated test borings were performed by using a limited-access drill rig for the south side of the house to a depth of 21.5 feet and a portable smaller machine for the remaining 3 borings north of the house to a maximum depth of 10 feet. Hand holes were dug by using a hand-operated auger to a maximum depth of 1.5 feet below grade. Test boring locations were determined in the field by measurements from existing site features and buildings. The approximate location of the test borings is shown on the attached Exploration Location Plan, Figure 2. Test Boring Logs are attached as Figures A-2 through A-11.

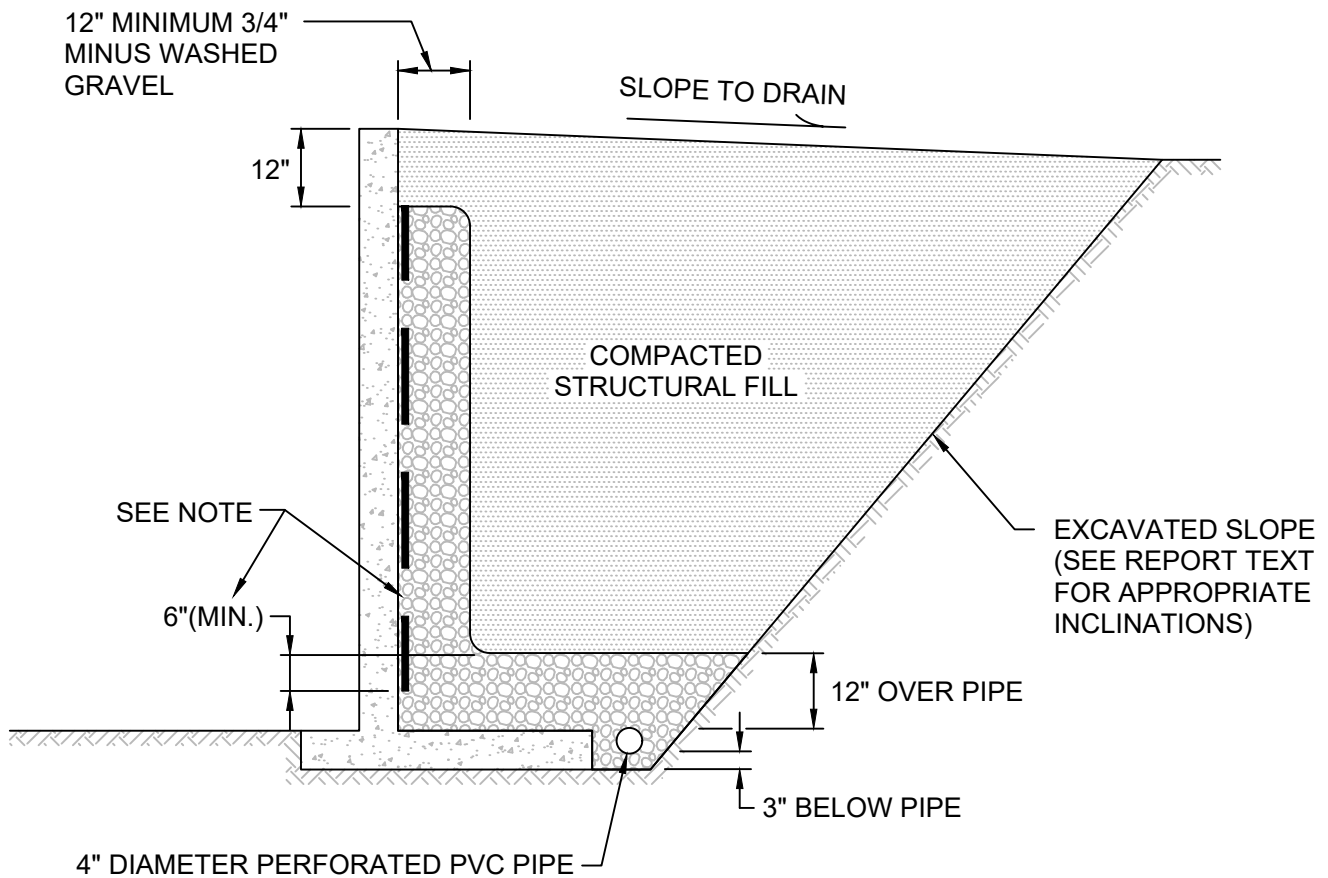
**NOT TO SCALE**

Vicinity Map .....	Figure 1
Exploration Location Plan .....	Figure 2
Typical Wall Drainage Detail .....	Figure 3

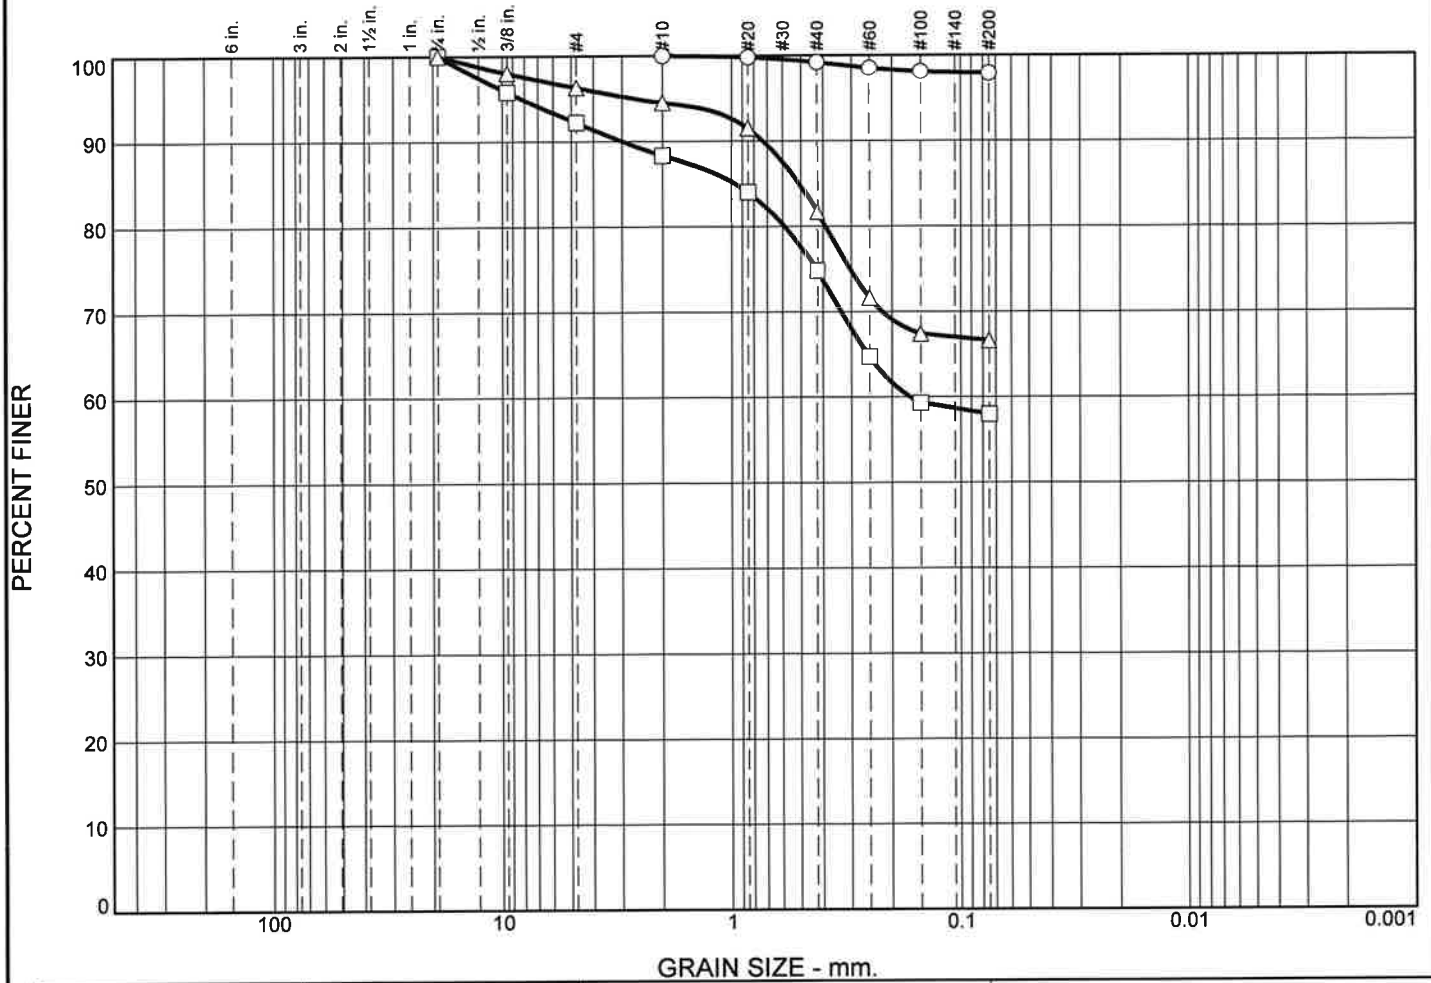
# Particle Size Distribution Report

% +3"	% Gravel		% Sand			% Fines			
		Coarse	Fine	Coarse	Medium	Fine	Silt	Clay		
○	0.0	0.0	0.0	0.0	0.8	1.3	97.9			
□	0.0	0.0	7.8	3.9	13.5	16.8	58.0			
△	0.0	0.0	3.7	1.8	12.8	15.1	66.6			
⊗	LL	PL	D85	D60	D50	D30	D15	D10	Cc	Cu
○										
□			0.9691	0.1668						
△			0.5099

Material Description	USCS	AASHTO
○ SILT	ML	
□ Sandy SILT	ML	
△ Sandy SILT	ML

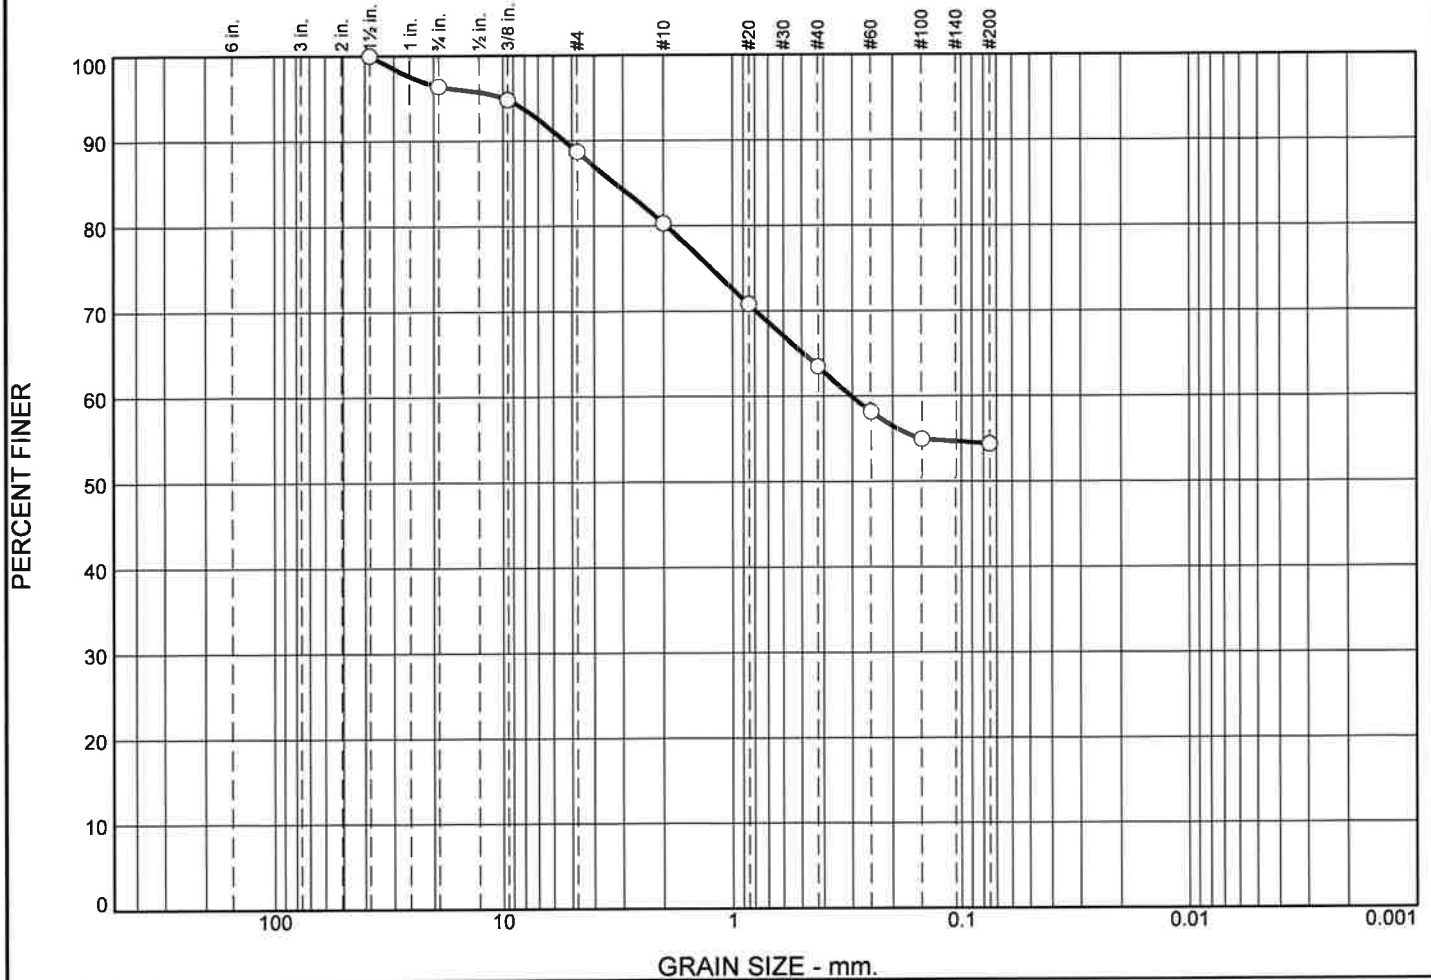
# Particle Size Distribution Report

% +3"	% Gravel		% Sand			% Fines			
		Coarse	Fine	Coarse	Medium	Fine	Silt	Clay		
<input type="radio"/>	0.0	3.6	7.7	8.4	16.8	9.1	54.4			
<input checked="" type="checkbox"/>	LL	PL	D <sub>85</sub>	D <sub>60</sub>	D <sub>50</sub>	D <sub>30</sub>	D <sub>15</sub>	D <sub>10</sub>	C <sub>c</sub>	C <sub>u</sub>
<input type="radio"/>			3.2384	0.3032

Material Description	USCS	AASHTO
<input type="radio"/> Sandy SILT	ML

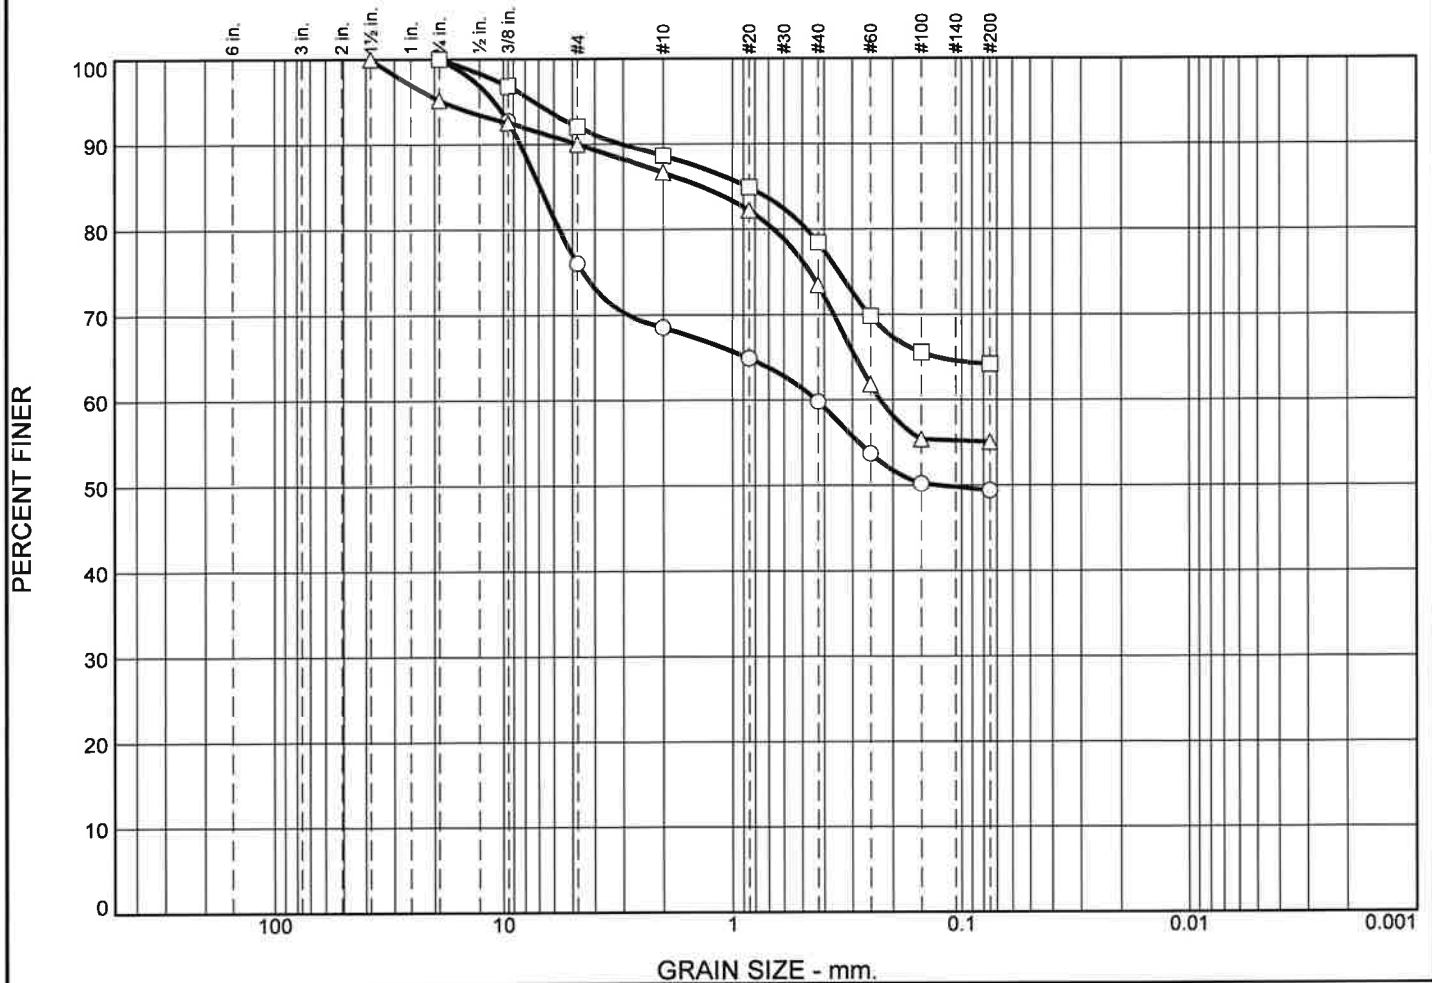
# Particle Size Distribution Report

% +3"		% Gravel		% Sand			% Fines		
			Coarse	Fine	Coarse	Medium	Fine	Silt	Clay	
○	0.0		0.0	24.0	7.5	8.7	10.4	49.4		
□	0.0		0.0	8.0	3.4	10.2	14.2	64.2		
△	0.0		4.8	5.2	3.4	13.2	18.3	55.1		
⊗	LL	PL	D <sub>85</sub>	D <sub>60</sub>	D <sub>50</sub>	D <sub>30</sub>	D <sub>15</sub>	D <sub>10</sub>	C <sub>c</sub>	C <sub>u</sub>
○			6.8927	0.4332	0.1261					
□			0.8647							
△			1.3612	0.2261

Material Description	USCS	AASHTO
○ SILT with sand and gravel	ML	
□ SILT with sand	ML	
△ Sandy SILT	ML

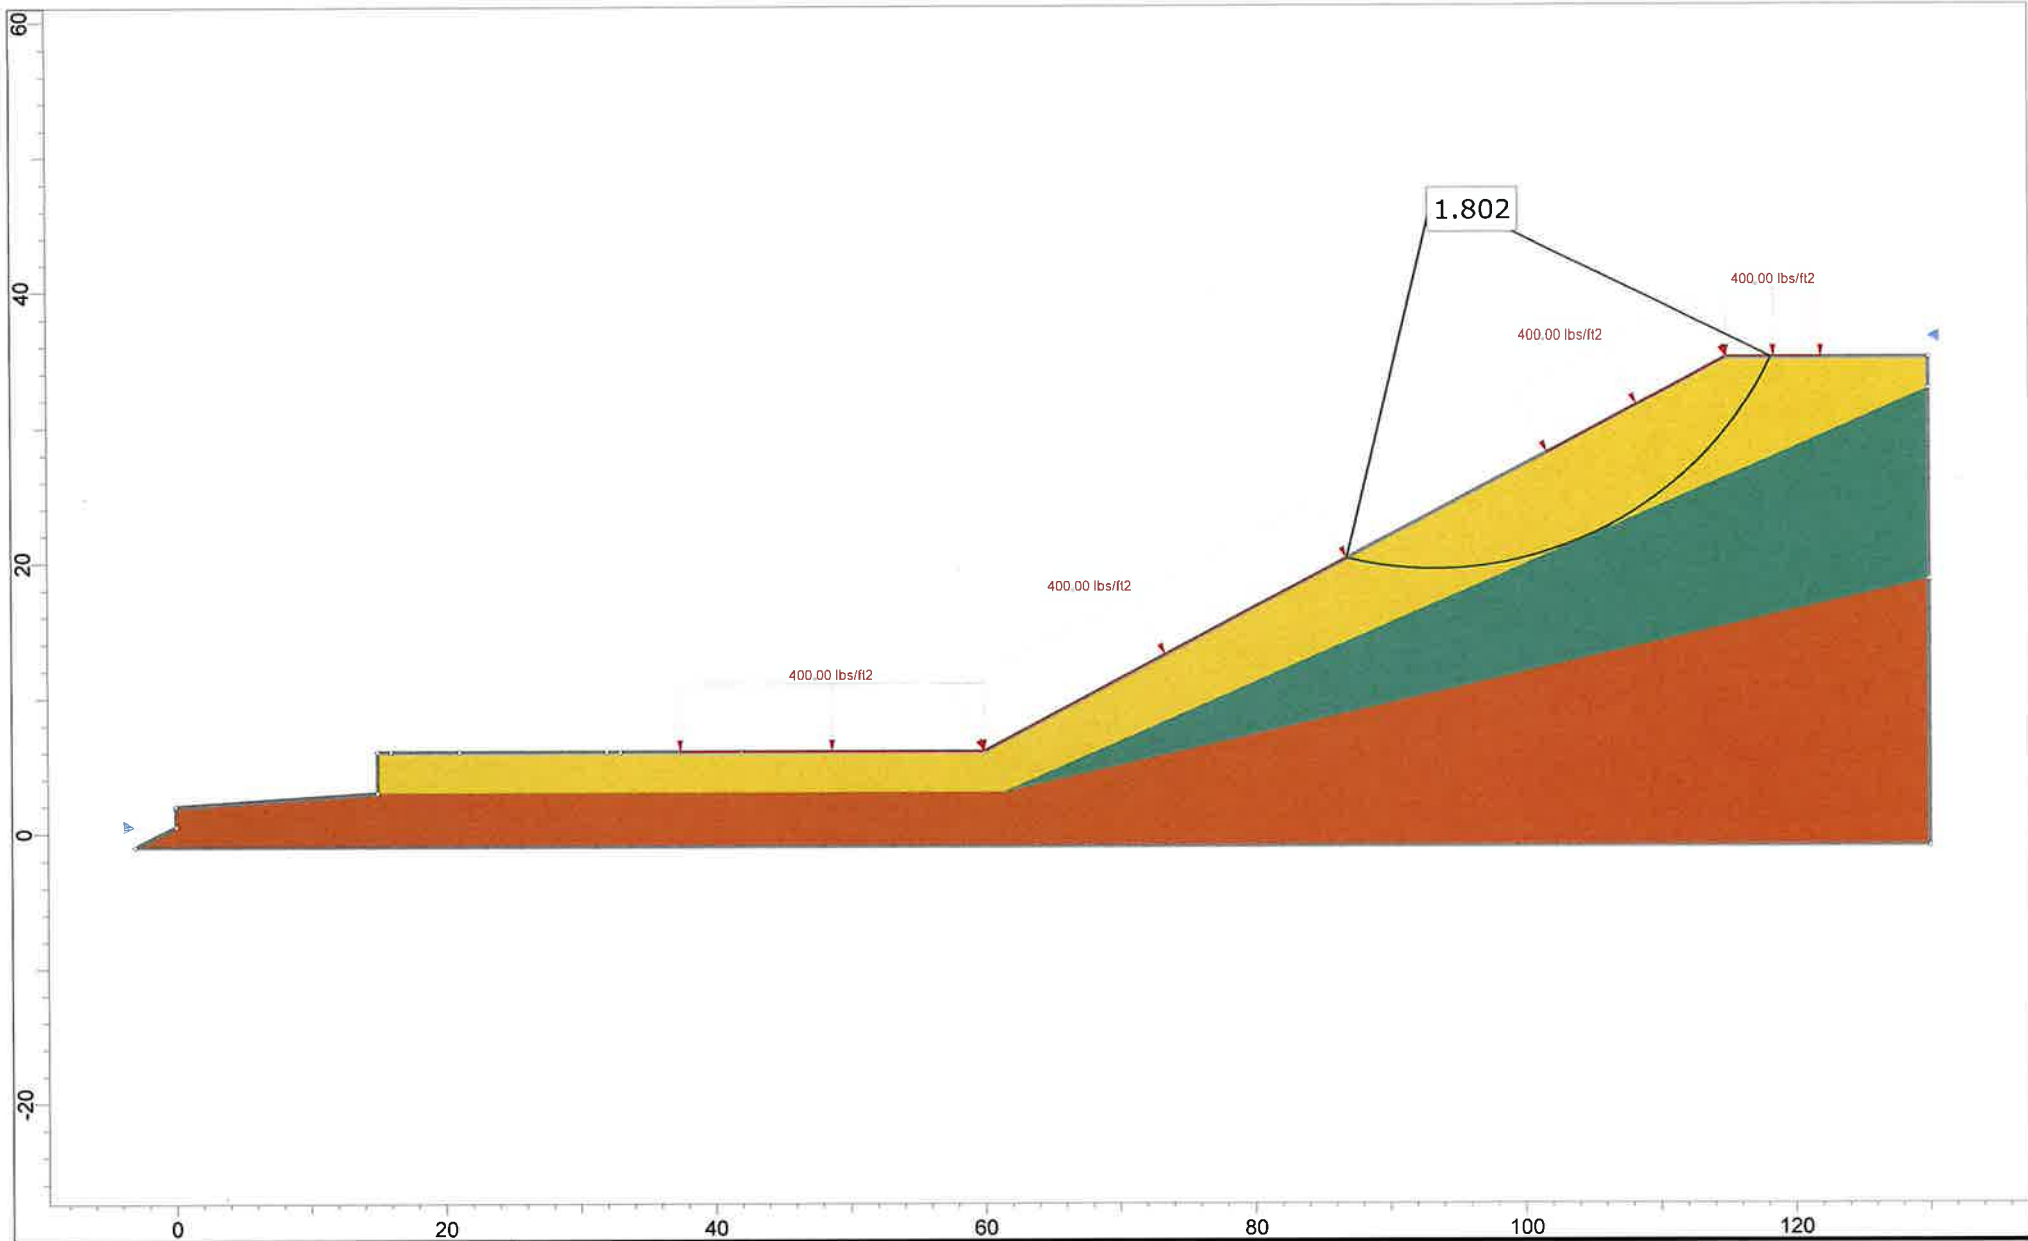
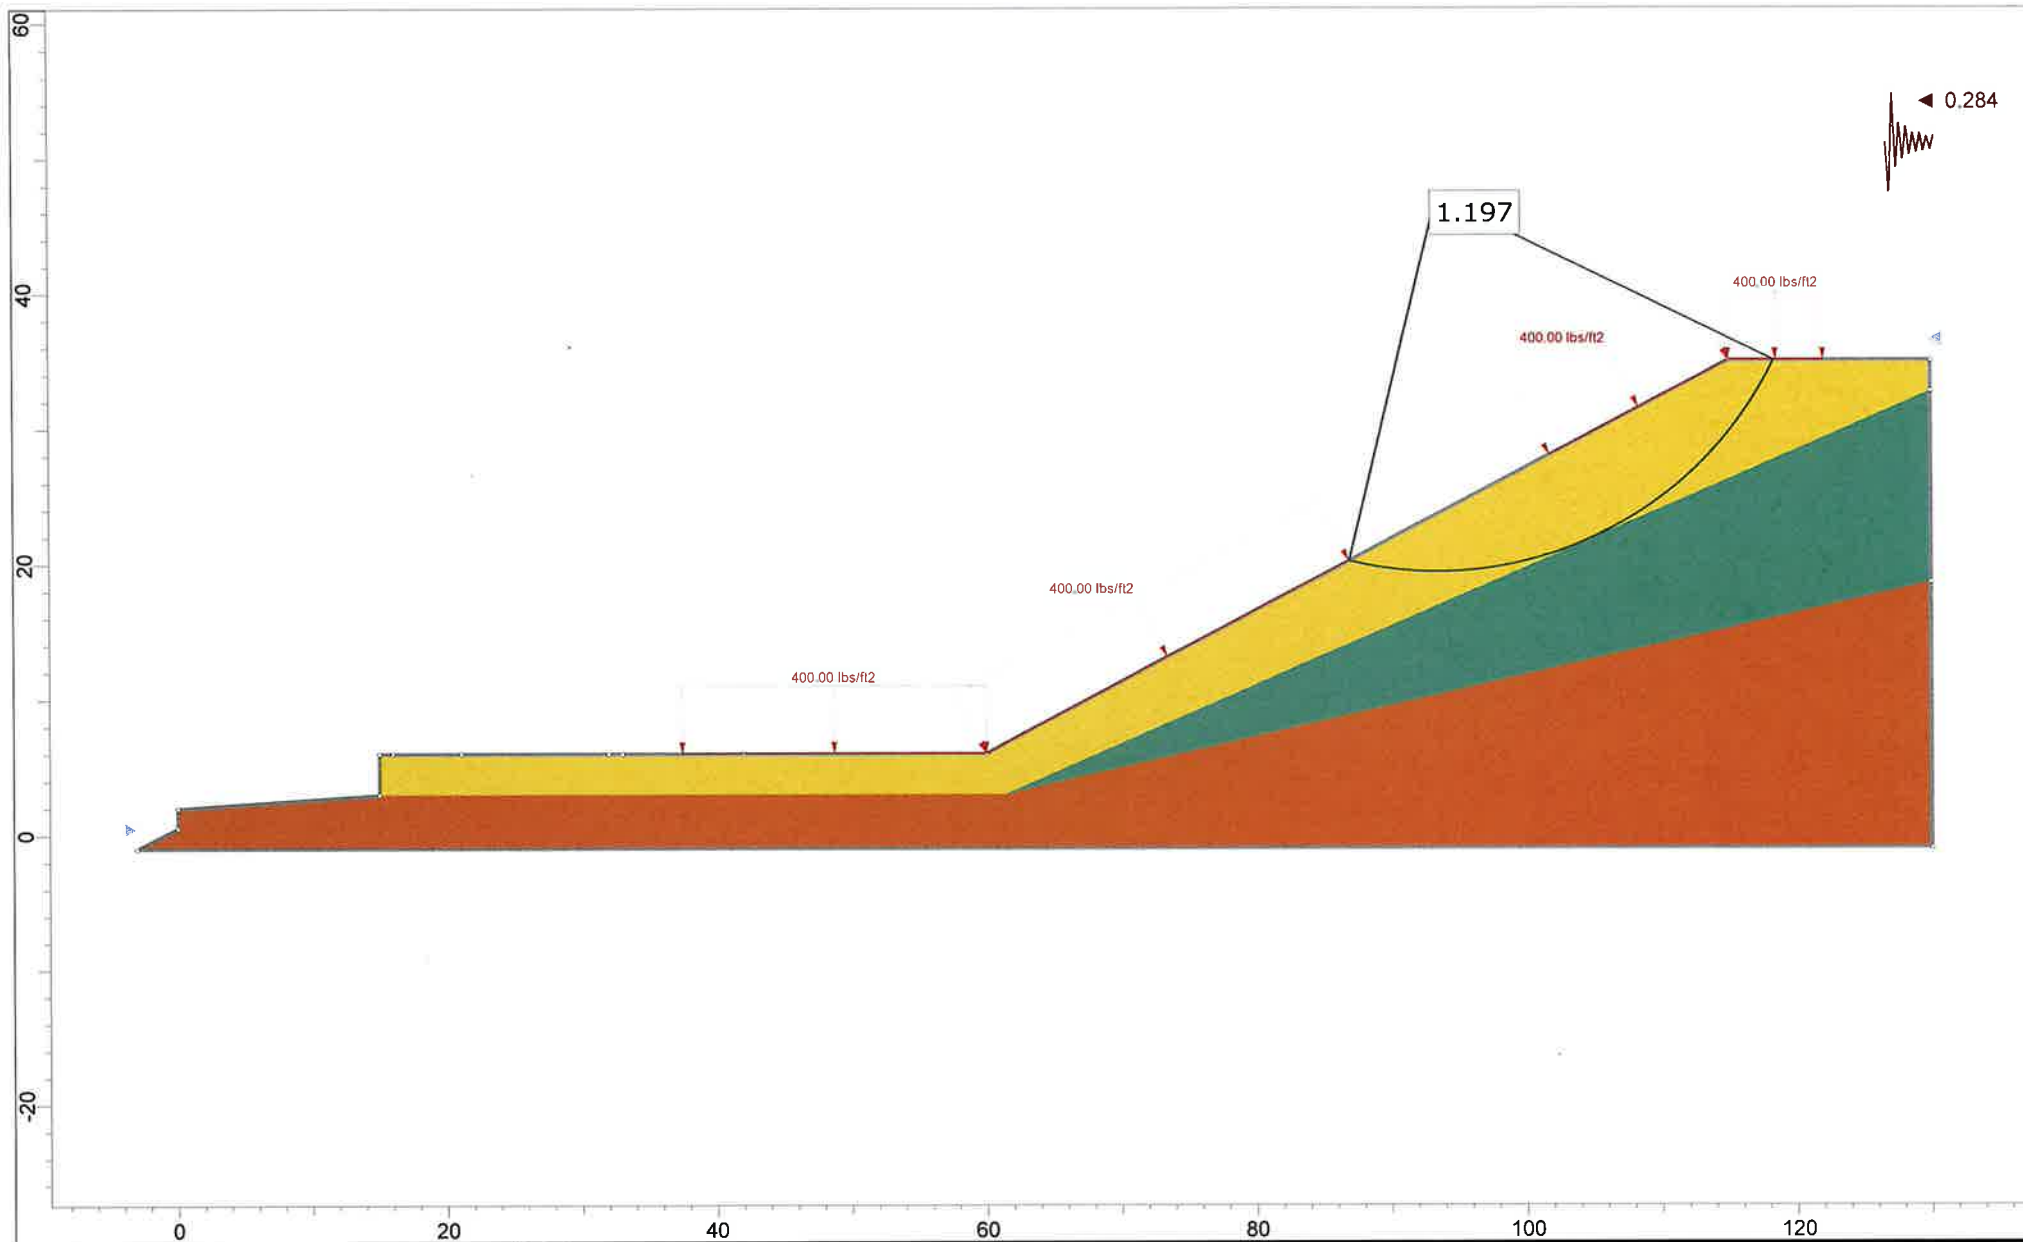
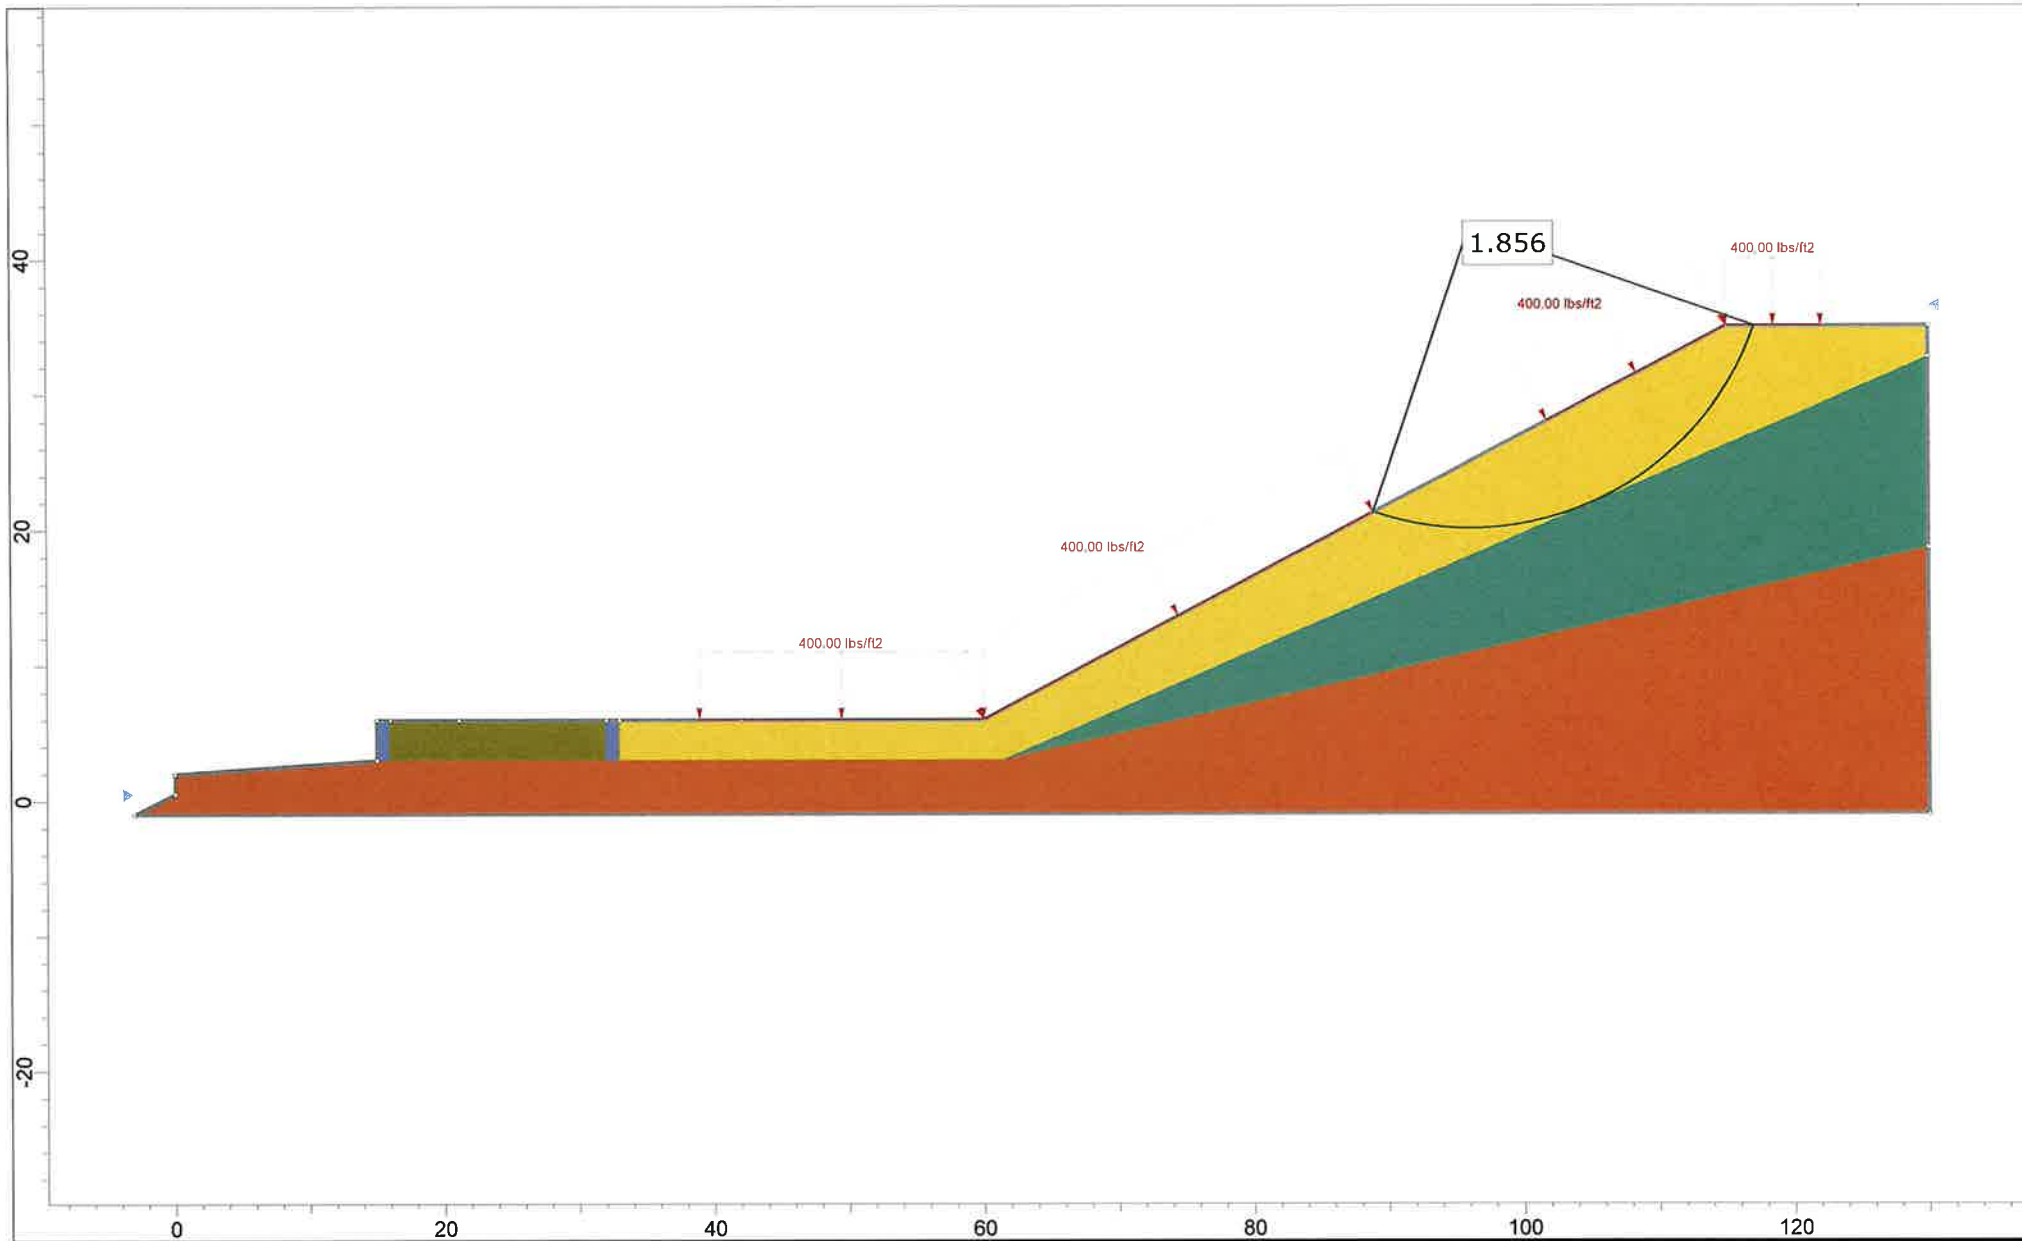
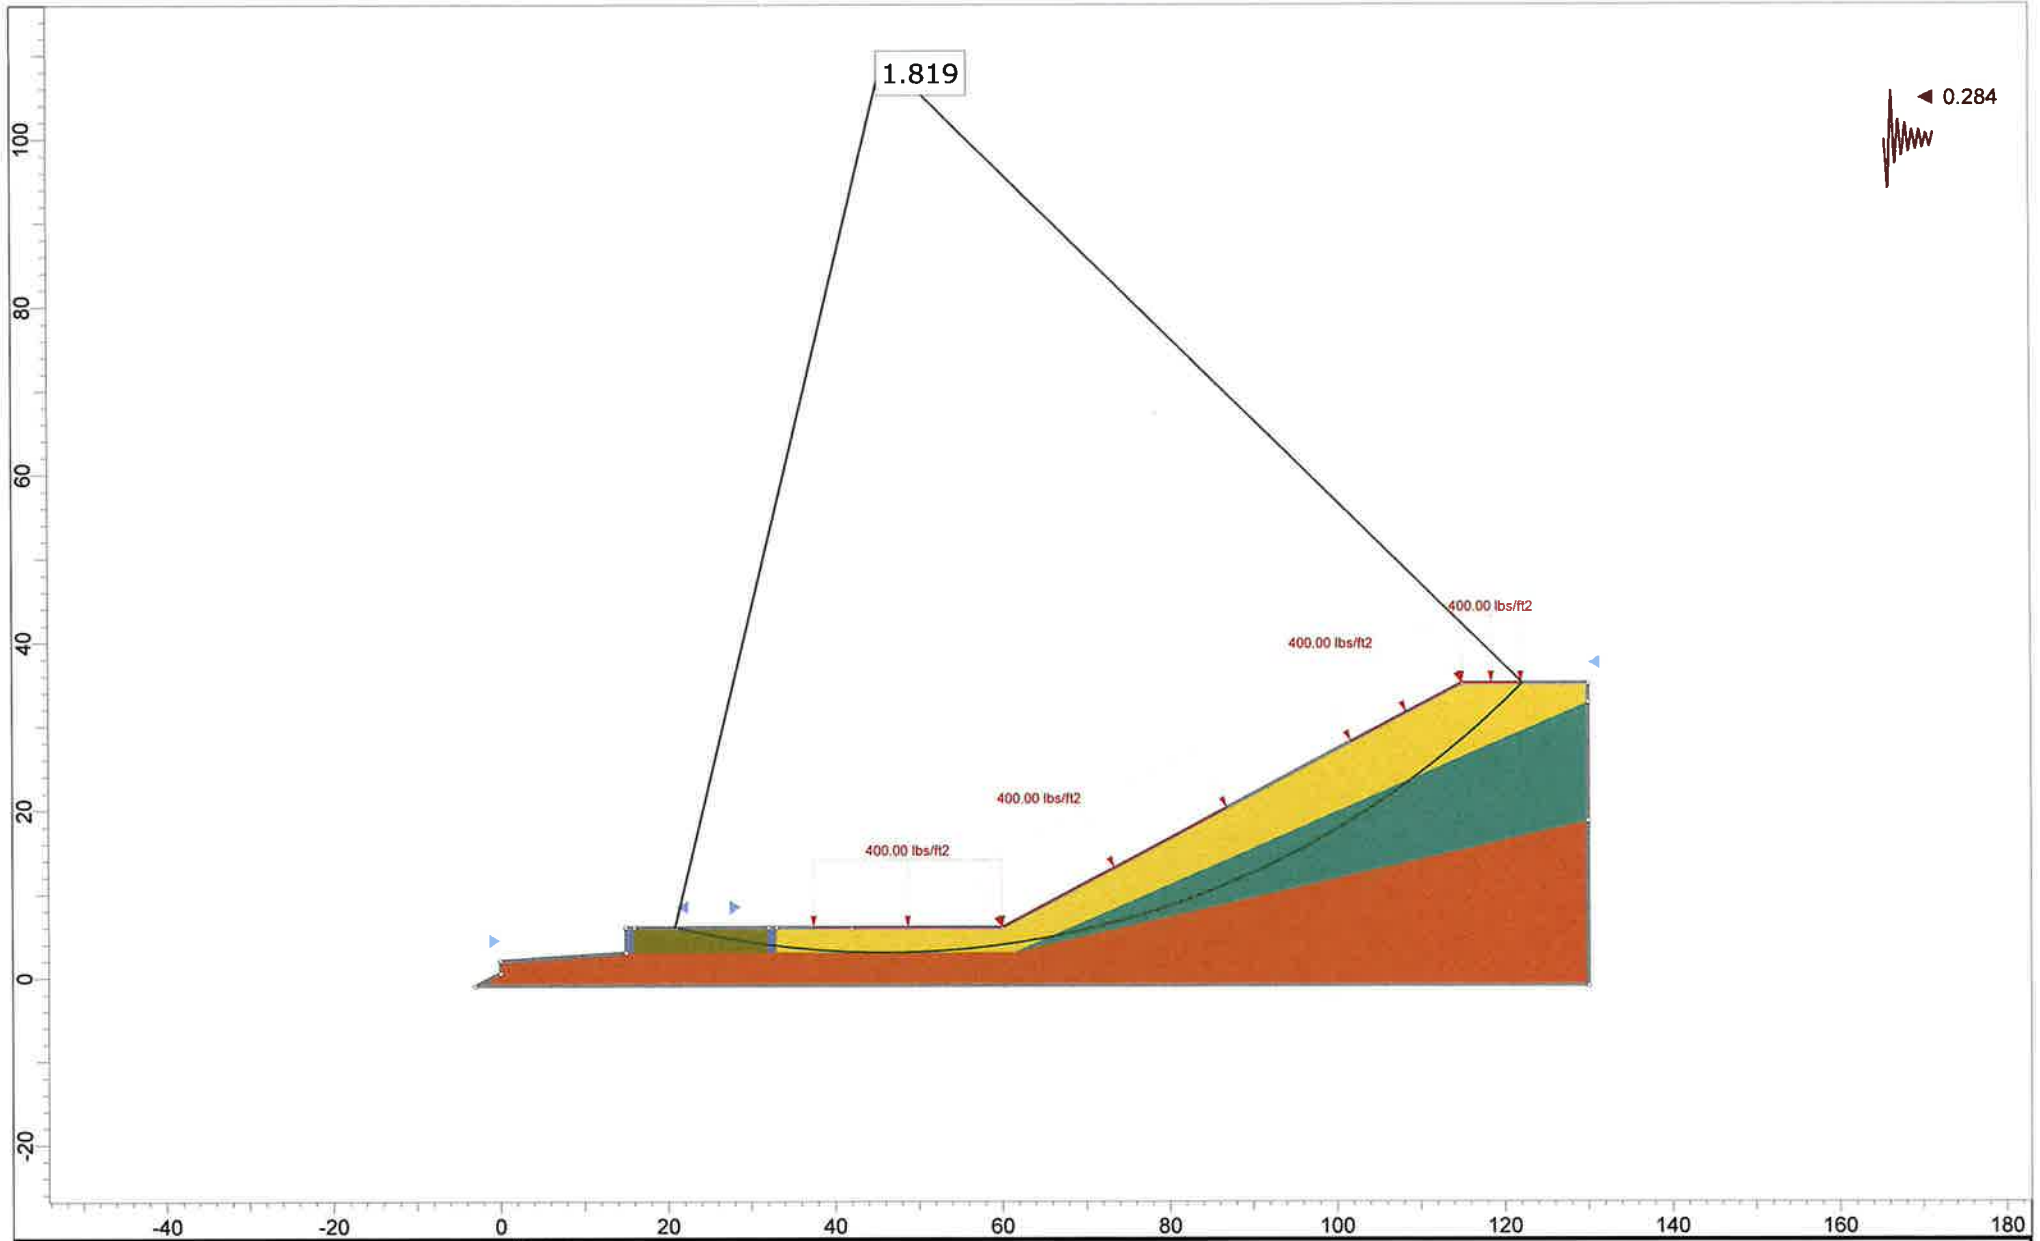
**APPENDIX B**  
**RELATIVE SLOPE STABILITY RESULTS**

Project		SLIDE - An Interactive Slope Stability Program	
Analysis Description		Mercer Island Residence	
Drawn By	S. King	Scale	1:171
		Company	Terra Associates, Inc.
Date	December 12, 2019	File Name	existing.slmd
