Subject: **Transmittal Letter – Geotechnical Engineering Study and Critical Area Study**
Proposed Additions to Existing McLearn Residence
9120 Southeast 50th Street
Mercer Island, Washington

GEOTECHNICAL ENGINEERING STUDY AND CRITICAL AREA STUDY
Proposed Additions to Existing McLear Residence
9120 Southeast 50th Street
Mercer Island, Washington

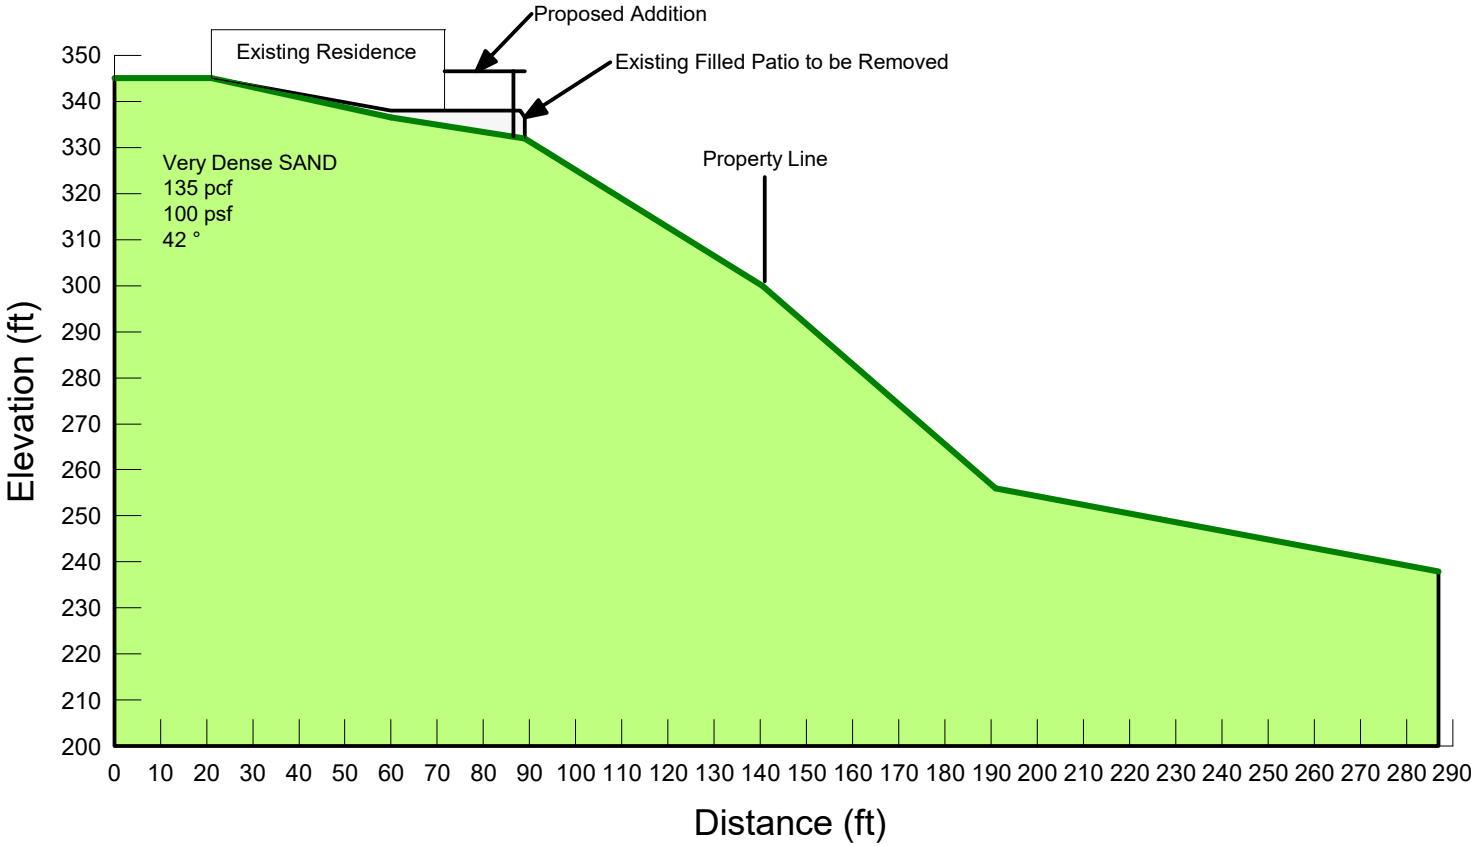
Cross Section

Static

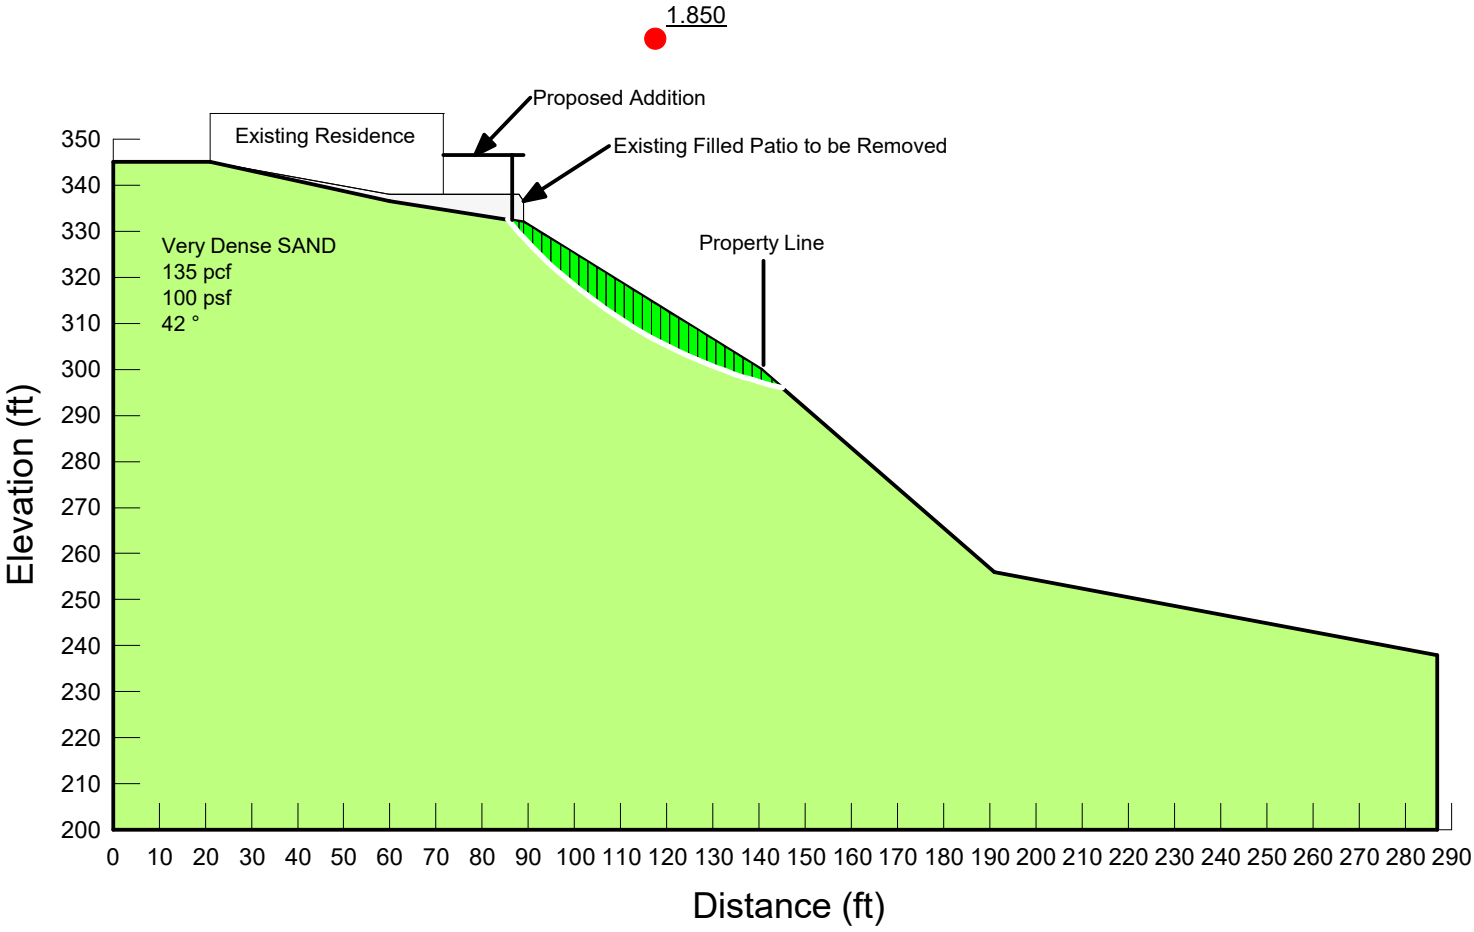
Static

Report generated using GeoStudio 2012. Copyright © 1991-2016 GEO-SLOPE International Ltd.
