LITCHFIELD ENGINEERING

TECHNICAL INFORMATION REPORT for the BCH 93rd AVENUE PROJECT

Prepared By:
Keith A. Litchfield, P.E.

Date Issued: March 30, 2021
Date Revised: May 25, 2021

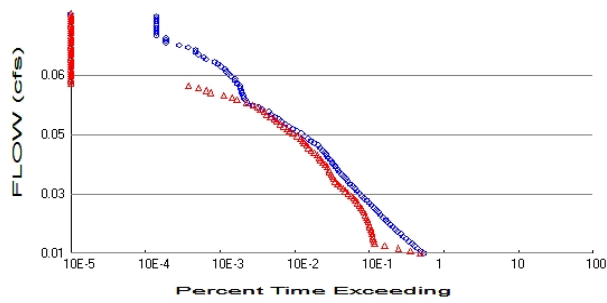
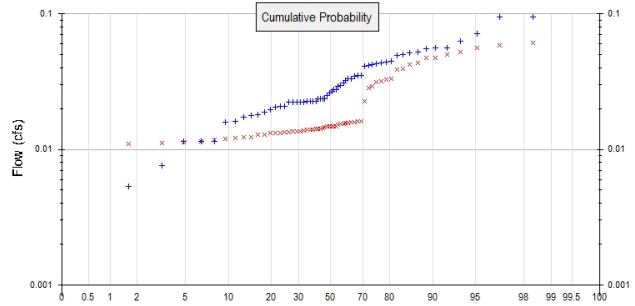
POC 1

Analysis Results

+ Predeveloped x Mitigated

Flow(cfs)	Predev	Mit	Percentage	Pass/Fail
0.0143	11424	10307	90	Pass
0.0150	10371	7602	73	Pass
0.0156	9441	5227	55	Pass
0.0163	8630	3418	39	Pass
0.0169	7948	2513	31	Pass
