Subject: **Transmittal Letter – Geotechnical Engineering Study**
Proposed Four Lot Short-Plat
5224 Forest Avenue Southeast
Mercer Island, Washington

GEOTECHNICAL ENGINEERING STUDY
Proposed Four Lot Short-Plat
5224 Forest Avenue Southeast
Mercer Island, Washington

This report presents the findings and recommendations of our geotechnical engineering study for the site of the proposed four lot short plat to be located in Mercer Island.

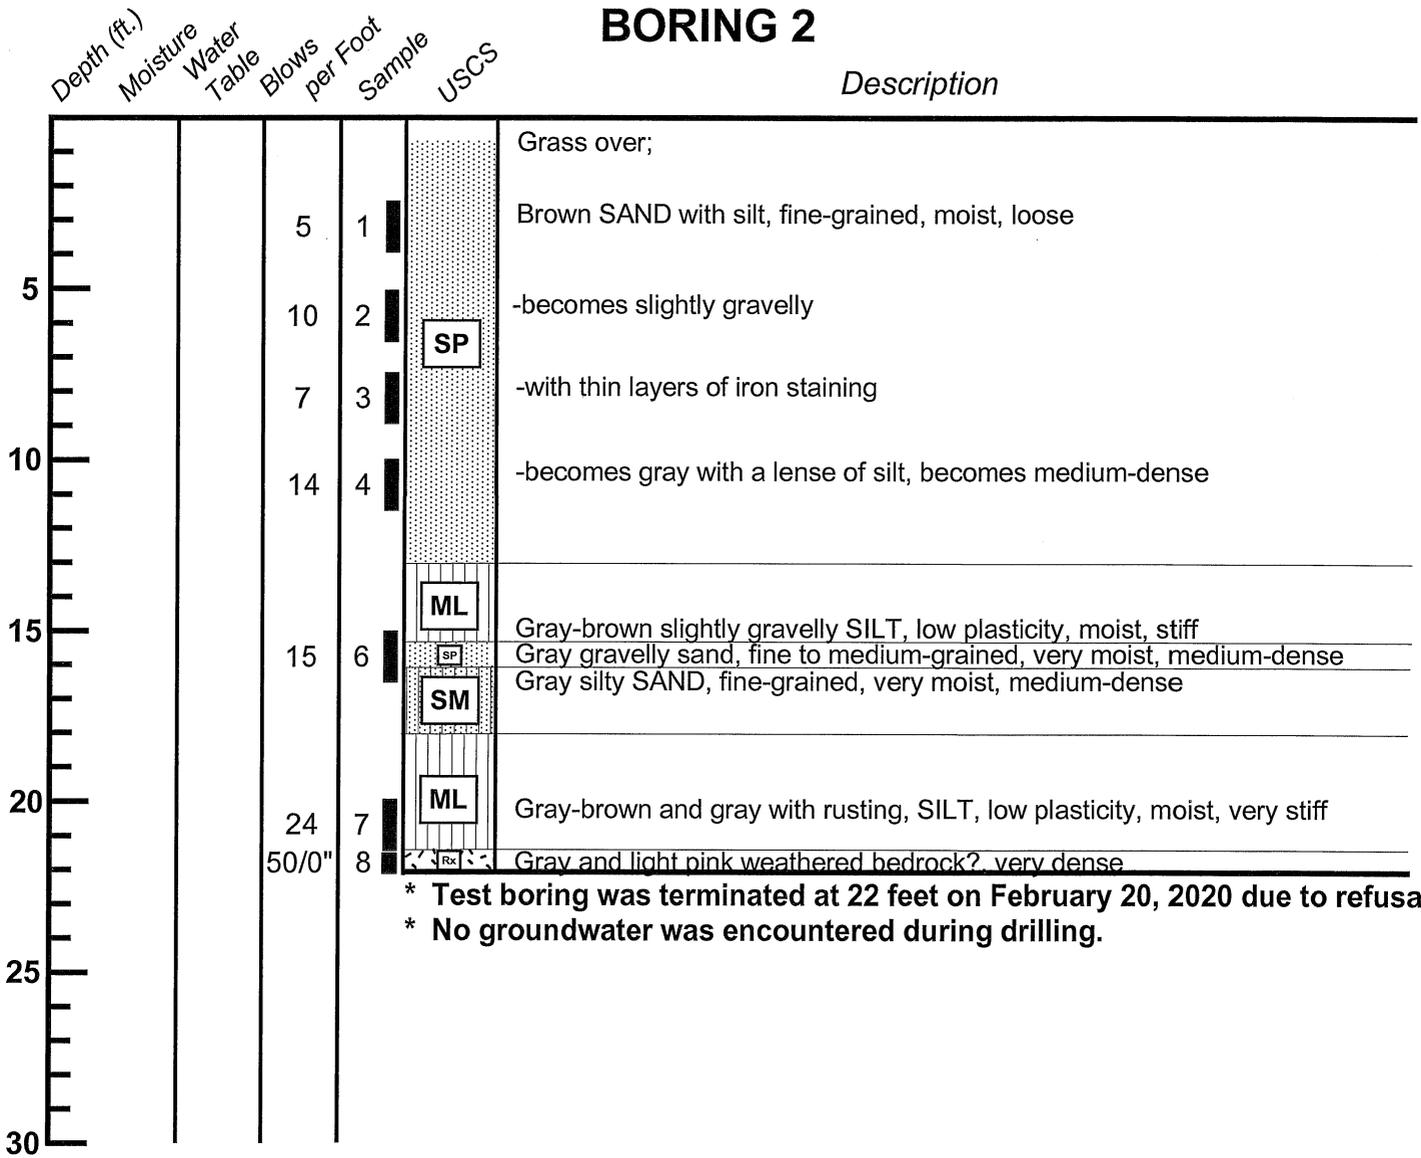
BORING 2

* Test boring was terminated at 22 feet on February 20, 2020 due to refusal.
 * No groundwater was encountered during drilling.

The borings were drilled on February 20, 2020 using a track-mounted, hollow-stem auger drill. Samples were taken at approximate 2.5 and 5-foot intervals with a standard penetration sampler. This split-spoon sampler, which has a 2-inch outside diameter, is driven into the soil with a 140-pound hammer falling 30 inches. The number of blows required to advance the sampler a given distance is an indication of the soil density or consistency. A geotechnical engineer from our staff observed the drilling process, logged the test borings, and obtained representative samples of the soil encountered. The Test Boring Logs are attached as Plates 3 through 6.

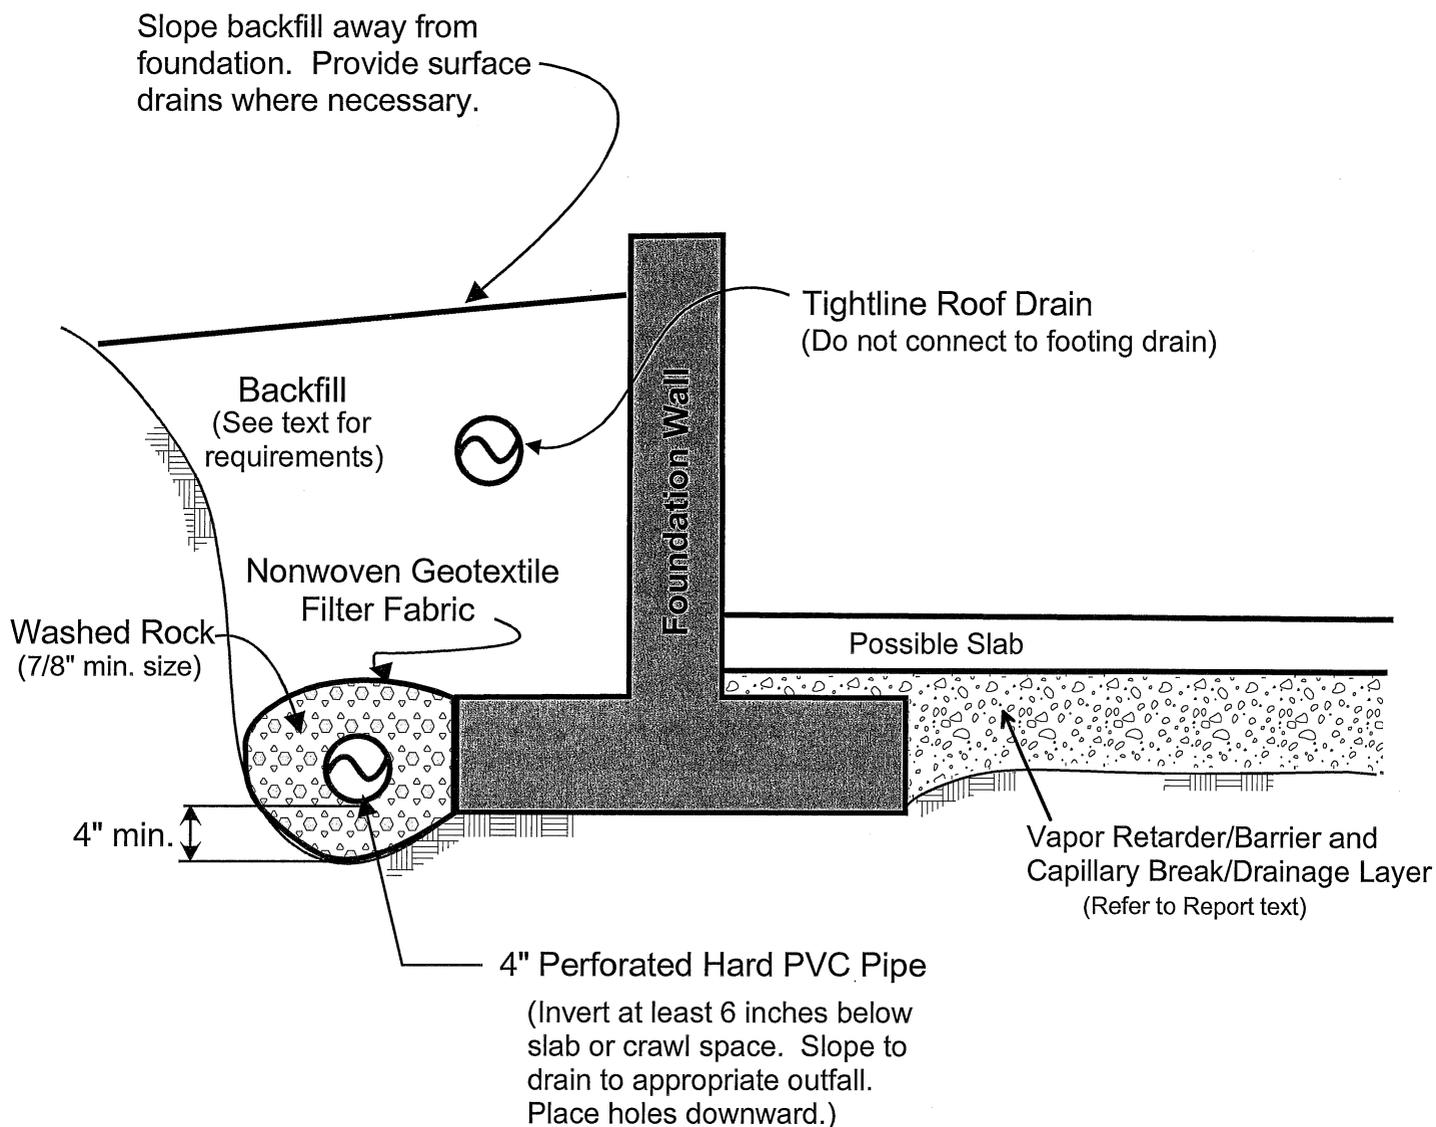
FOOTING DRAIN DETAIL
 5224 Forest Avenue Southeast
 Mercer Island, Washington

- (1) In crawl spaces, provide an outlet drain to prevent buildup of water that bypasses the perimeter footing drains.
- (2) Refer to report text for additional drainage, waterproofing, and slab considerations.

Footing drains should be used where: (1) crawl spaces or basements will be below a structure; (2) a slab is below the outside grade; or, (3) the outside grade does not slope downward from a building. Drains should also be placed at the base of all earth-retaining walls. These drains should be surrounded by at least 6 inches of 1-inch-minus, washed rock that is encircled with non-woven, geotextile filter fabric (Mirafi 140N, Supac 4NP, or similar material). At its highest point, a perforated pipe invert should be at least 6 inches below the bottom of a slab floor or the level of a crawl space. The discharge pipe for subsurface drains should be sloped for flow to the outlet point. Roof and surface water drains must not discharge into the foundation drain system. A typical footing drain detail is attached to this report as Plate 7. For the best long-term performance, perforated PVC pipe is recommended for all subsurface drains. Clean-outs should be provided for potential future flushing or cleaning of footing drains.

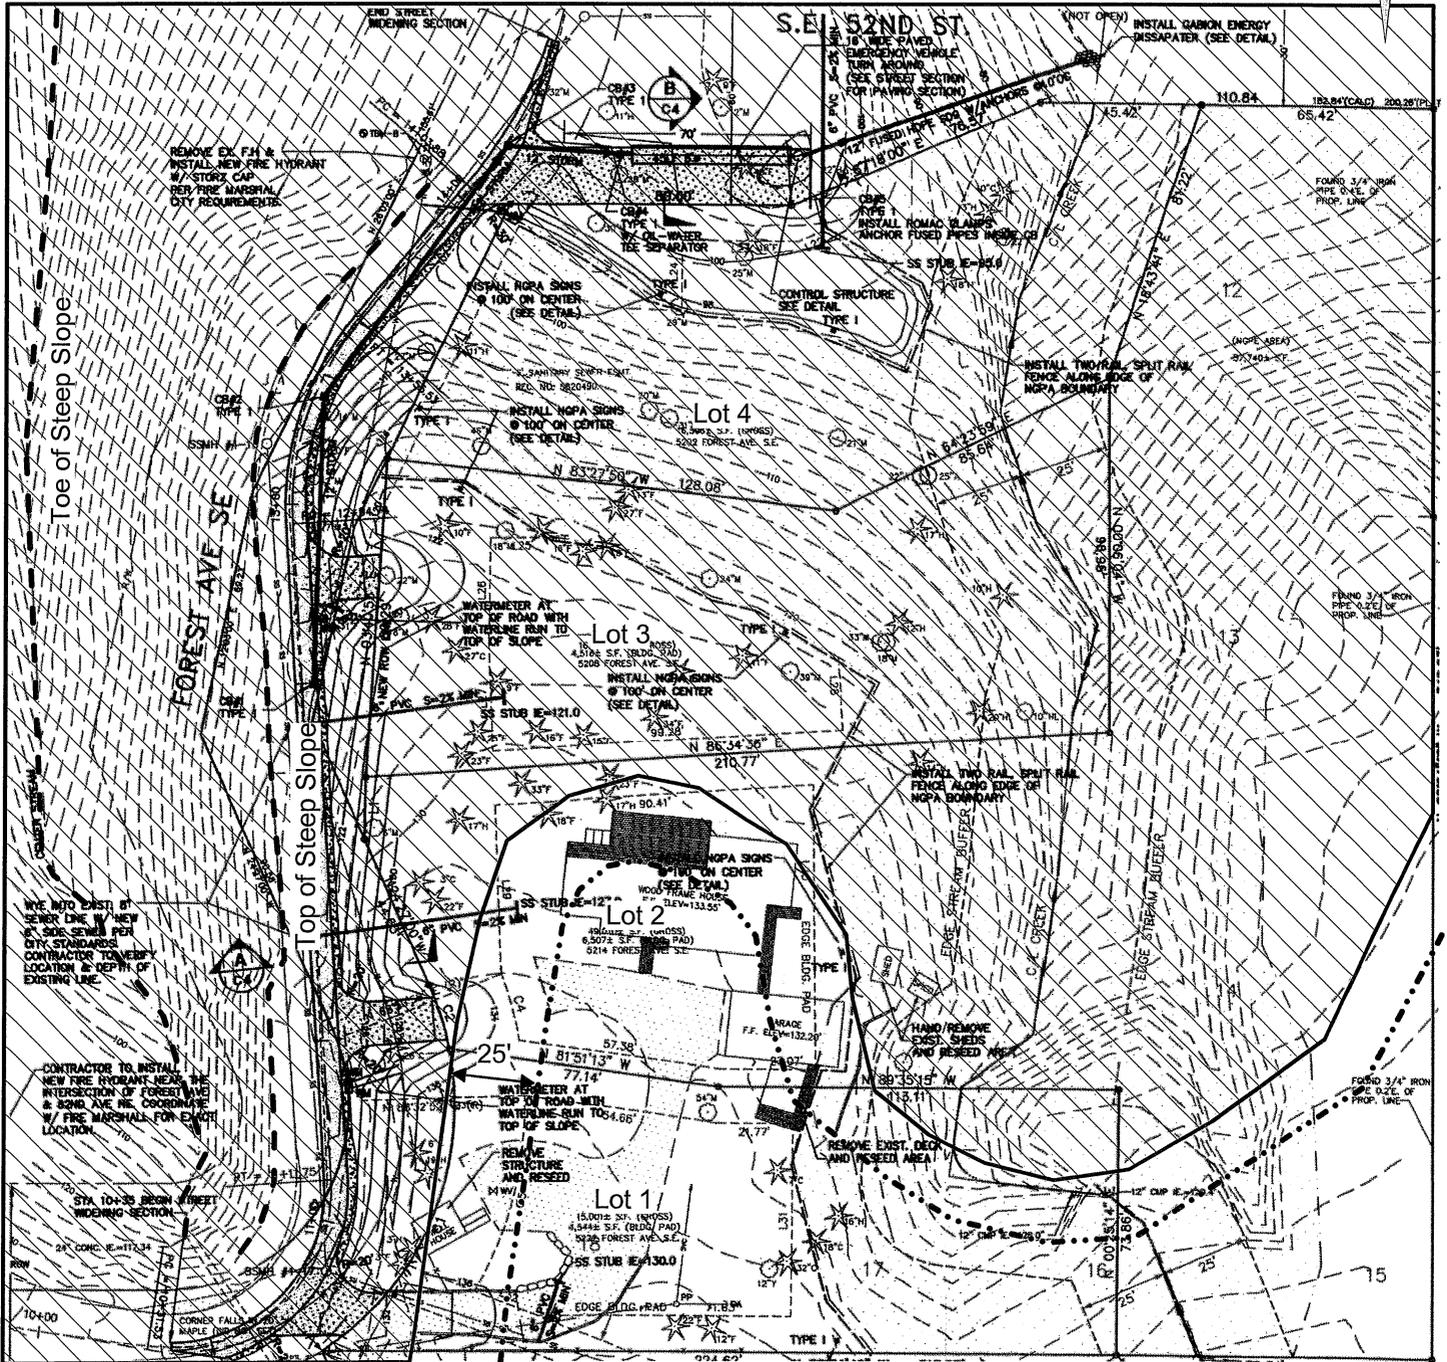
CRITICAL AREAS DELINEATION MAP

Potential Landslide Hazard & Erosion Hazard Area (Based on Mercer Island Mapping)

..... Approximate 25-Foot Potential Landslide Hazard Area Buffer

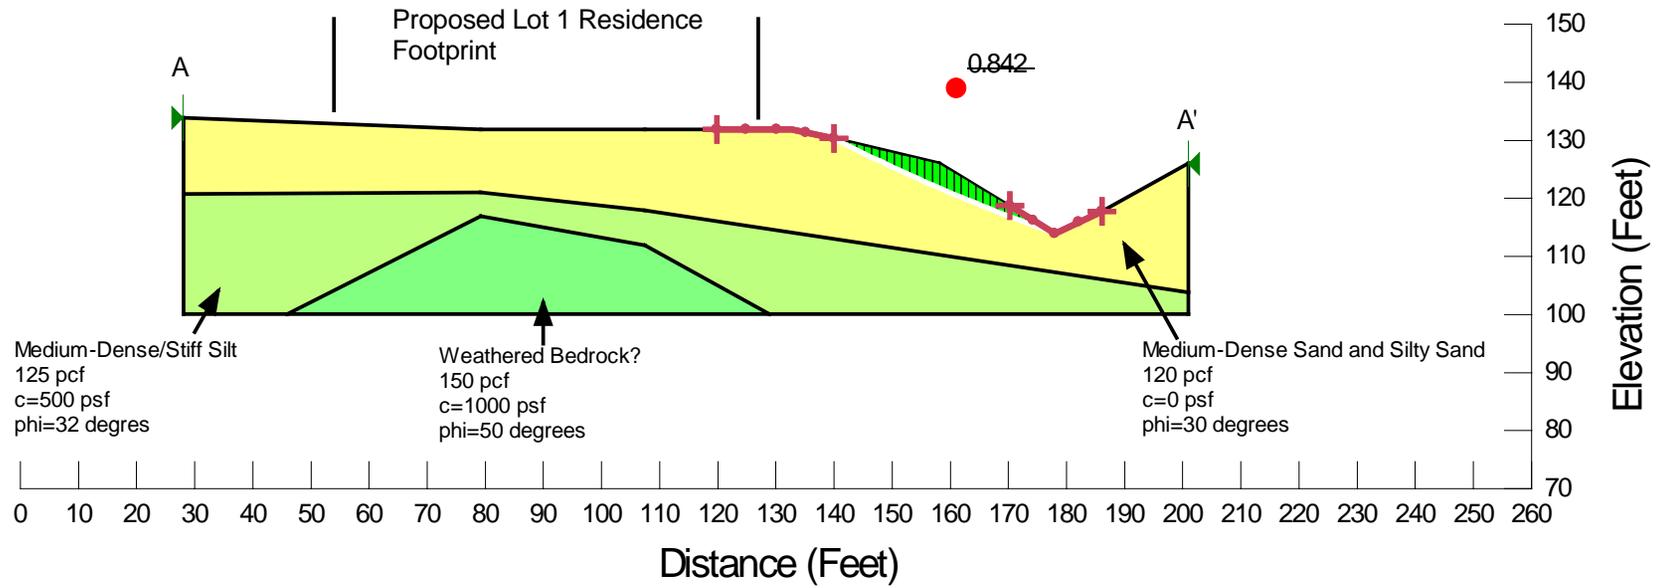
20046 - Seascape Homes
Seismic

Slope Stability Sections
